# **Red Bank Corridor Project**

### **Red Bank Corridor Red Flag Summary Report**

**RELOCATED SR-32 SEGMENT 1**

**RED BANK CORRIDOR IMPROVEMENTS**

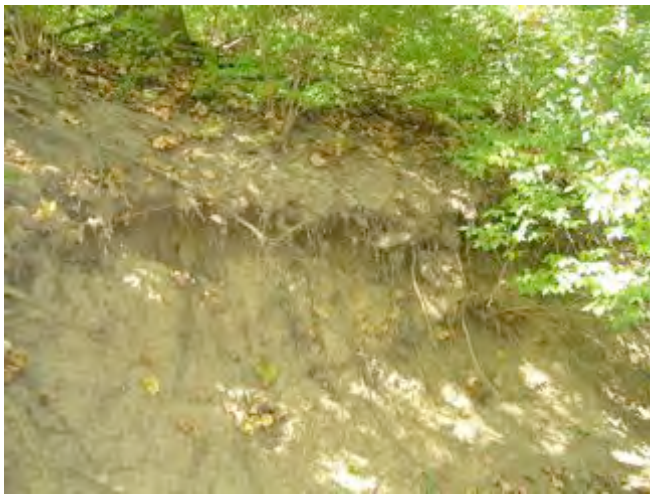
1. Erosion of silty creek bank soils - Duck Creek

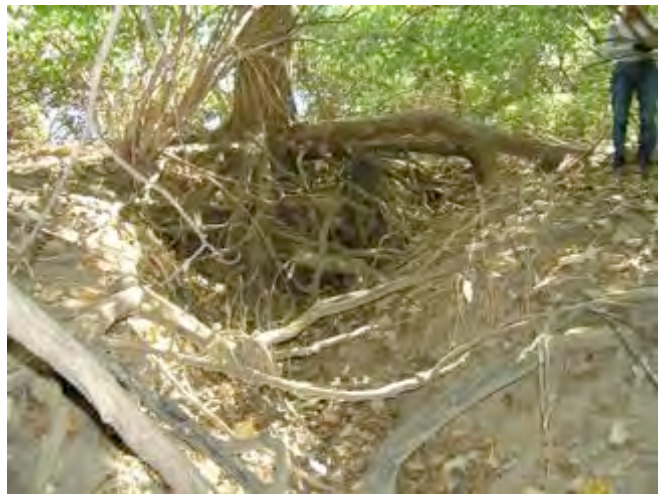
2. Erosion of silty creek bank soils - Northwest Tributary

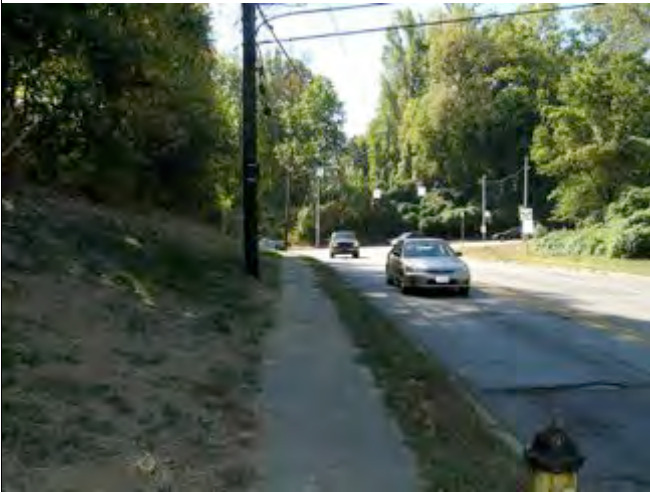
7. Cut slope - Red Bank Road looking south to Duck Creek Road

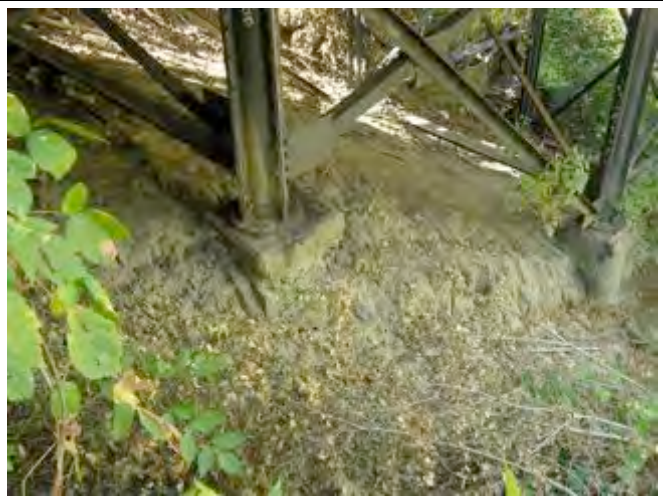
12. Erosion damage to bridge piers – Red Bank Road over Indiana and Ohio Railroad

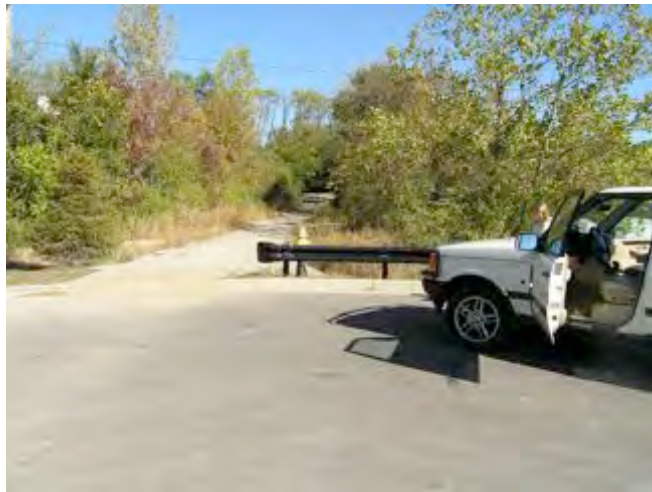
13. Current end of Track Street (Shannon Way) looking east - abrupt elevation change occurs in distance to Virginia Avenue.

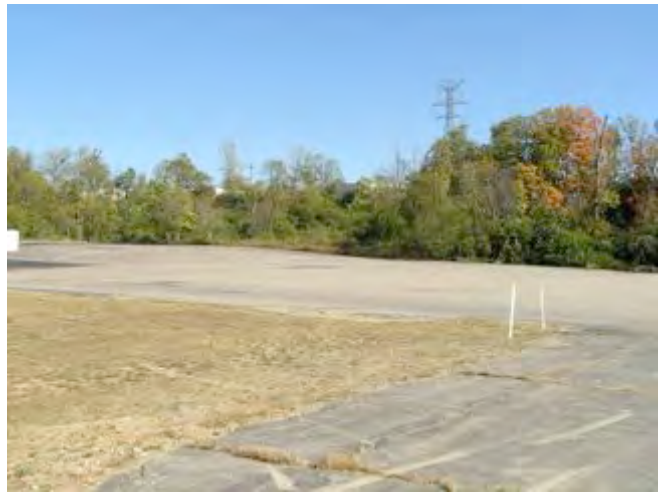
14. General view towards proposed Jonlen Drive/ South Access. Duck Creek ox-bow approximately at tree line and abrupt elevation change to Virginia Avenue beyond.
