Phase I Feasibility Analysis Report

Eastern Corridor Multi-Modal Projects
Segment II/III - Priority Part B Work
Little Miami River Geomorphic
Assessment

February 17, 2009

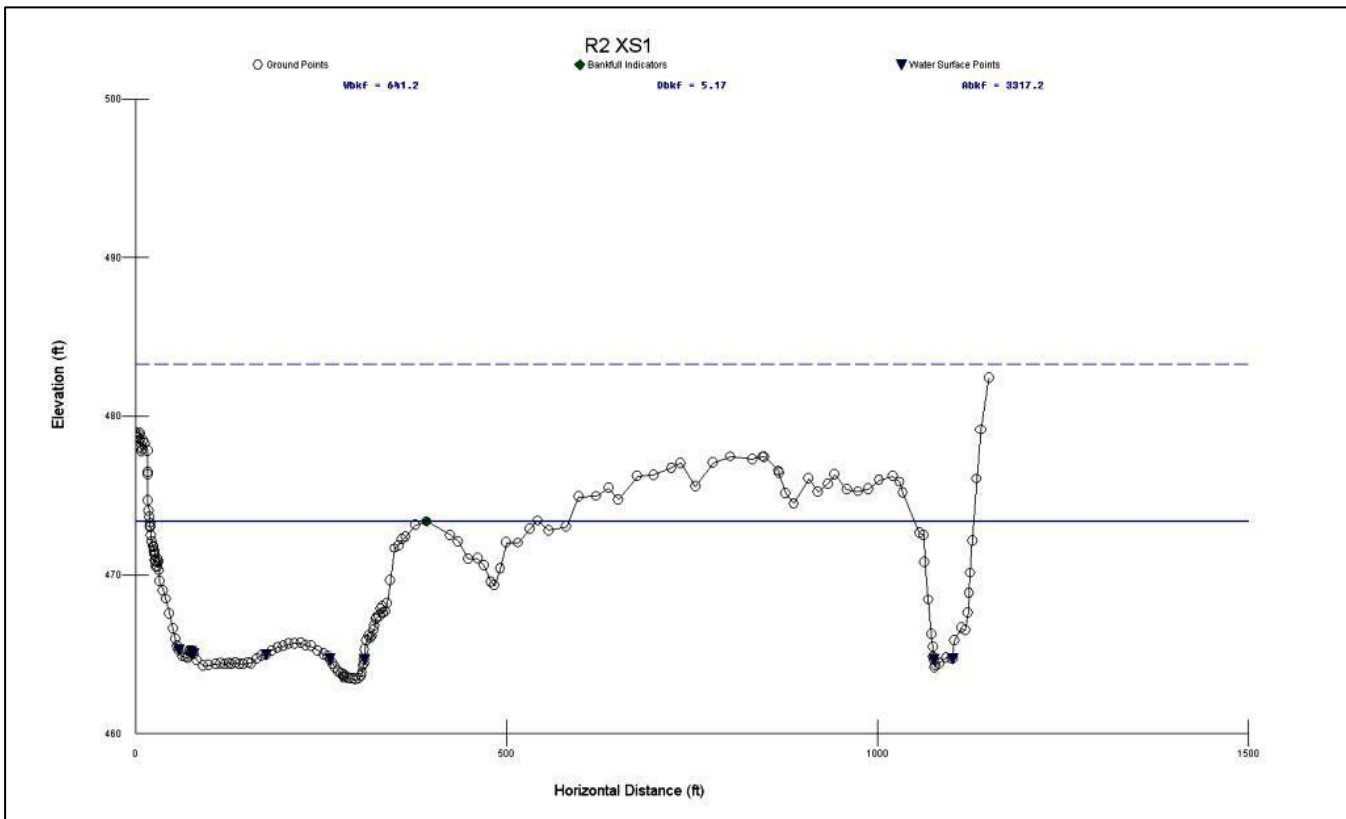
River Name: Little Miami River
Reach Name: RM 4.5 to RM 7.0
Cross Section: R2 XS1
Survey Date: 10/15/2008

Reach 2 The riffle section (R2_XS1) in this reach has a very high width to depth ratio of 124. This high width to depth ratio causes a reduction in stream power, causing sediment to fall out in this reach, also known as aggradation. The aggradation and instability is apparent by an observed gravel island in the middle of the active channel before Horseshoe Bend in Reach 2. The island is not discernible in 2004 aerial photography, although depositional processes are evident in this area. In 1990, one channel followed along the existing right alignment in a northwest direction. The channel appears to have widened and flowed in a more westerly direction with visible deposition in the island area in 2004. By 2007, the island and dual low flow alignments had formed. A submerged transverse bar connects the head of the island to a gravel bar feature along the right bank, visible only during lower flows. A long, wide, shallow riffle is present along the left low flow path. The right side loops around the island and is near half the width and slightly deeper than the left low flow path. The right alignment bends left along a large side bar to rejoin the left alignment and continue along the left's heading into the bend.

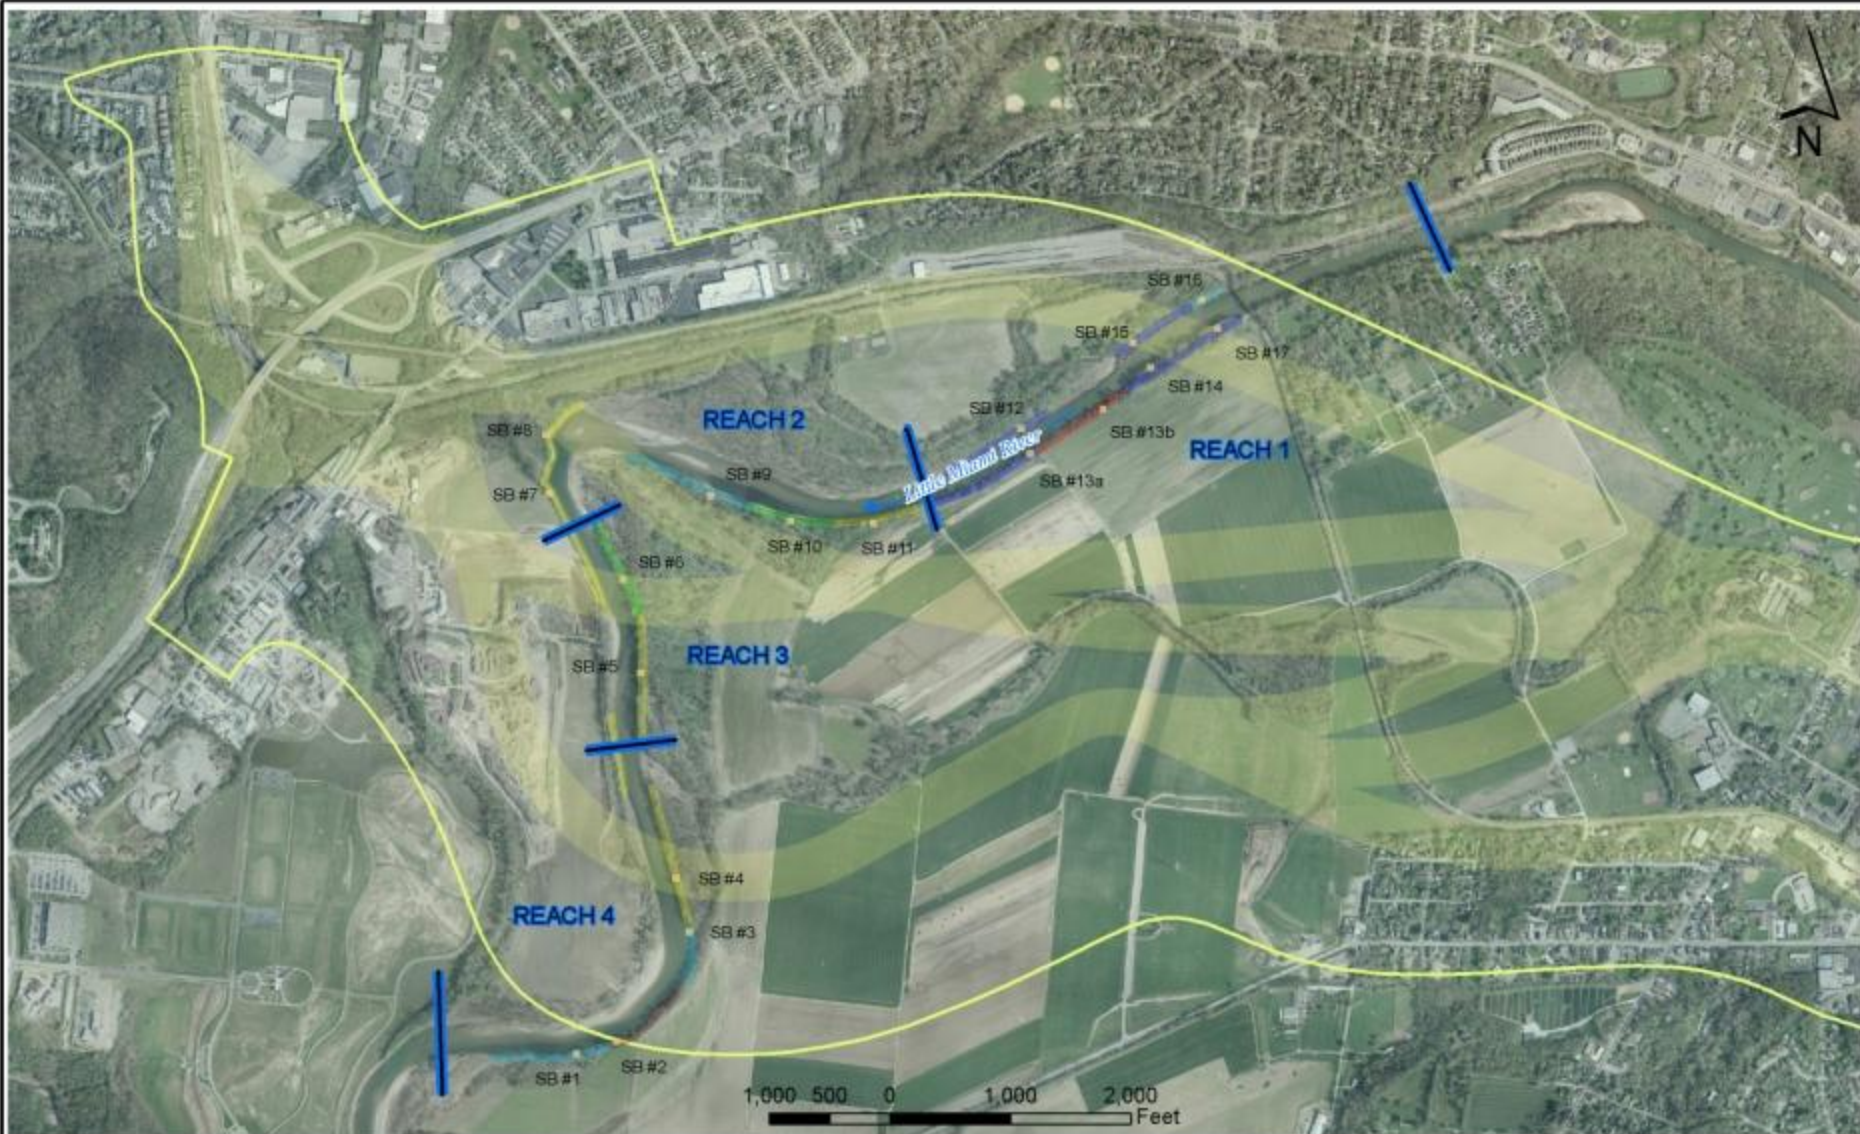
Bank Erodibility Drawing E-1

characterize bank stability. Banks were rated using the Bank Erodibility Hazard Index (BEHI) and Near Bank Stress (NBS) evaluations. In general, the BEHI procedure helps to predict erosion potential based on a number of variables including bank height, rooting depth, rooting density, surface protection, bank angle, bank stratification and soil composition. The NBS procedure evaluates the potential for increased shear stresses in the near bank region. For this study, Phase I is a predictive assessment of erosion rates and Phase II will validate those erosion rate predictions. Predicted bank erosion rates are presented in detail in Drawing E-1 in Appendix E.

Overall, bank erosion potential increased in the downstream direction. Figure E-1, found in Appendix E, illustrates the banks studied and predicted erosion rates throughout the study area.

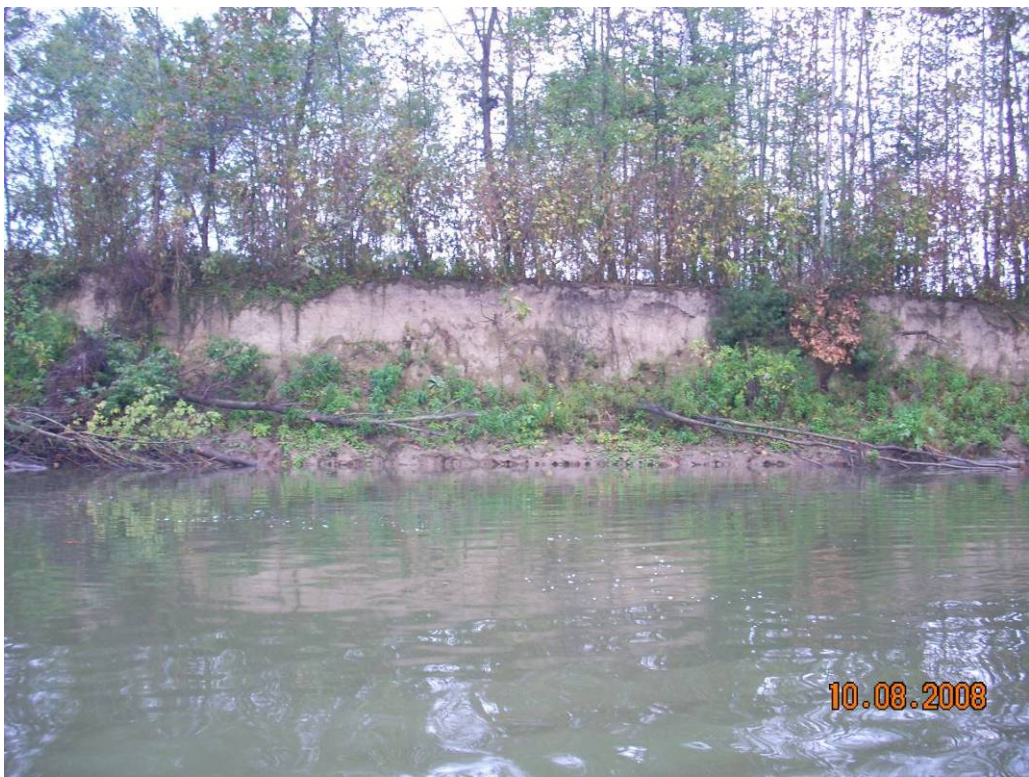
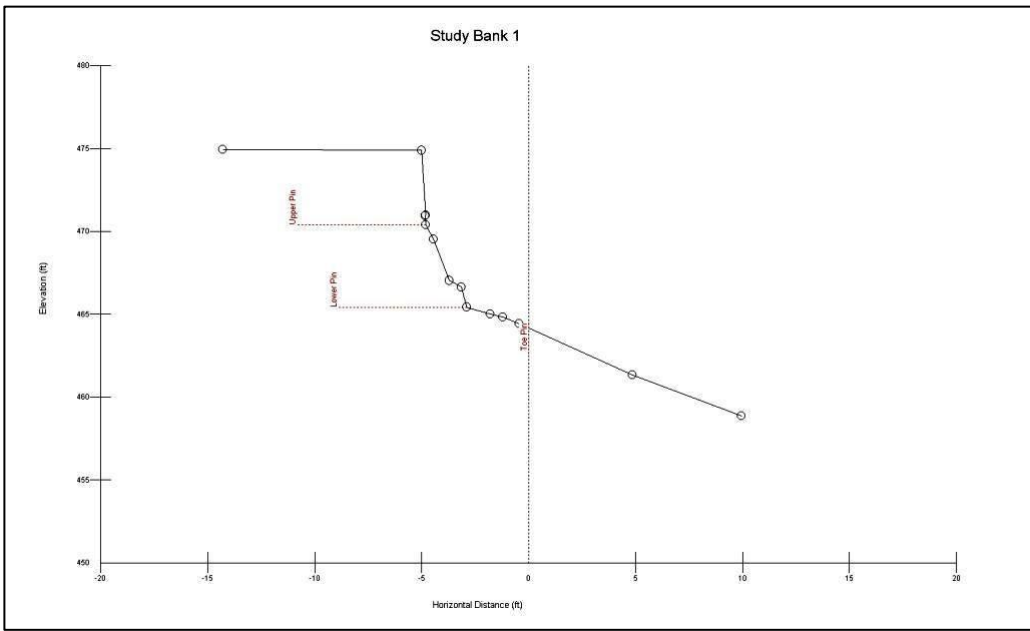
Study Bank 1

Erosion potential in Reach 4 varies from very low to extreme. The upper portion of this reach has banks of high sand content with stratification and low rooting depth and the lower portion has extremely steep slopes and high banks with low root density and rooting depth. Some banks are stratified with gravel, sand and silt/clay. Large slope failures were observed at Study Banks 1 and 2 in Reach 4 during the time of data collection.

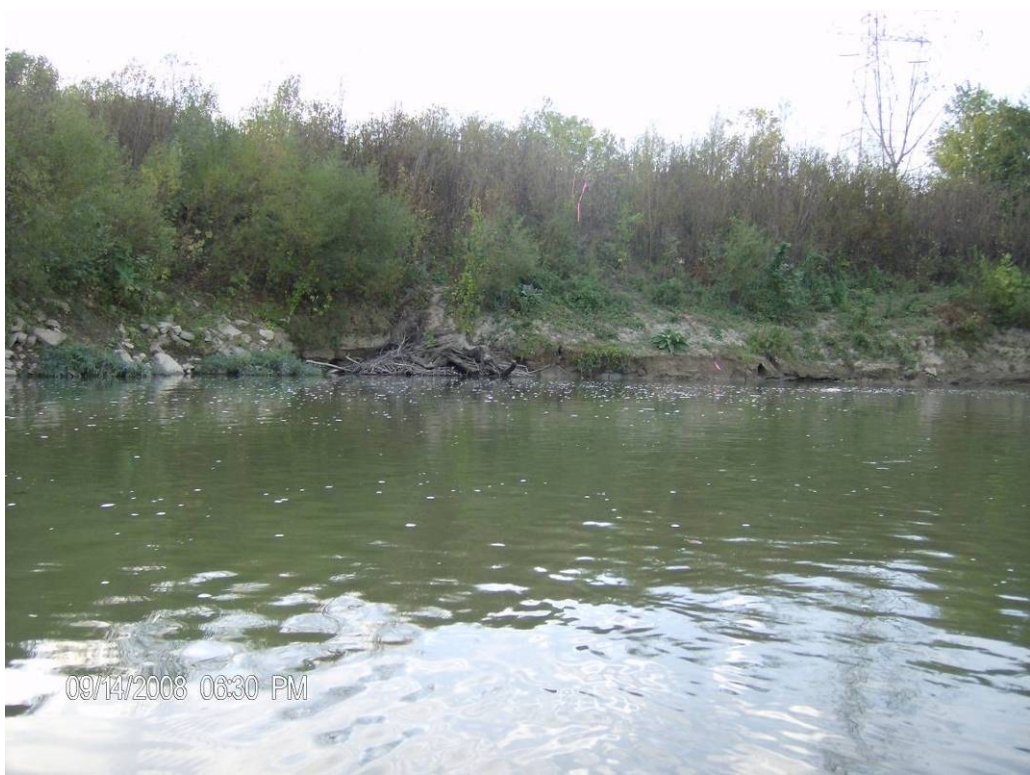
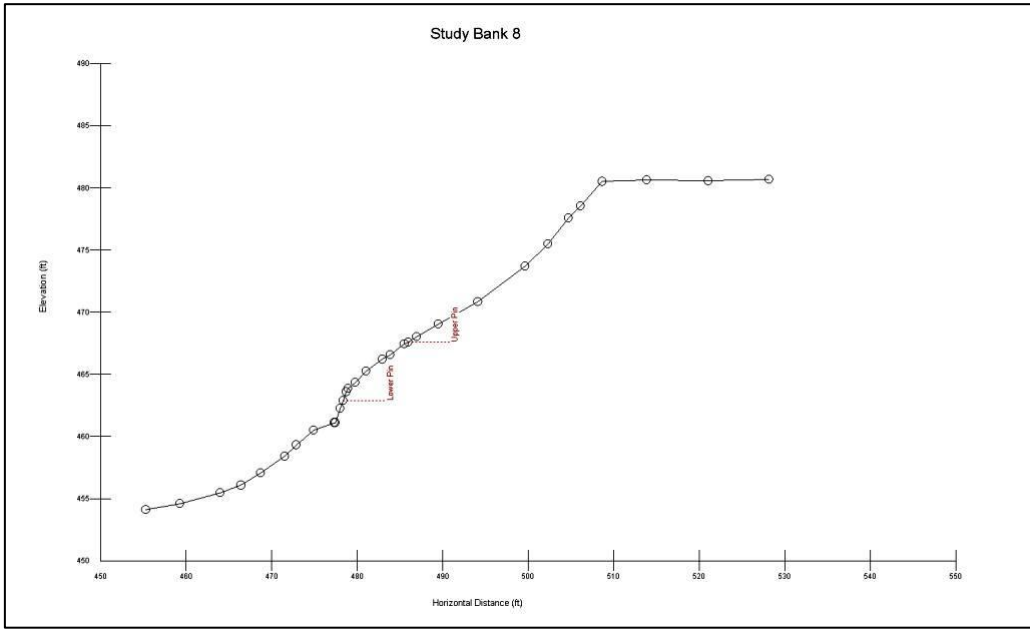
Study Bank 8

Study Banks 8, 9, 10, and 11 in Reach 2 have bare soil faces with low rooting depths and densities and low percentages of surface protection. Frequent bank stratification was observed on many of the banks in Reach 2. These banks have mostly moderate and high erosion potential. Study Bank 7 has a high percentage of surface protection from concrete rubble but has a high erosion potential due to very high shear stresses in the near bank.
