Stream Stability Analysis Report

Eastern Corridor Multi-modal Projects Segment II/III - Priority Part B Work Little Miami River Geomorphic Assessment

December 18, 2009

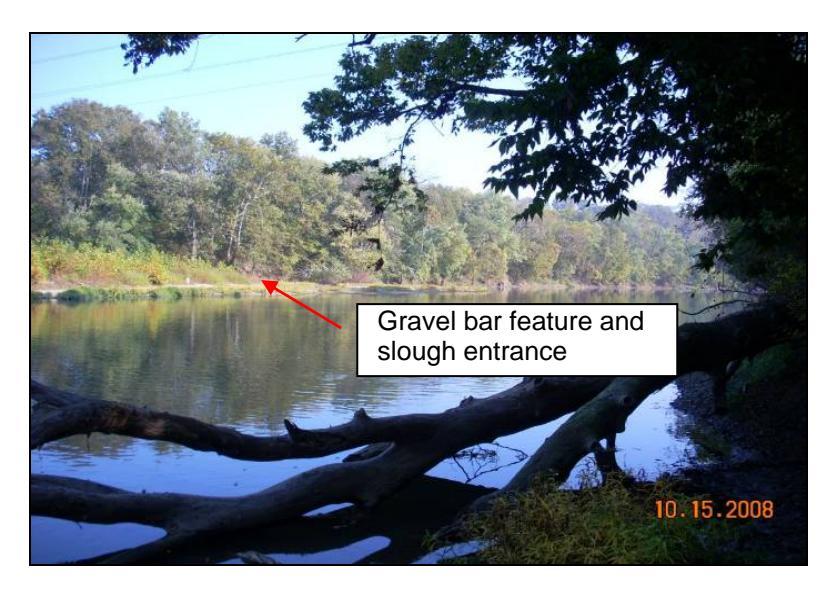
a. Gravel bar on right bank near slough/distributary

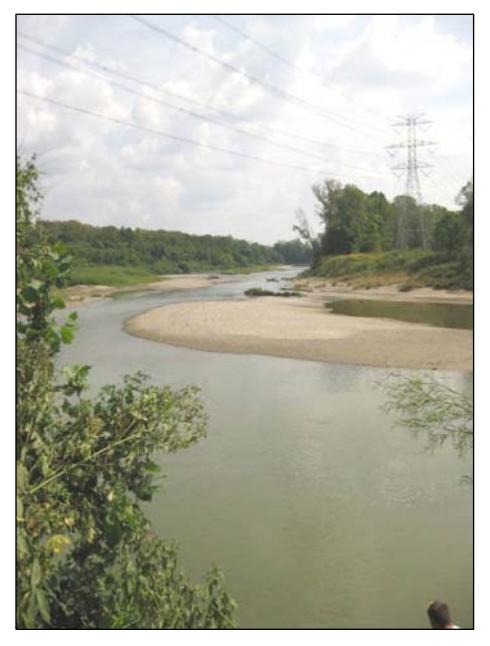
Currently, Horseshoe Bend has a large point bar on the inside of the meander bend, stretching approximately 1,500 ft in river length. The bar is composed predominantly of gravel, near the low flow water surface, with an increasing sand component up the point-bar slope to the bankfull elevation, where the particle distribution is almost entirely sand. A mid-channel, gravel bar began forming on the upstream side of the bend near the point of curvature in 2005. By 2007, the bar had moved outward further into the bend. In 2008, the bar grew larger and connected to the point bar by a thin strip of gravel near the upper third of the point bar. This depositional pattern is not evident in the 2007 aerial photography.

Figure 8. East/Upstream View from the Outer Bank of Horseshoe Bend

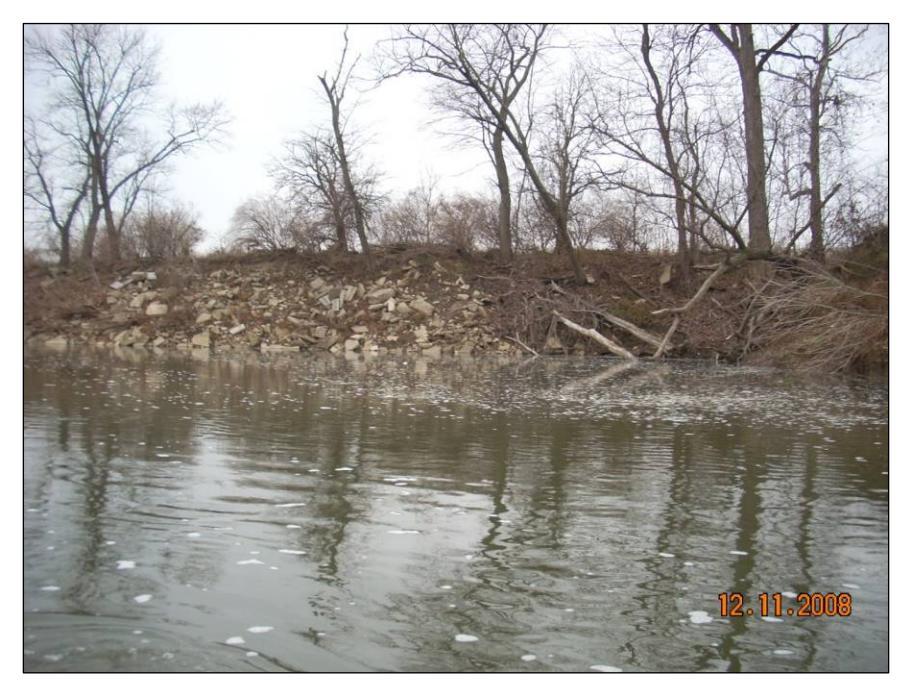
Figure 10. Rubble Armoring of Right Bank Below Horseshoe Bend

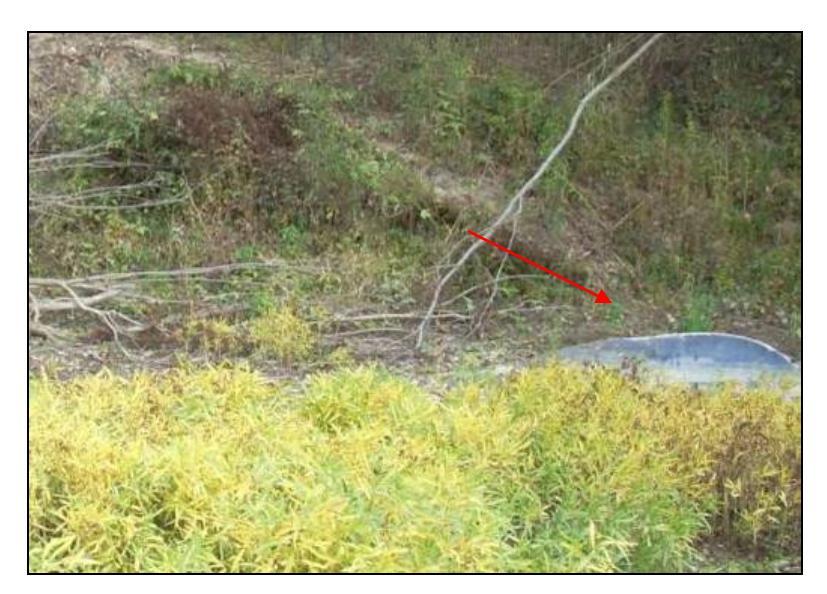
a. Partial Boat Hull

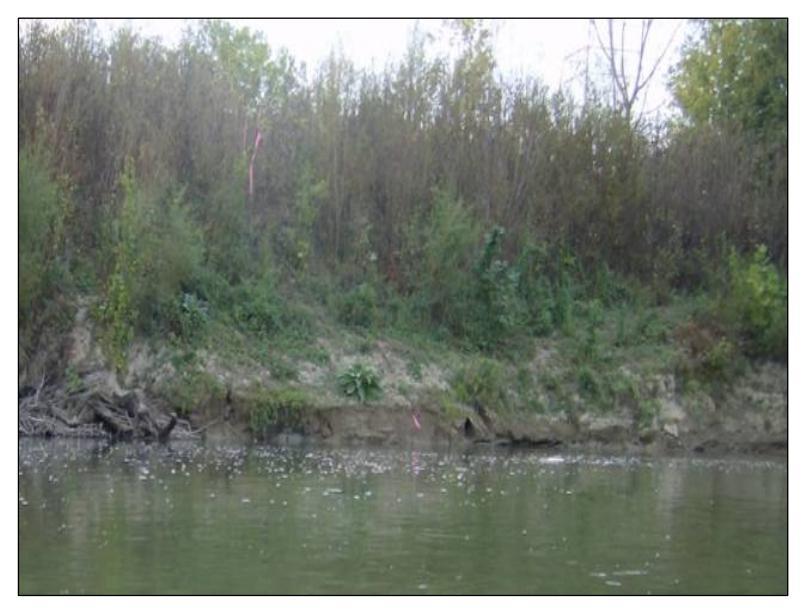
Reach 2 SBs 8, 9, 10, and 11 have bare soil faces with low rooting depths and densities coupled with low percentages of surface protection. Frequent bank stratification was observed on many of the banks in Reach 2. These banks have mostly high erosion potential. SB 7 has very high NBS but low erosion potential due to concrete rubble armoring (Figure 10). SB 8 (Figure 13), located on the outer bank of Horseshoe Bend, exhibited very high erosion potential due to low rooting depths and densities, along with poor surface protection and extreme NBS.

Figure 13. Study Bank 8 on the Outside of Horseshoe Bend

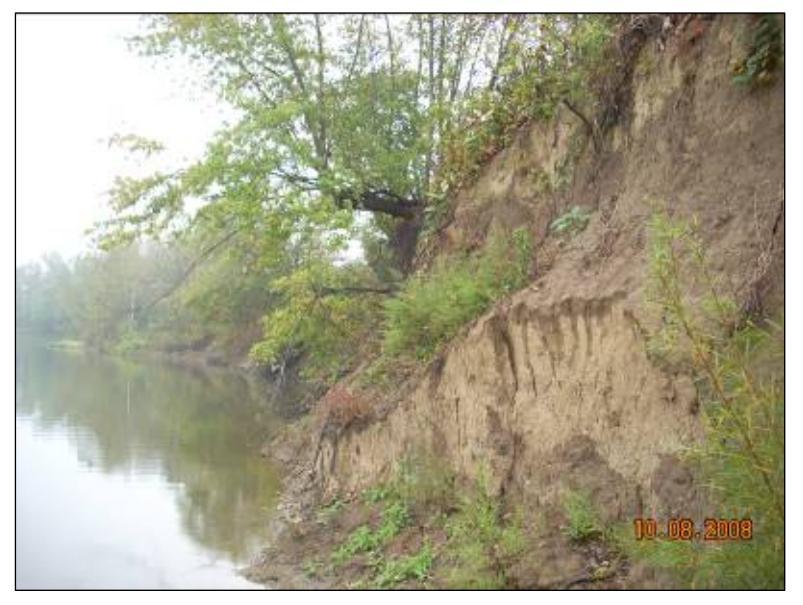
Reach 4 Erosion potential in Reach 4 varies from moderate to extreme. The upper portion of this reach has banks of high sand content with stratification and low rooting depth, while the lower portion has high banks with extremely steep slopes, low root densities and depths, and minimal vegetative coverage and protection. Some banks are stratified with gravel, sand and silt/clay. SB 3, in Reach 4, is located near the exit of the Clear Creek slough, which creates additional impacts due to inundation and flows from multiple directions. SB 2 has a notable absence of riparian buffer. Large slope failures of various mechanisms were observed at SBs 1 and 2 in both phases of the study as shown in Figure 15.

Figure 15. Bank Failure Near Study Bank 2

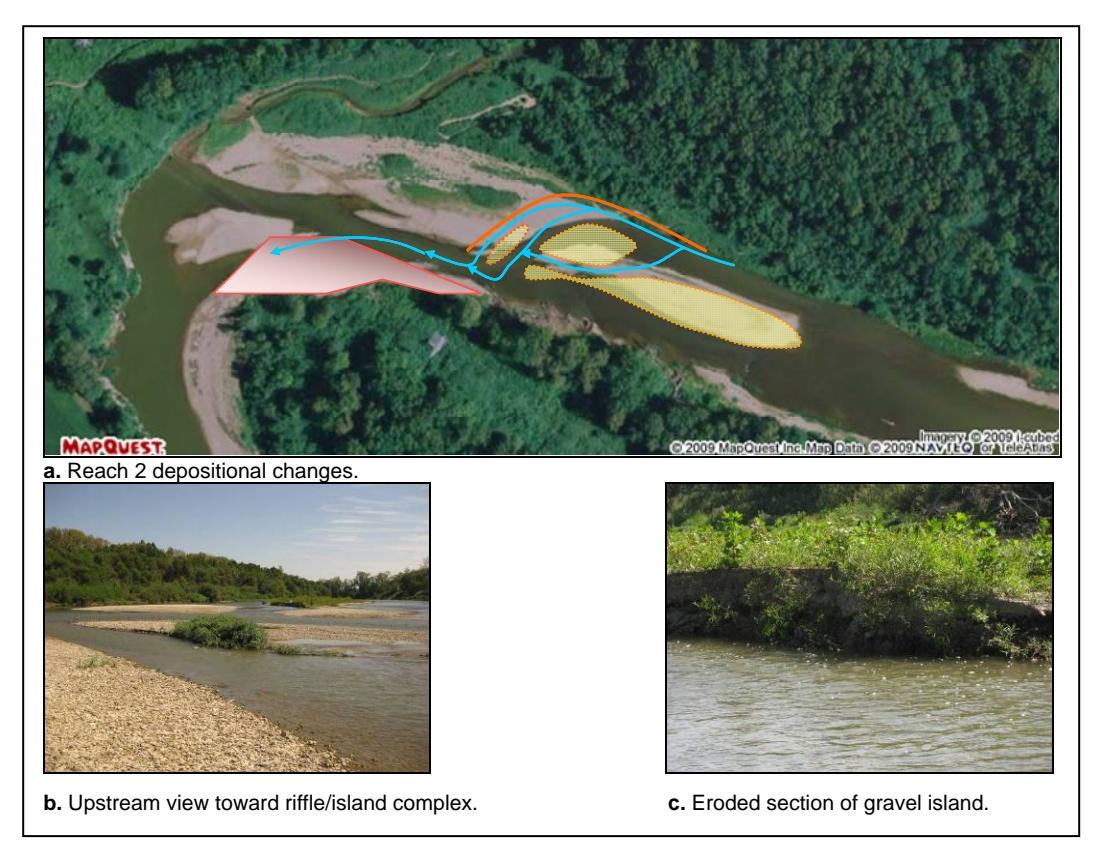
Several changes occurred in Reach 2. Cross section R2 XS1, located in the Reach 2 riffle and through the head of the gravel island above Horseshoe Bend, indicates slight deposition of the left alignment and slight scour of the right alignment. Scour chains reevaluated in Phase II indicated the same results. Scour chain results may be viewed in Appendix F. Further analysis of the reach profile revealed no overall aggradation or degradation of the river profile at the riffle. Pebble counts collected through the section were very similar between study phases, with only a very slight shift to coarser material in 2009. During the study period, significant depositional processes have been observed at the downstream end of the riffle/island complex. Additional mid-channel bar features were created in the northern/downstream path of the river. These features formed as a result of the river eroding away and cutting through the right bank and lower end of the existing gravel island and then depositing the material downstream (Figure 16). Depositional features/patterns were observed during the study period and documented on Worksheet 5-10 in Appendix F. The new channel configuration directs flow towards the left bank and inside of the point bar at Horseshoe Bend. This flow pattern increases local near-bank stress and susceptibility to erosion, which corresponds with field observations of erosion along the inside of Horseshoe Bend and data from cross section R2_XS2.

Figure 16. Reach 2 Depositional Changes

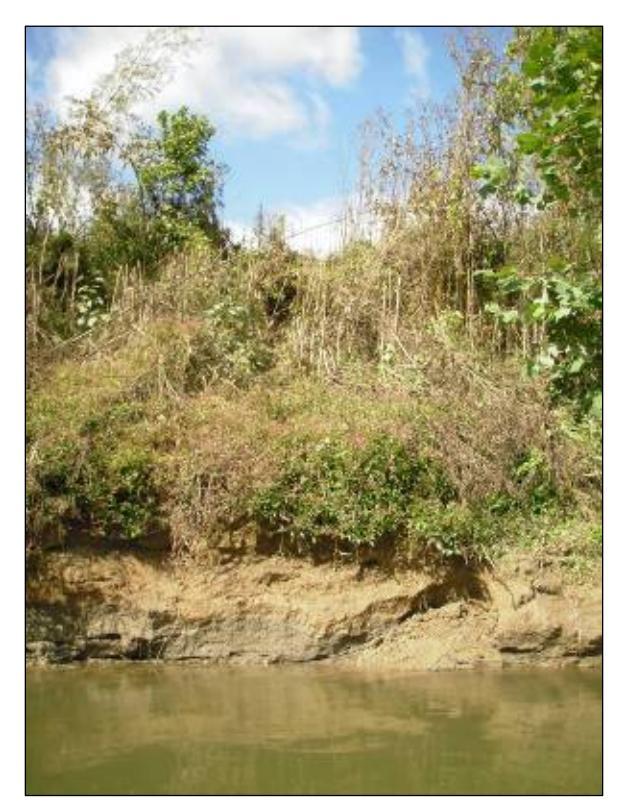
Reach 2 Erosion at SBs 11, 10, and 9 increased with proximity to Horseshoe Bend, ranging from 0.12 to 0.15 ft/yr, respectively. SB 8, which is on the outside bank of Horseshoe Bend, exhibited very high erosion potential according to the BEHI and NBS evaluations of Phase I. Data from Phase II shows that the lower portion of SB 8 experienced several feet of lateral erosion (See Figure 17), while the upper portion remained relatively unchanged. The average erosion rate for this bank was 1.34 feet. This erosion was observed frequently along the bank. As described in Section 3.2, the submerged logs extending from the bank were notably more exposed during Phase II data collection. Large bank slumps were also noted just downstream of SB 8, below the sewer outfall. This portion of bank is located in a small "pocket" on the outside of the bend, making it susceptible to eddy scour. It is also in the path of the modified flow line which comes across the inner portion of the bend, as illustrated in Figure 16a.

Figure 17. Erosion at Study Bank 8

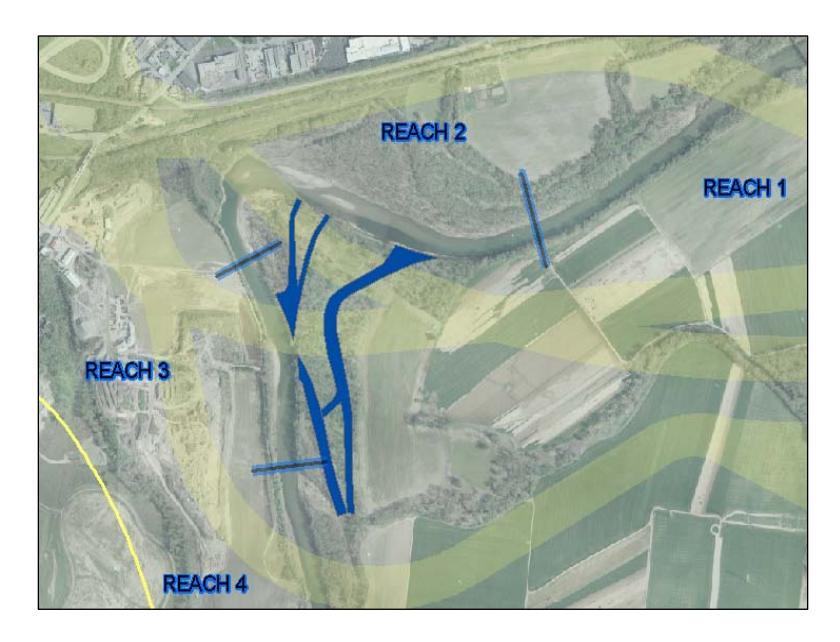
Reach 2 Reach 2 has a history of lateral migration and avulsion, and is the most active of the four reaches (within the overall study reach) with regard to lateral movement in recent vears. Since 1959, the entrance to Horseshoe Bend has migrated downstream by approximately 500 feet. However, downstream of the bend at cross section R3_XS1, the banks have moved less than half that distance. From 1990 to present, the entrance to the bend has migrated 275 feet while the exit has moved less than 50 feet. The most recent bend configuration began around 1980, closely following the construction of the Harsha Dam on the East Fork. From 1981 to 2000 the bend extended outward roughly 200 feet, which equals around 10 feet/year. The armoring on the downstream banks of the bend prevented any further migration outward or downstream; however, the river alignment above the bend continued to move downstream, reducing the radius of the bend. These are all indicators of a significant channel movement and potentially a future avulsion. Since 2004, banks in the Horseshoe Bend area have not experienced significant movement. Data and observations presented in Section 3, however, indicate that these processes are still causing change along the river. The outside of the bend continues to erode as evidenced by the loss of over 2 feet of bank at the toe, and the active reconfiguration of the flow around the gravel island upstream. It appears to be removing the point bar at the inside of the bend, exposing even more length of bank around the outside of the bend. Depositional activity remains significant as indicated by the changes in the gravel bars in the bend and upstream of the bend. In the past, significant depositional activity has signified rapid channel movement. Reach 2 is expected to have significant channel movement or possibly an avulsion within the design life of the clear span bridge, which is estimated to be 80 years. Possible avulsion paths are illustrated in Figure 19.

Figure 19. Possible Avulsion Locations Originating in Reach 2

It is anticipated that the Horseshoe Bend will experience a river avulsion or significant downvalley migration during the design life of the clear span bridge. Erosion rates are closely tied to the frequency and magnitude of flood events on the Little Miami River, which adds uncertainty to the complex analyses in determining river avulsion time frames. Of the four reaches, Reach 2 is the most unstable. A clear-span bridge crossing is not recommended for placement in Reach 2.
