# Eastern Corridor Segments II and III

## ANCOR/SR 32 Hill Focus Area

## 2.1 ANCOR/SR 32 HILL FOCUS AREA

**EASTERN CORRIDOR SEGMENTS II AND III  
(PID 86462)  
TRANSPORTATION NEEDS ANALYSIS**

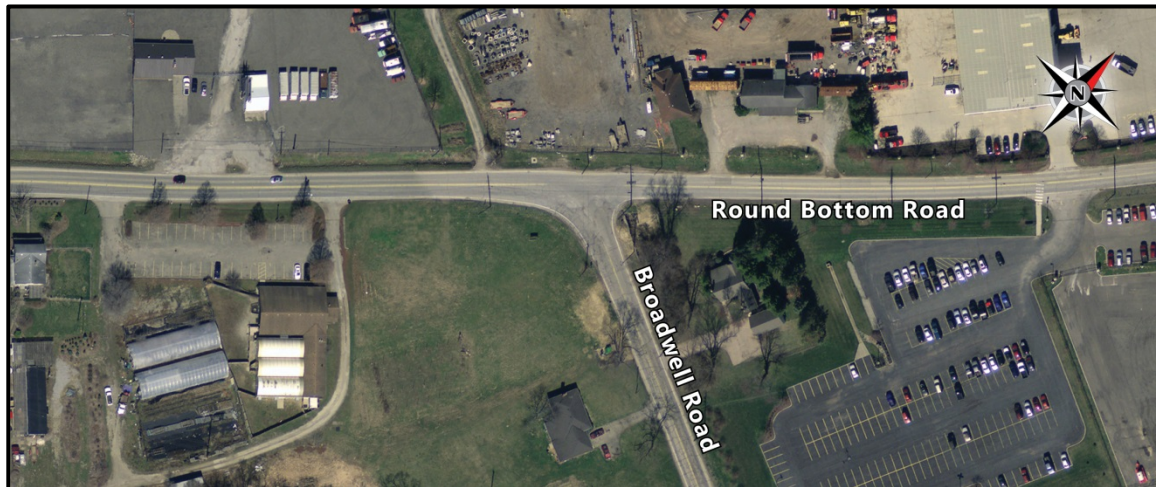
Figure 2. Round Bottom Road/Broadwell Road Intersection

- Broadwell Road is in poor condition and needs to be repaired
- A bike path is needed along Broadwell, which is too narrow for both bikes and cars
- An accessible transit stop is needed in this area

**Crash Data:** An ODOT crash screening did not identify this as a high-hazard intersection. Data indicates that one crash occurred at this intersection over a three-year period (2013-2015).

**LOS Analysis:** The HCS analysis indicates that the intersection currently operates at an acceptable LOS and will continue to operate at an acceptable LOS for the No Build opening year (2022) and No Build design year (2042) conditions. No intersection improvements are required.

**Geometric Deficiencies:** One crest vertical curve on Round Bottom Road has a substandard k-value for the design speed (45 mph) at this location. The actual k-value for Round Bottom Road through this intersection is 40; the required k-value is 61.

**Pedestrian Data:** No pedestrians were observed at the intersection during a 24-hour period recorded on December 2, 2015.

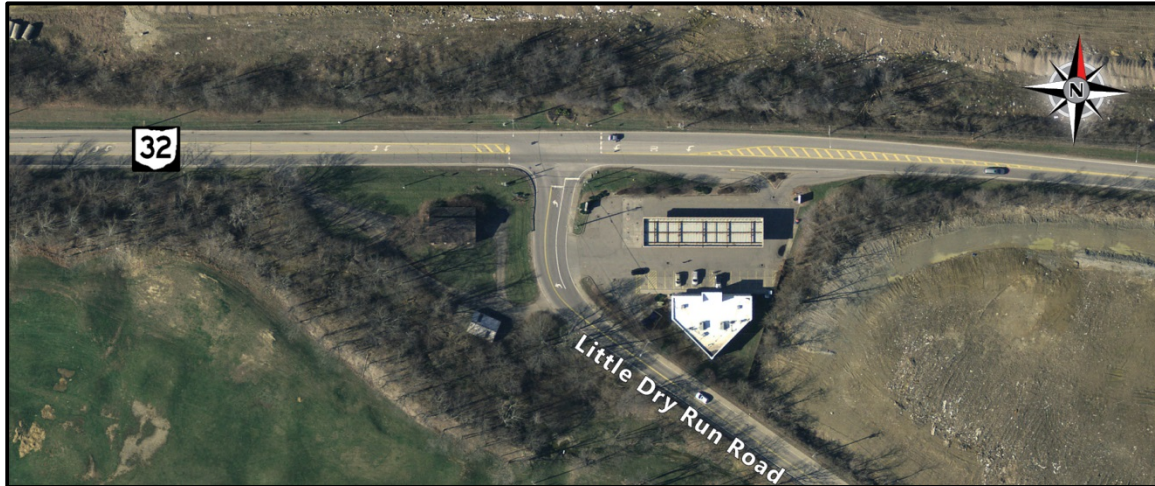
**Figure 3. SR 32/Little Dry Run Road Intersection**

- Poor signal timing (5 comments)
- Need for a right-turn lane from eastbound SR 32 to Little Dry Run Road (1 comment)
- Traffic backups occur at the signal (2 comments)

**Crash Data:** An ODOT crash screening did not identify this intersection as an area of high-hazard. Three crashes occurred at this intersection over a three-year period (2013-2015).

**LOS Analysis:** The HCS analysis indicates that the eastbound through/right-turn movement is currently failing during the PM peak-hour with a v/c ratio of 1.06. This problem is only exacerbated in the No Build opening year (2022) and No Build design year (2042) conditions. During the AM peak-hour in the opening and design years, the westbound through-movement is failing with v/c ratios of 1.05 and 1.06, respectively. It is anticipated that operational or minor intersection improvements are required for the existing, No Build opening year conditions and No Build design year conditions.

**Geometric Data:** Field investigation of this intersection found poor stopping sight distance for northbound Little Dry Run Road due to the combined horizontal/vertical curve at the SR 32 approach.

**Pedestrian Data:** One pedestrian was observed at the intersection during a 24-hour period recorded on December 9, 2015.

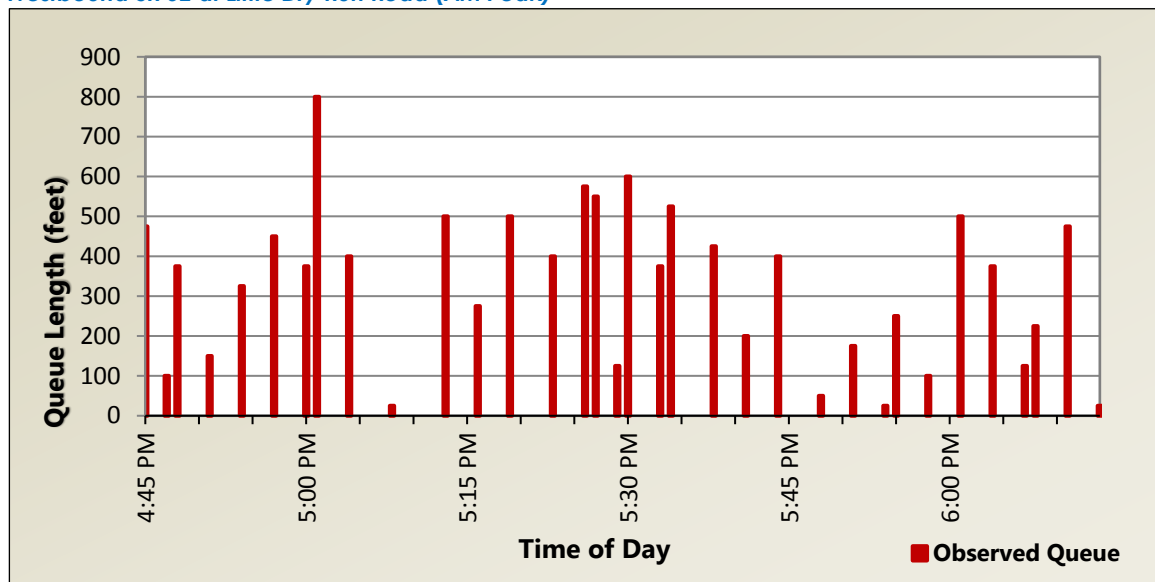
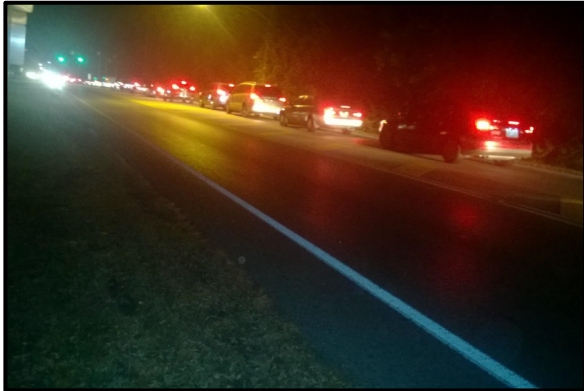
[Figure 4. Westbound SR 32 AM Peak Period Queues at Little Dry Run Road](#)

To supplement the HCS analysis, a queue study was conducted for the westbound approach during the AM peak period and the eastbound approach during the PM peak period. The number of cars in each queue was recorded at the end of the green cycle, beginning 15 minutes prior to the peak hour and ending 15 minutes after the peak hour. The number of cars was translated to a length by assuming a queue length of 25 feet per vehicle. During the AM peak period the maximum queue extended 475 feet and during the PM peak period the maximum queue extended 800 feet. The recorded queues during the AM peak period are shown in [Figure 4](#) and the recorded queues during the PM peak period are shown in [Figure 5](#).

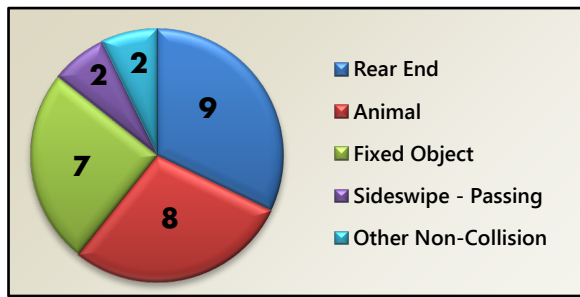
**Figure 6. Frequency of Crashes by Crash Type  
SR 32: Little Dry Run Road to Eight Mile Road**

**Crash Data:** An ODOT crash screening identified an area of SR 32 between Hickory Creek Drive and Eight Mile Road as a high-hazard location. A detailed crash analysis of the entire segment of SR 32 from Little Dry Run Road to Eight Mile Road was therefore completed.

As illustrated in [Figure 6](#), there were 28 total crashes in this roadway section during the three-year analysis period (2013-2015). Rear-end, animal, and fixed object crashes represent 85% of the total crashes. Eleven of the 28 total crashes on the segment (40%) occurred in the high-hazard area.

Three rear-end crashes occurred near the Hickory Creek Drive intersection, where westbound vehicles were struck while waiting to make the left-turn to southbound Hickory Creek Drive (there is no designated left-turn lane for this movement). Another three rear-end crashes involving westbound vehicles occurred further east of this location (all of which occurred in wet conditions during the AM peak period); two of these three rear-end crashes involved vehicles slowing for a school bus making a passenger stop. A plot of all 28 crashes is included in [Attachment A-2](#).

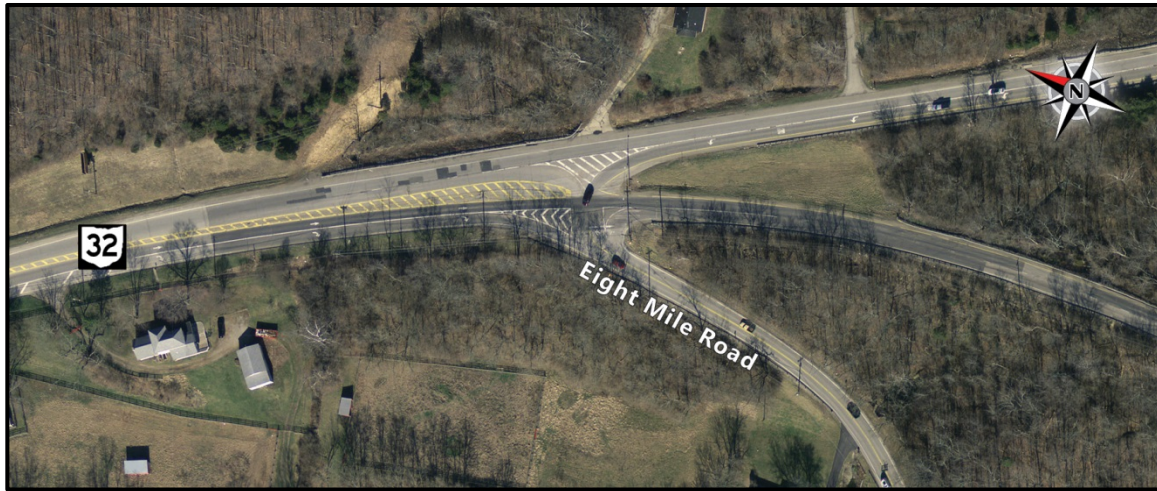
**Figure 7: SR 32/Eight Mile Road Intersection**

- Difficult to make left-turns from Eight Mile Road onto westbound SR 32, particularly during periods of heavy congestion (8 comments)
- Dangerous intersection (10 comments)
- Frequent accidents (6 comments)
- The continuous right-turn lane from Eight Mile Road onto eastbound SR 32 is not functioning properly due to driver hesitancy (2 comments)
- A traffic signal is needed at this intersection (4 comments)
- Re-route SR 32 (1 comment)
- Poor intersection alignment (1 comment)
- Wider intersection needed (2 comments)
- The intersection is unsafe; redesign the intersection (1 comment)
- Weaving traffic on the eastbound approach is a concern (2 comments)

**LOS Analysis:** The HCS analysis indicates that traffic on Eight Mile Road waiting to enter SR 32 is LOS F during both the AM and PM peak hour for the existing, No Build opening year (2022), and No Build design year (2042) conditions. During the AM peak-hour, the northbound left turn movement has a v/c ratio of 1.07 in the opening year and is expected to increase to 1.39 by the design year. During the PM peak-hour, the northbound left turn movement has a v/c ratio of 1.72 and the northbound right turn movement has a v/c ratio of 1.15 in the opening year. They are expected to increase to 3.76 and 1.41 by the design year. It is anticipated that operational or minor intersection improvements are required for the existing conditions, and that major capacity improvements will be required for the No Build opening year and No Build design year conditions.

**Geometric Data:** Deficient stopping sight distances and intersection sight distances were identified at this intersection. The required stopping sight distance for a design speed of 55 mph is 495 feet; however, the stopping sight distance is 350 feet for eastbound vehicles and 415 feet for westbound vehicles. The intersection sight distance for northbound vehicles on Eight Mile Road is 300 feet for vehicles making right turns onto SR 32 and 310 feet for vehicles making left turns. The required intersection sight distance is 610 feet for left-turning vehicles, and 530 feet for right-turning vehicles.

Eight Mile Road exceeds the maximum grade criterion at this intersection, which is 10% for urban arterial at 35 mph (*Location & Design Volume 1, Figure 203-1, ODOT 2016*). This criterion is exceeded by the right-turn lane on northbound Eight Mile Road; right-turning vehicles on northbound Eight Mile Road experience grades of nearly 15%, as measured in the field.

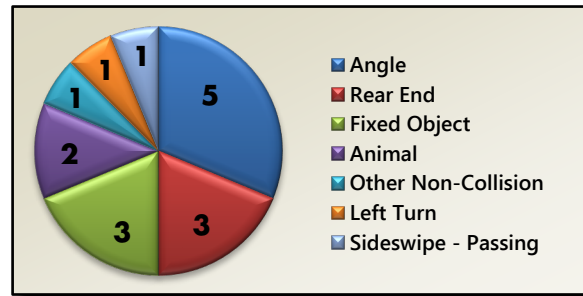
**Figure 8. Frequency of Crashes by Crash Type  
SR 32/Eight Mile Road Intersection**

**Crash Data:** Over the three-year period from 2013 to 2015, there were a total of 14 crashes, of which the most common collision was an angle collision. The type and frequency of crashes at the intersection are shown in [Figure 8](#). Of the 14 total crashes, 11 (80%) of the crashes occurred as a result of vehicles turning to or from Eight Mile Road. Causal factors for these turn-related crashes are restricted sight distance, excessive speed, and inadequate traffic control. The five angle crashes and the three fixed-object crashes all involved vehicles making a westbound to southbound left turn onto Eight Mile Road and striking the guardrail on the west side of the road. A plot of all 14 crashes is included in [Attachment A-2](#).

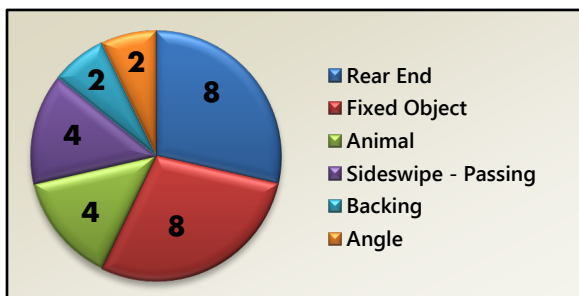
**Figure 9. Frequency of Crashes by Crash Type  
SR 32: Eight Mile Road to Beechwood Road**

**Crash Data:** The sub- segment of SR 32 from Eight Mile Road to the merge (the point at which SR 32 becomes undivided) was identified as a high hazard area in ODOT's crash screening of the Segments II and III roadway network. Because a sub-segment was identified, a detailed crash analysis of the entire segment from Eight Mile Road to Beechwood Road was completed.

As illustrated in **Figure 9**, there were 28 total crashes in this roadway section during the three-year period between 2013 and 2015. Rear-end and fixed object crashes represent 60% of the total crashes. Of the 28 total crashes on the segment, 16 (60%) occurred in the high hazard section. Within the high hazard segment, half of

the crashes occurred on a curve with grade. The most common crash type was fixed object. Potential causal factors include: excessive speed, slippery pavement, inadequate geometry, or inadequate delineation. A curve analysis should be completed to ensure it meets design standards. For a plot of all 28 crashes, please refer to **Attachment A-2**.

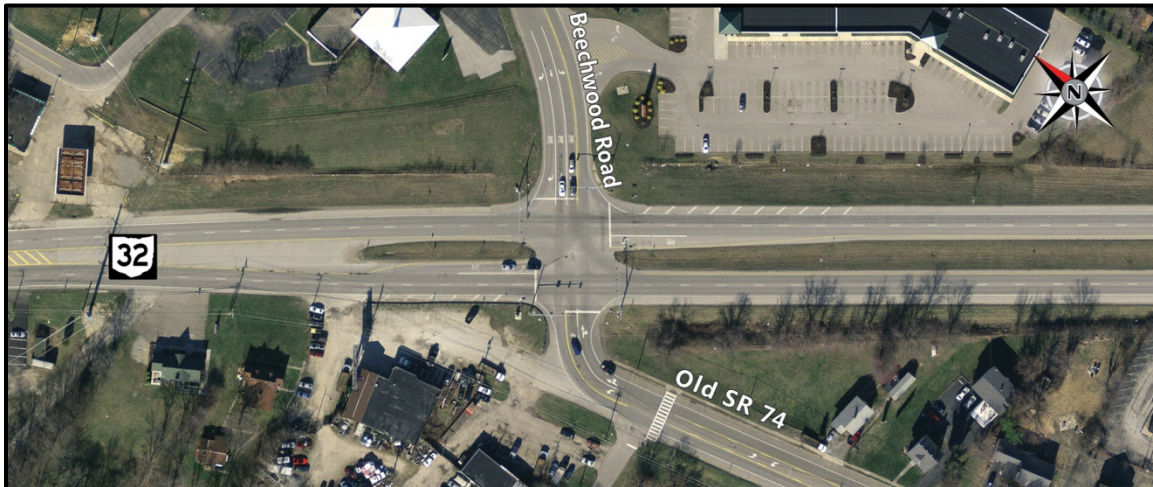
**Figure 10: SR 32/Old SR 74/Beechwood Road Intersection**

- Poor signal timing is an issue (2 comments)
- Signal should be replaced with combination of exit ramps and overpasses (1 comment)
- Dedicated right-turn lane on westbound SR 32 is needed (1 comment)

**LOS Data:** The HCS analysis indicates that the eastbound left turn movement is currently failing during the PM peak-hour with a v/c ratio of 1.01. In the No Build opening year (2022) and No Build design year (2042) conditions, the failure is corrected and v/c ratio is less than 1.0 due to the ODOT methodology of balancing delays for future intersection analyses. This indicates that the failure of the eastbound left turn movement is likely due to a signal timing issue. It is anticipated that operational or minor intersection improvements are required for the existing, No Build opening year conditions and No Build design year conditions.

**Geometric Data:** No geometric deficiencies were identified at this intersection.

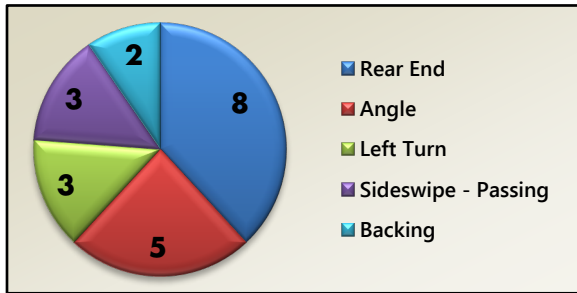
**Figure 11: Frequency of Crashes by Crash Type  
SR 32/Old SR 74/Beechwood Road Intersection**

**Crash Data:** Over a three-year period (2013-2015), 21 crashes occurred at this intersection. Rear-end and angle crashes accounted for about 60% of these crashes. The frequency of crashes by crash type is shown on [Figure 11](#). See [Attachment A-2](#) for a plot of all 21 crashes.

Five of the eight rear-end crashes occurred in 2013, and four occurred at 11:00 AM. Given that they occurred in the middle of the day, sun blindness was not a contributing cause. Other than the observations described above, there were no correlation between the crash data and a specific contributing cause for rear-end crashes.

Three of the five angle crashes occurred in the rain. Of the three crashes that occurred in the rain, two were caused by motorists running red lights, indicating that there may be slick pavement or inadequate clearance intervals at the intersection. Given the infrequent amount of angle crashes, it is difficult to correlate a specific deficiency as a contributing cause for angle crashes.

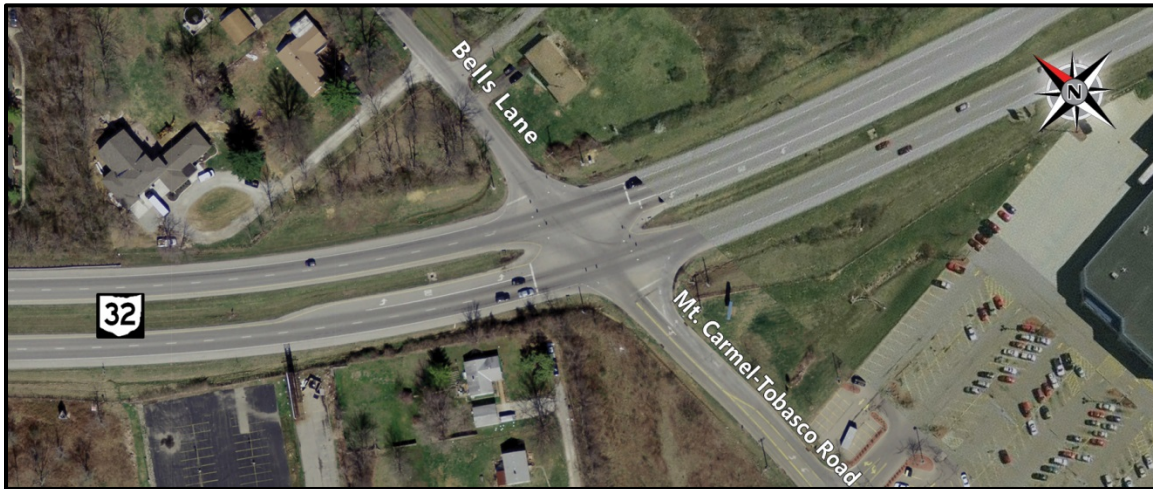
**Figure 12: SR 32/Mt. Carmel-Tobasco Road/Bells Lane Intersection**

- Widen intersection and erect barrier to allow traffic to bypass the traffic signal en route to northbound I-275 ramp (1 comment)
- Turning left from Bells Lane to eastbound SR 32 is not safe (1 comment)

**Crash Data:** ODOT's crash screening did not identify this intersection as an area of high hazard. Crash data indicates that 19 crashes occurred over the three-year period (2013 – 2015).

**LOS Analysis:** The HCS analysis indicates that the westbound left turn movement will fail during the PM peak-hour during the No Build opening year (2022) and No Build design year (2042) conditions. For the opening year, the v/c ratio is 1.14 and by the design year the v/c ratio increases to 1.23. No intersection improvements are required for the exiting conditions, but it is anticipated that operational or minor intersection improvements are required for the No Build opening year conditions and that major capacity improvements will be required for the No Build design year conditions.

**Pedestrian Data:** Thirty-two (32) pedestrians were observed at this intersection during a 24-hour period recorded on November 24, 2015. This is significantly more pedestrians observed than at any other intersection in the ANCOR/SR 32 Hill Focus Area; during the same period, no other intersection had more than one pedestrian.
