*Phase II Report*

**Geomorphic and  
Two-Dimensional Hydraulic  
Modeling Evaluation of the  
Little Miami River in the Eastern  
Corridor Segment II/III Study Area**

December 2009

NewFields River Basin Services, LLC

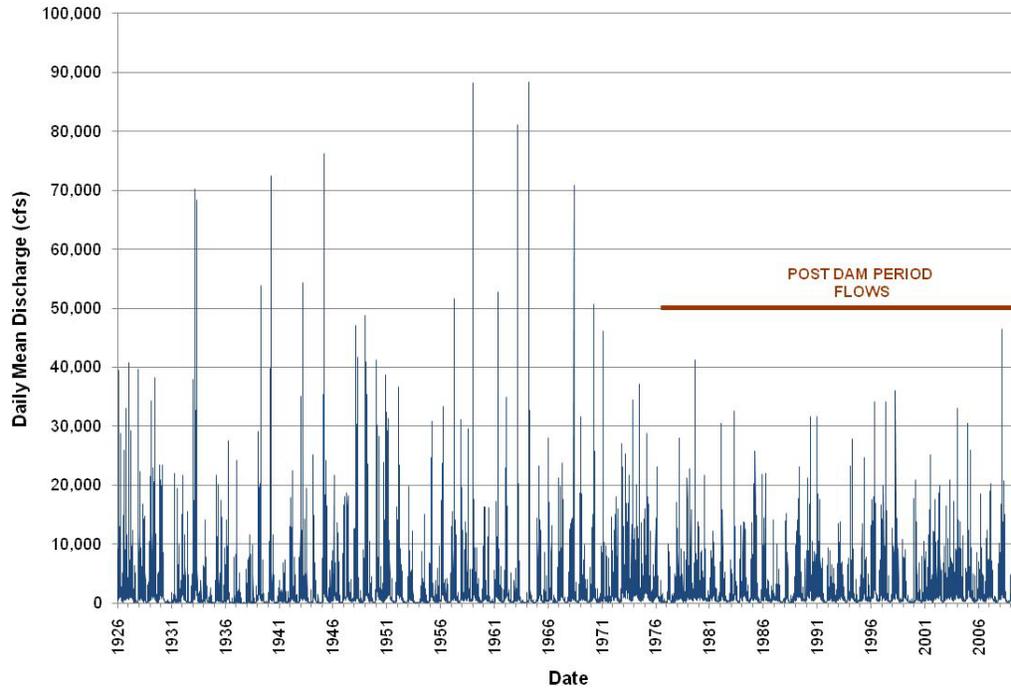
Figure 3: Daily mean discharge in the Study Reach (combined data from USGS gage 03245500 “Little Miami River at Milford OH” and USGS gage 03247500 “East Fork Little Miami River at Perintown OH”) for the period of record (1927-October 7, 2009).

Figures 3 and 4 show that daily streamflow during the 2008/2009 study period was low relative to the preceding four years and the period of record. This provides hydrologic context for high flow scour and erosion measurements made by Stantec during the study period, which were used to help validate the long-term average meander migration rates calculated in Phase 1, and in the refinement of meander migration rates calculated in Phase 2 for the geomorphic reaches not eliminated in Phase 1.

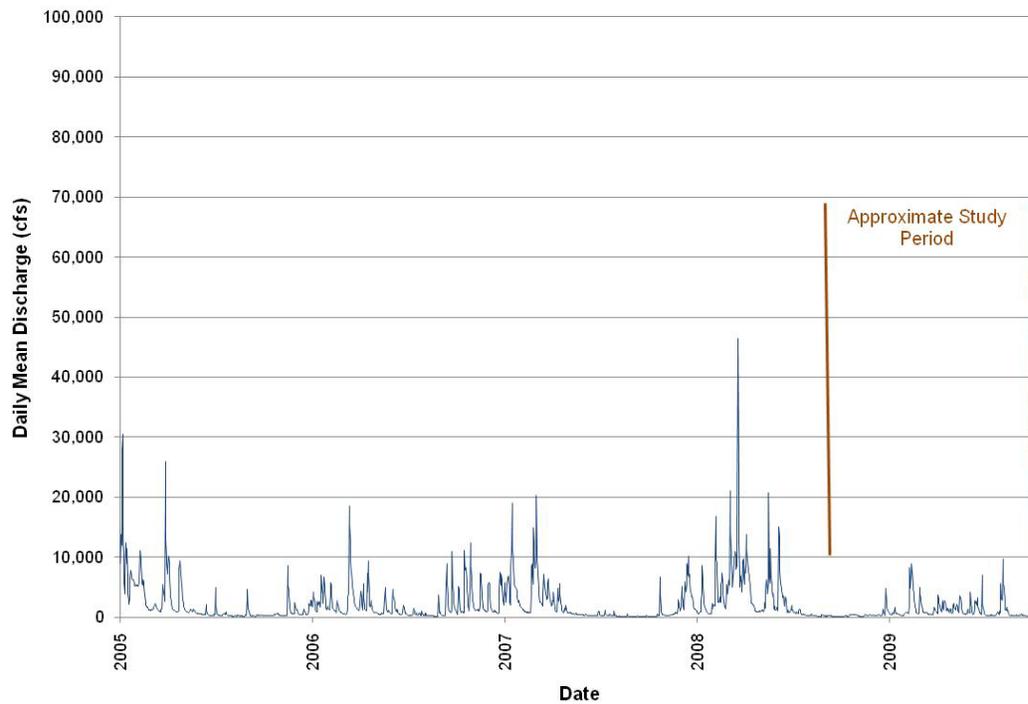
Figure 4: Daily mean discharge in the Study Reach (combined data from USGS gage 03245500 “Little Miami River at Milford OH” and USGS gage 03247500 “East Fork Little Miami River at Perintown OH”) for the five year period preceding and including the study period. Note that daily mean discharge is low during the study period relative to the preceding four years.

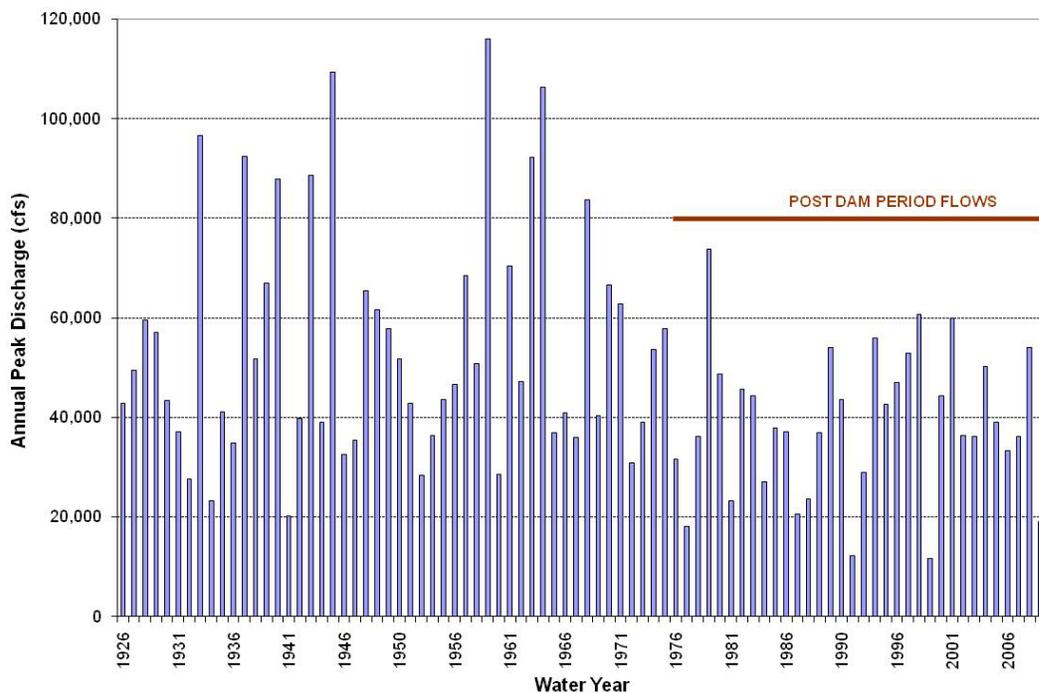
**Figure 5: Annual peak discharge in the Study Reach (combined data from USGS gage 03245500 “Little Miami River at Milford OH” and USGS gage 03247500 “East Fork Little Miami River at Perintown OH”) for the period of record 1927 to 2009. Note that peak discharge is low during the study period relative to the preceding nine years.**

The flood frequency analysis was also updated with peak discharges from 2008 and 2009 that were not available in Phase 1 of this analysis. Figure 5 shows the 2008 and 2009 peaks added to the record of peaks for the Study Reach. The 2008 peak occurred prior to initiation of this project but was not yet available from USGS at the time of the Phase 1 study. As illustrated in the daily mean discharge data, the annual peak flow during the study period was low relative to peaks of preceding years.

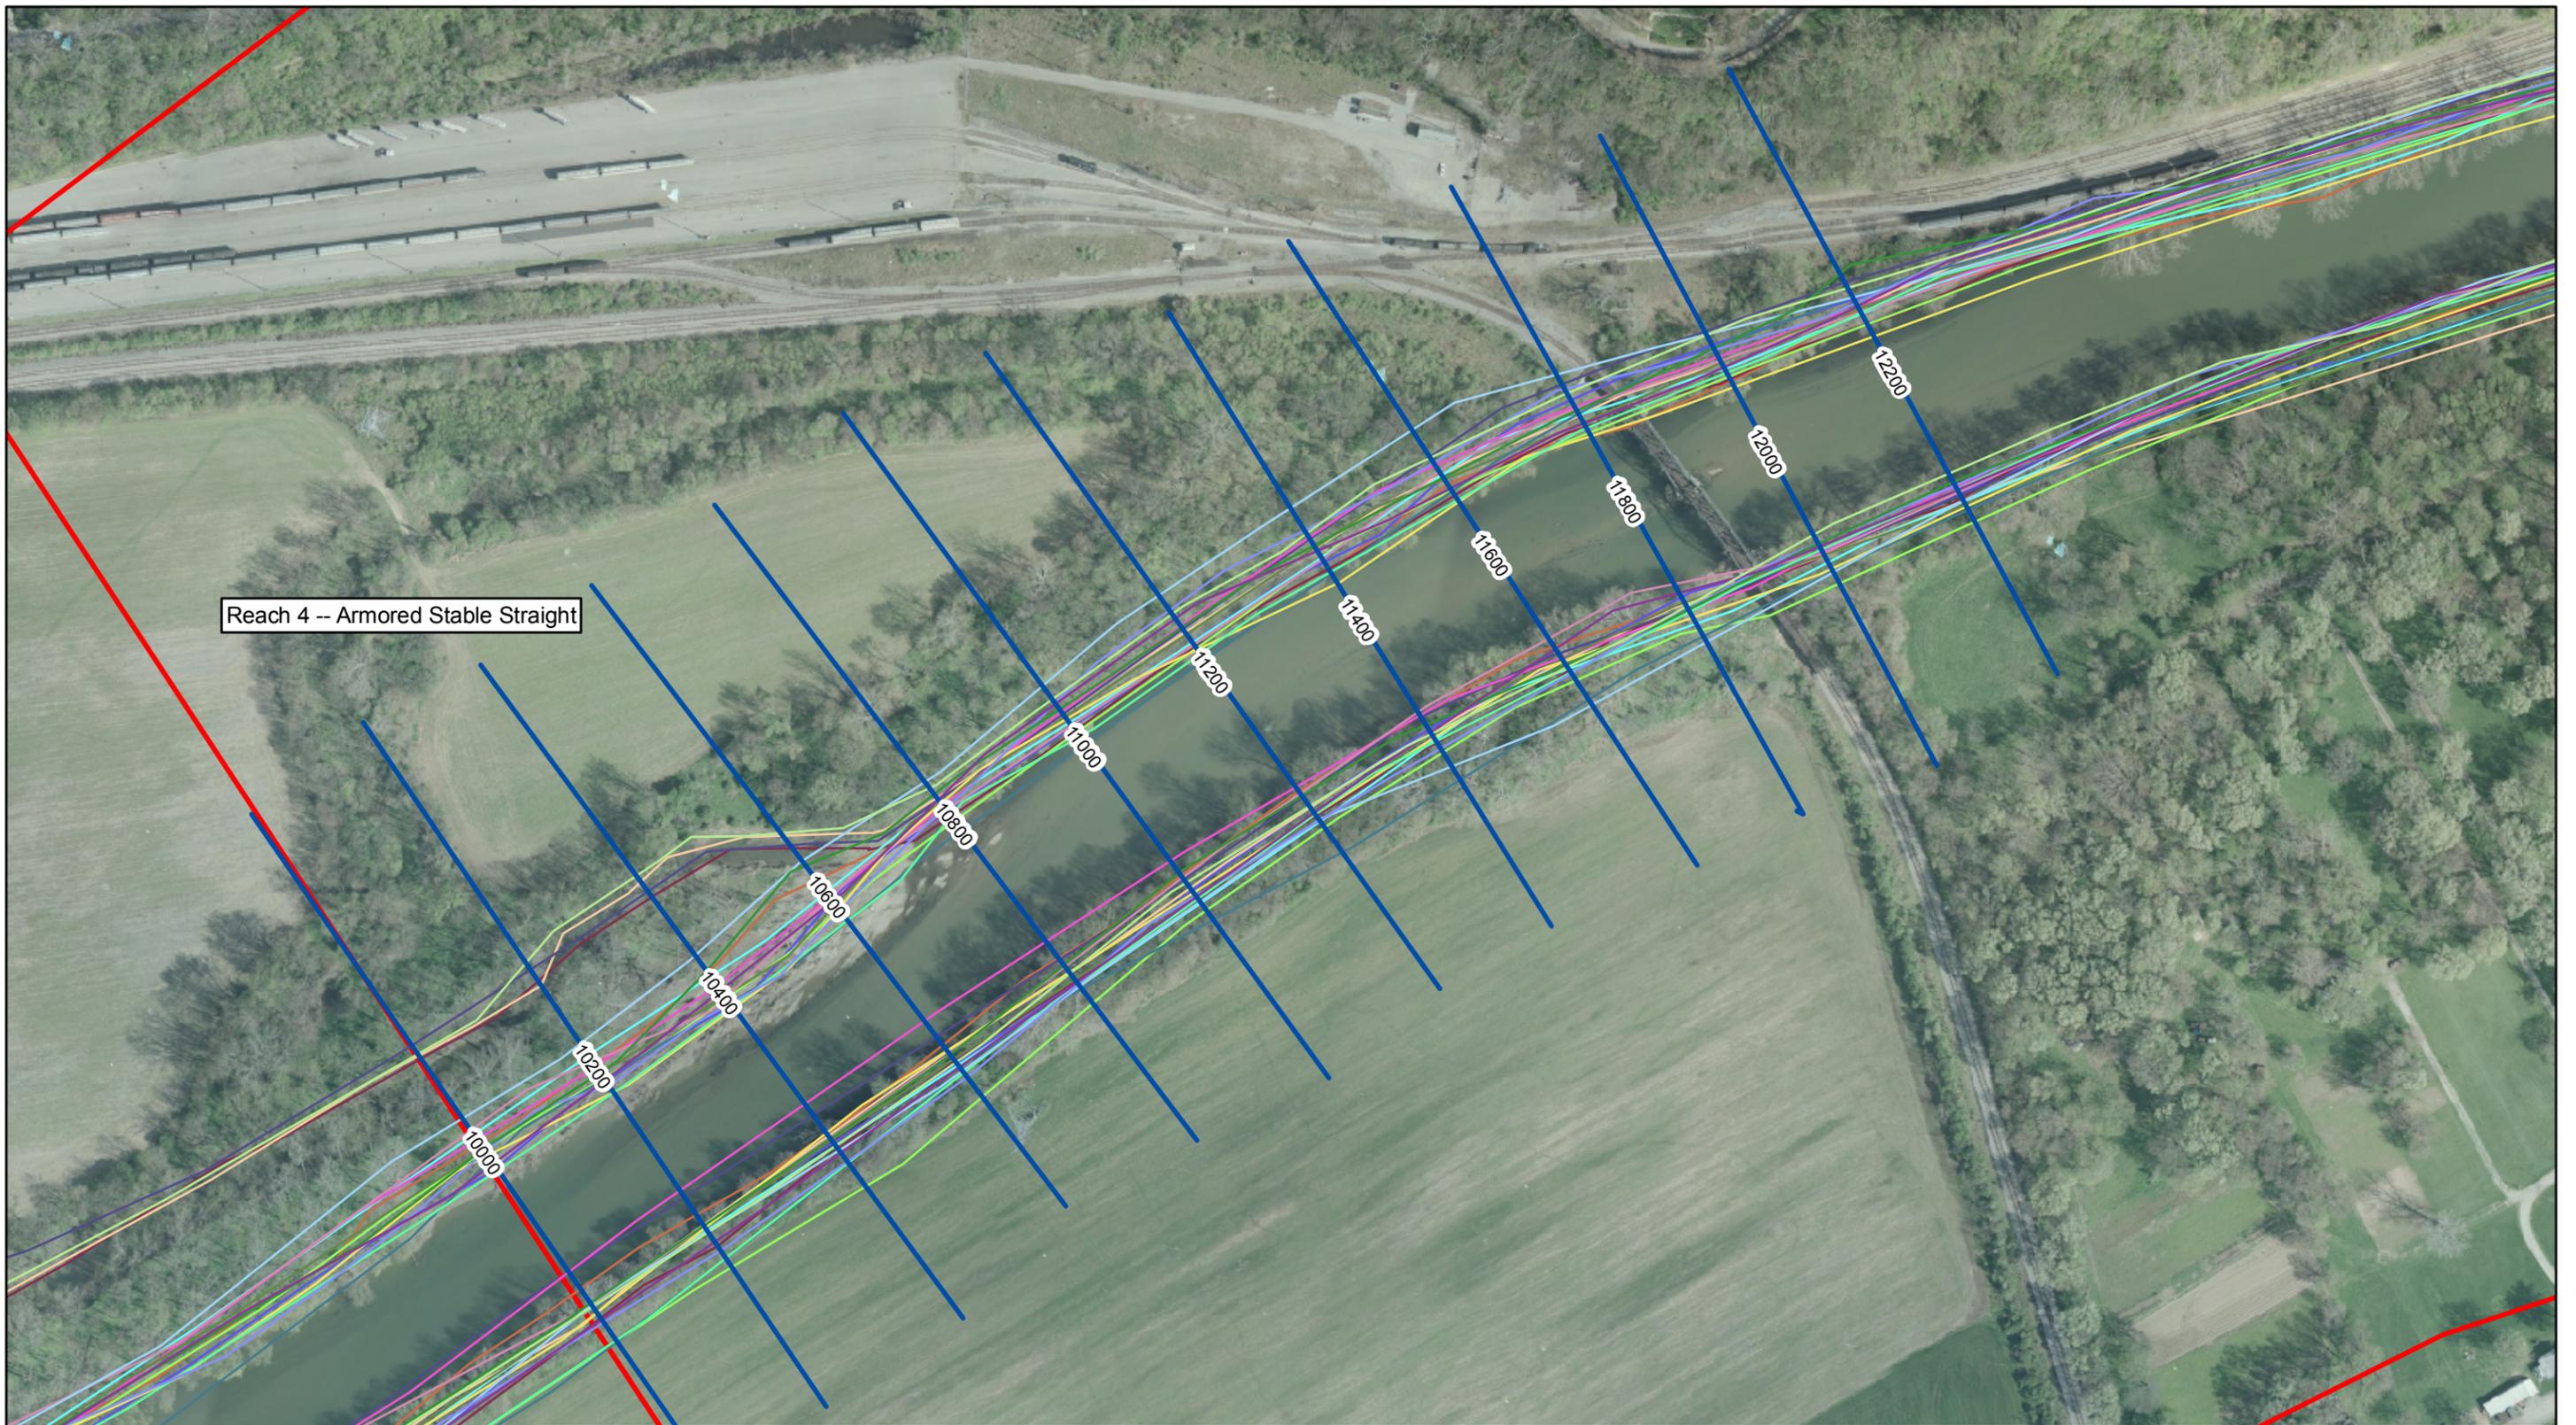
**FIGURE 6**  
**CHANNEL MIGRATION**  
**CROSS SECTIONS**  
 Little Miami River Geomorphic and Hydraulic Modeling Evaluation, Phase II

This more refined analysis of historical channel migration provides improved information for prioritization of potential clear span bridge crossing locations in Geomorphic Reaches 4 and 7. While the Phase 1 meander migration rates did capture natural and anthropogenic channel change, the additional measurements in Phase 2 provides more site-specific estimates of historical lateral channel migration. In addition, this analysis provides a useful guide for establishment of minimum width requirements for the clear span portion of a new bridge. The active channel width should be considered the absolute minimum requirement for the clear span portion of the proposed bridge at a given location, and the average annual migration rate should be used as an index of the uncertainty in the prediction of the required clear span width over the design life of the bridge in

that location. For example, a bridge crossing at station 10,800 in Reach 4 would require a minimum 377 foot clear span section and a relatively low factor of safety to account for the low rates of average annual channel migration (1.1 ft/yr to 1.4 ft/yr) in this location. In contrast, a bridge crossing at station 1,600 in Reach 7 would require a minimum 922 foot clear span section and a relatively high factor of safety to account for the high rates of average annual channel migration (5.9 ft/yr to 8.6 ft/yr).

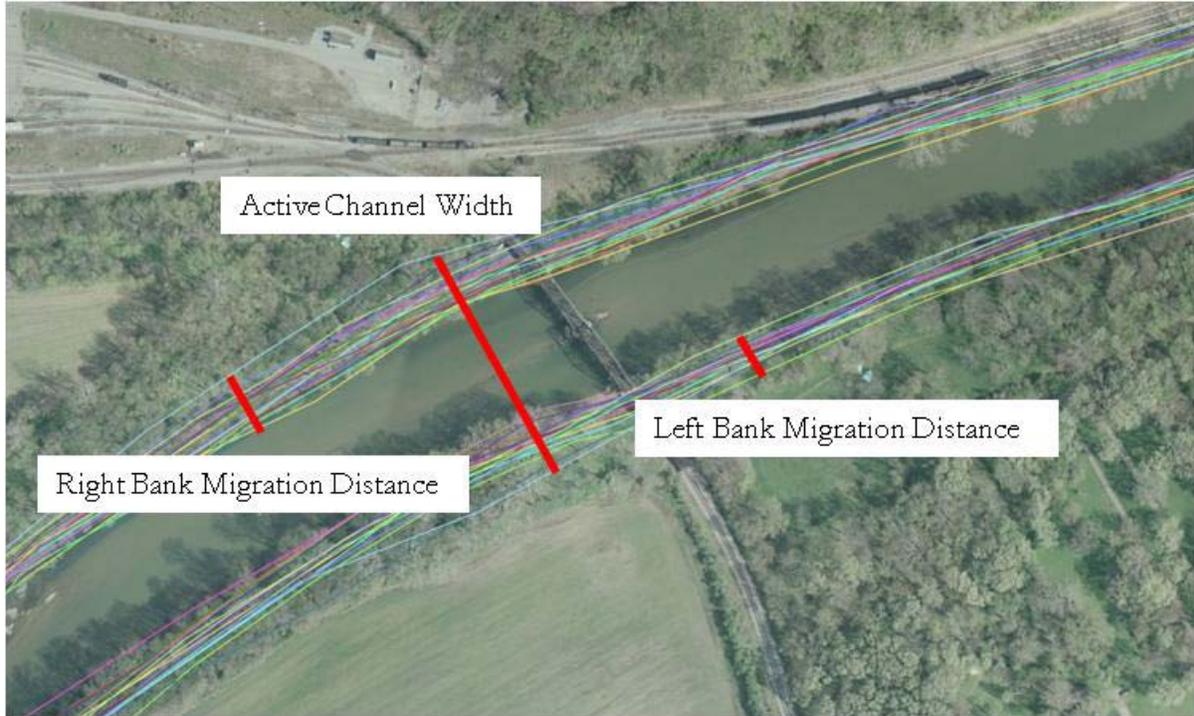
Figure 8: Schematic representation of active channel width and bank migration distances.

With a reasonable validation of lateral channel migration rates from Phase 1 completed, it was determined that additional measurements of historical meander migration could provide improved guidance for prioritization of clear span bridge crossing locations in Geomorphic Reaches 4 and 7. Figures 6 and 7 show transect locations and stations where additional meander migration rates were calculated using the techniques described in section 4.2 of the Phase 1 report (CH2M HILL 2009). Table 2 summarizes active channel widths and average annual lateral channel migration rates in locations still under consideration for a clear span bridge crossing. The active channel width is the width of the corridor bounded by the channel banks that are the farthest distance apart over the entire period of observation (1932 – 2007); the average annual lateral channel migration rate is the total distance of channel bank movement between 1932 and 2007 divided by the 75 year period of movement. Figure 8 illustrates how these values were measured.

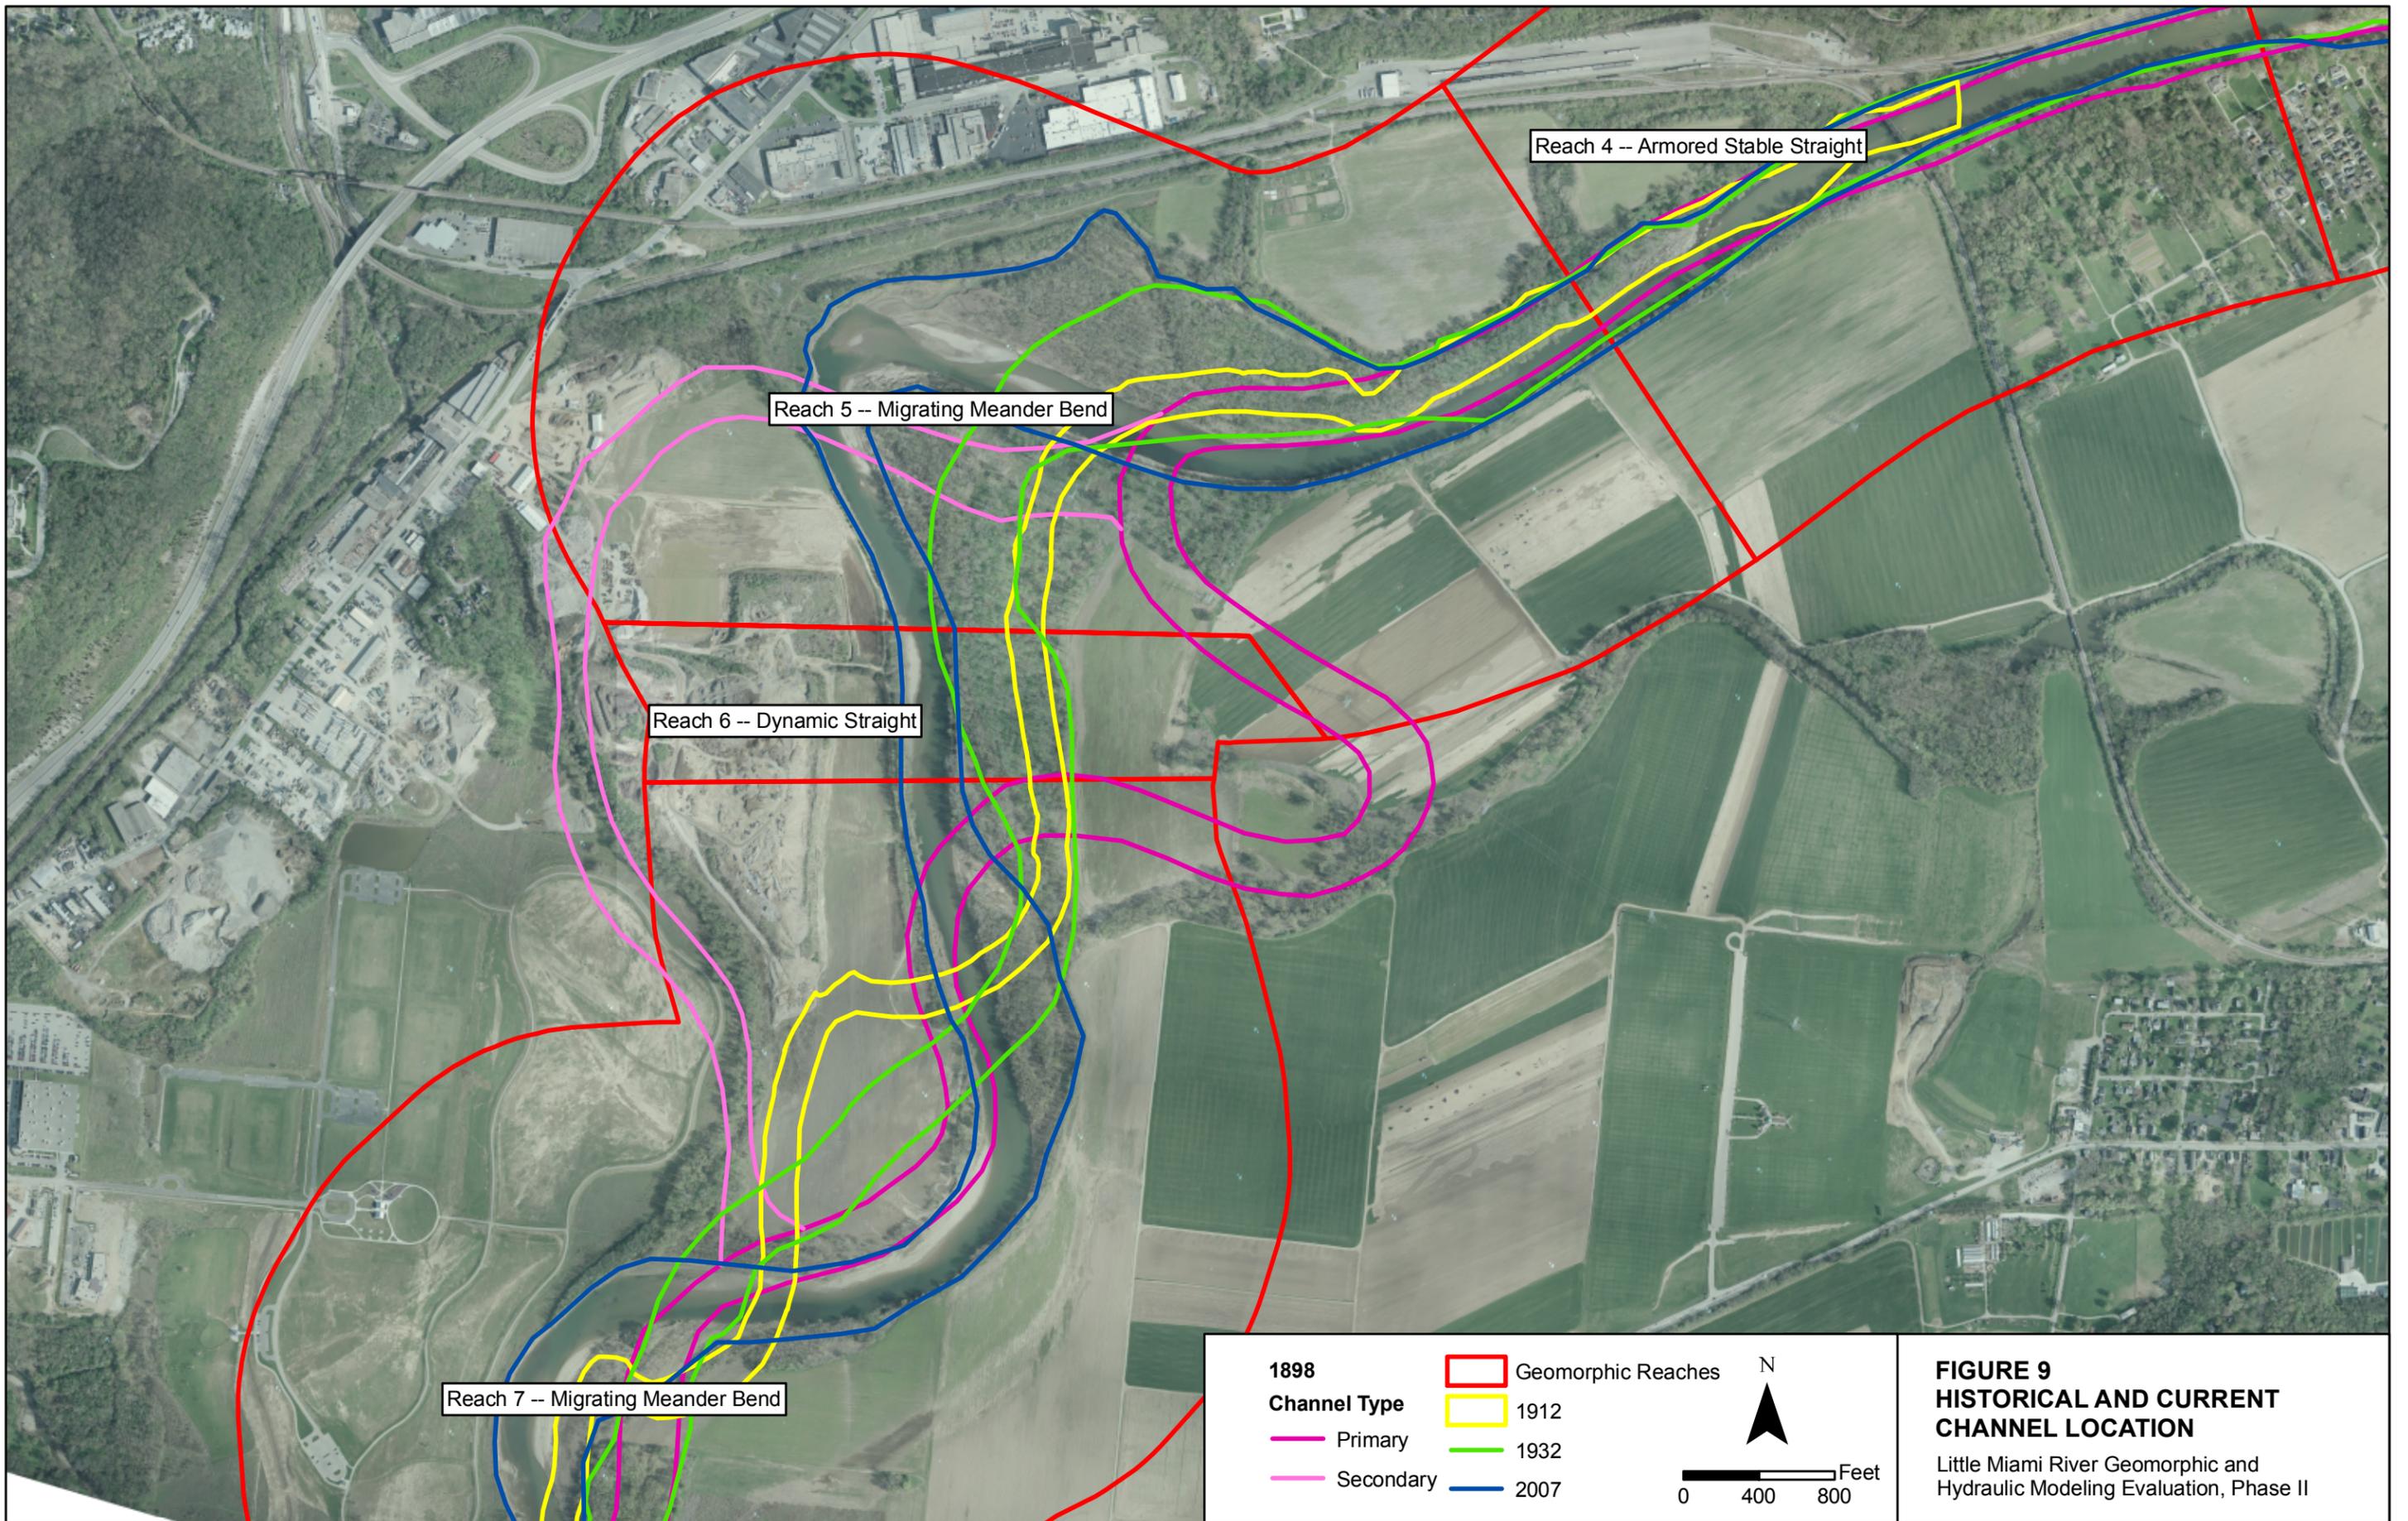
**FIGURE 9**  
**HISTORICAL AND CURRENT**  
**CHANNEL LOCATION**  
 Little Miami River Geomorphic and Hydraulic Modeling Evaluation, Phase II

Geomorphic analyses of historical maps, USGS topographic maps, and aerial photographs show that the Little Miami River has experienced significant channel migration, especially through the reach that includes Horseshoe Bend. This extreme meander bend has transitioned from an outside bend on the right side of the channel to an outside bend on the left side of the channel. As this bend continues to tighten and outward migration is arrested by riprap and other existing bank stabilization measures, a meander cutoff is likely in this location. To determine potential paths of a meander cutoff at the Horseshoe Bend, historical maps and aerial photographs were evaluated in GIS along with the calibrated hydraulic modeling results (discussed in Section 3). Figure 9 shows historical channel locations at Horseshoe Bend from 1898 to 2007.

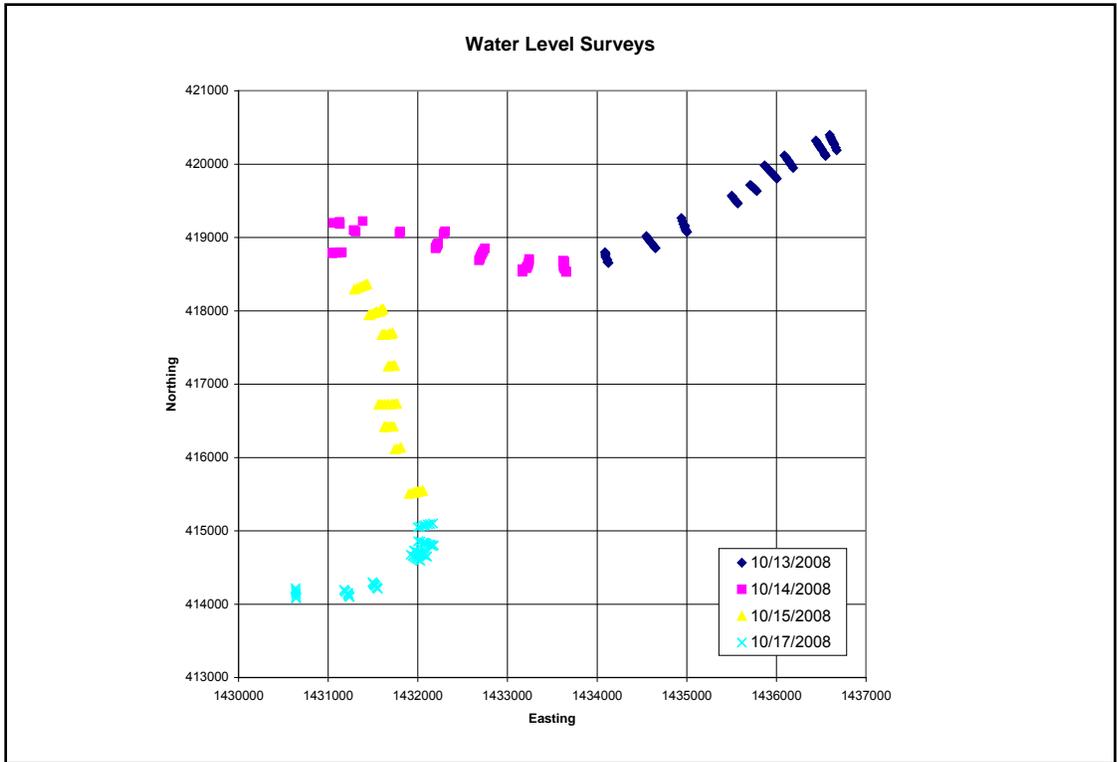
Figure 10: Low flow bathymetry and water surface elevation transect in Study Reach (October 2008)

Field surveys were conducted between 10/13/2008 and 10/17/2008 to measure channel transect and thalweg elevations in the project reach. The survey recorded water depths and water surface elevations at each survey point. These water surface elevations comprise the first calibration dataset. The field survey was initiated at the upstream end of the project reach and progressed downstream. Figure 10 shows the dates on which transects were surveyed. Figure 11 presents the average daily flow as measured at the Milford and Perintown USGS gages, as well as the combined flow for an eleven day period around the days of the low flow survey. Flow was nearly constant during the first three days of the survey (10/13 to 10/15), but increased on 10/17/08, apparently with a release from a reservoir on the East Fork (note the constant flow after 10/17).

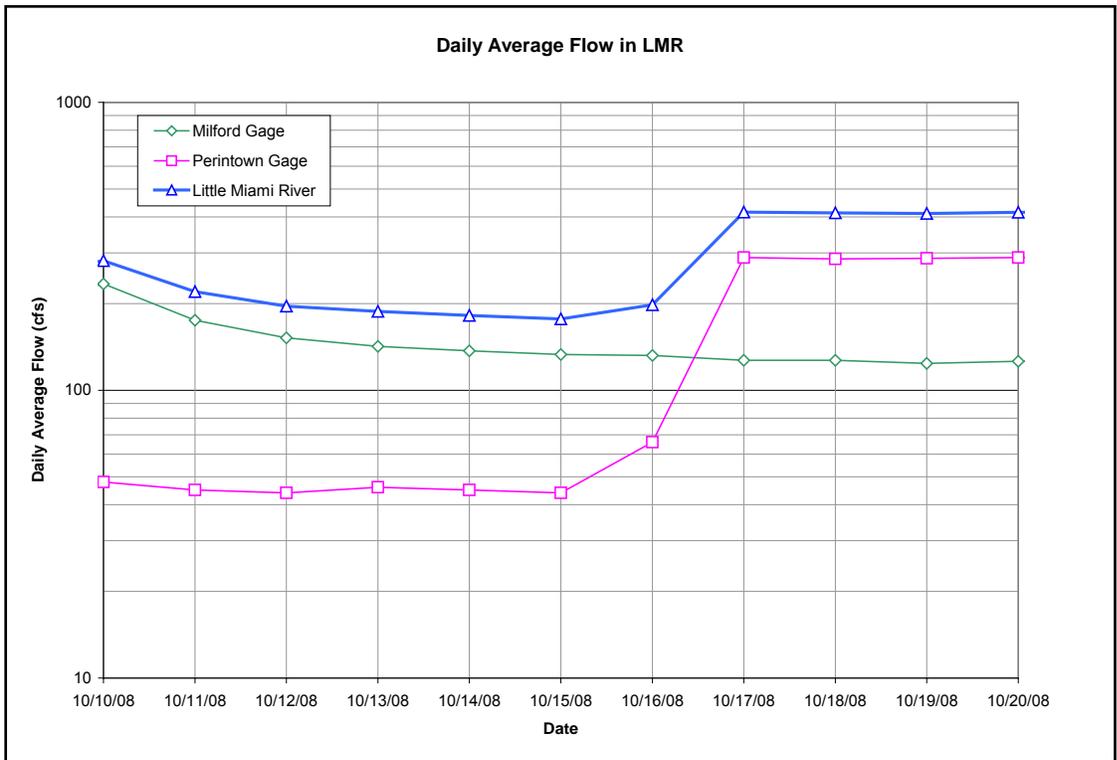
Figure 11: Flow in Little Miami River during low flow survey

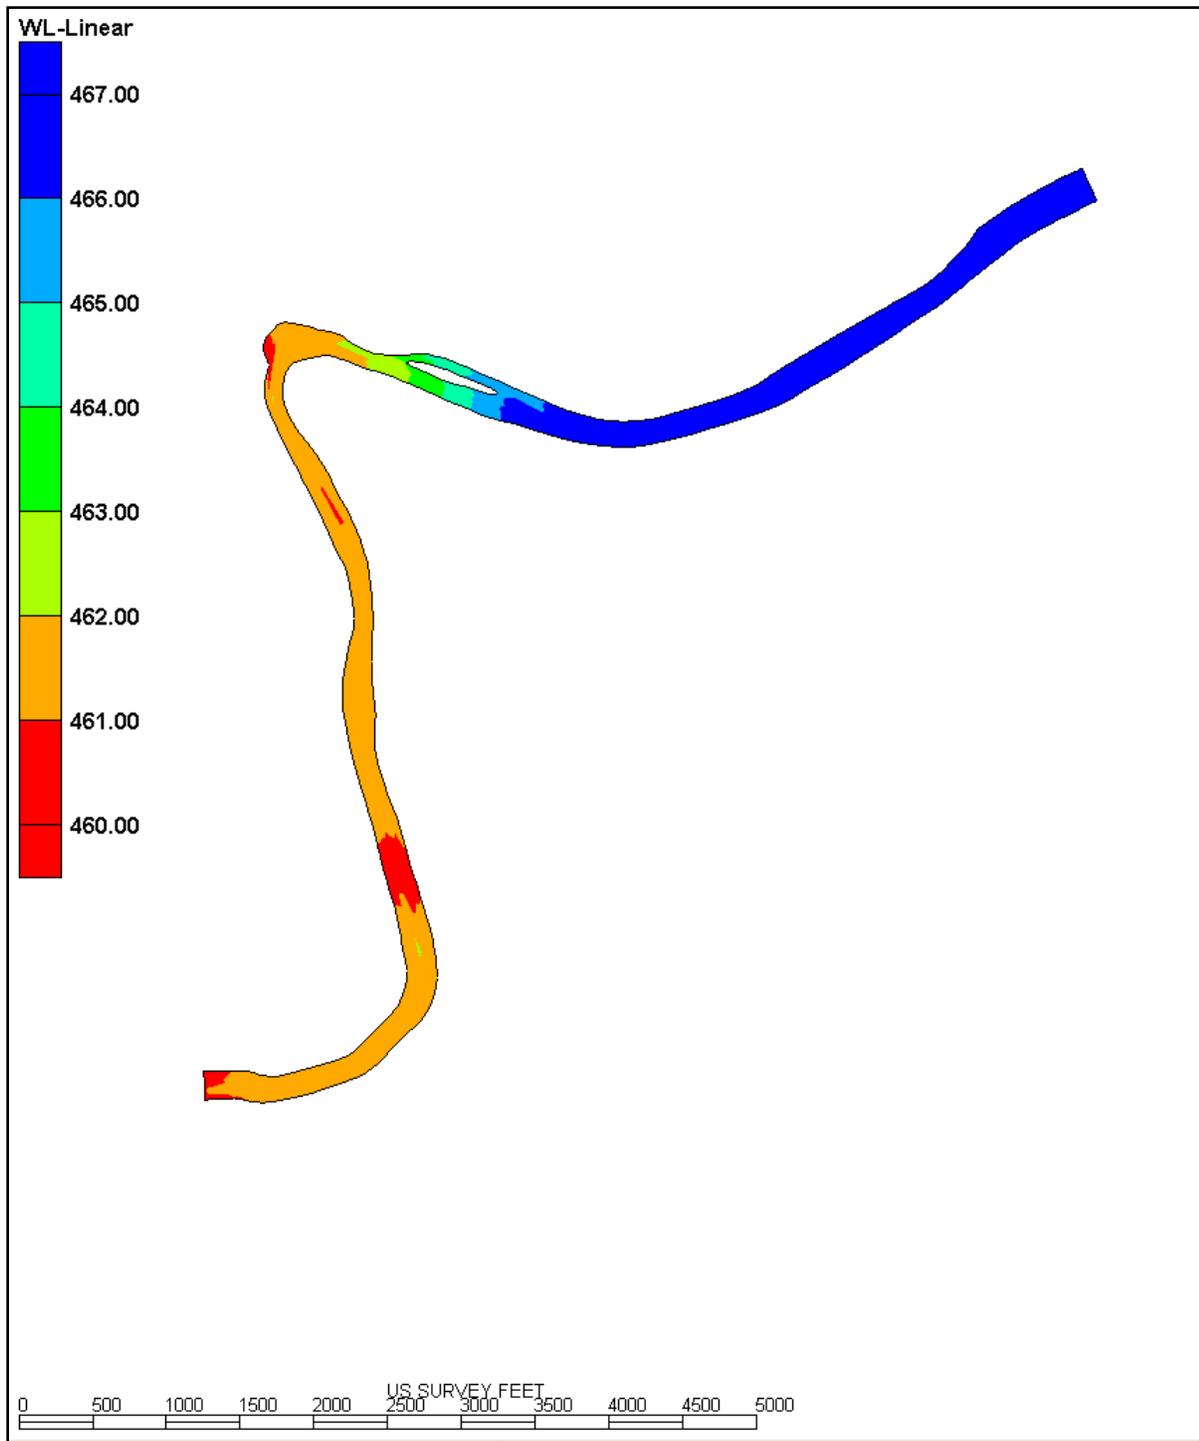
Figure 12: Interpolation of water surface survey data onto model grid

Figure 12 shows the water level survey data interpolated onto the model grid. Note the steep gradient just upstream of Horseshoe Bend. At low flows, this section of the Study Reach forms a shallow riffle. This riffle exerts considerable friction on the flow, and thus the Manning's n-value (friction coefficient) was increased from the value used in Phase 1. The increased roughness in this reach more accurately depicts low flow channel morphology. A new material type was created to represent the riffle, and a sensitivity study was conducted to determine the influence on predicted surface water profiles of incremental changes in the Manning's n-value for this section of the channel. The location of the riffle material added for the low flow calibration simulations is shown in Figure 13.

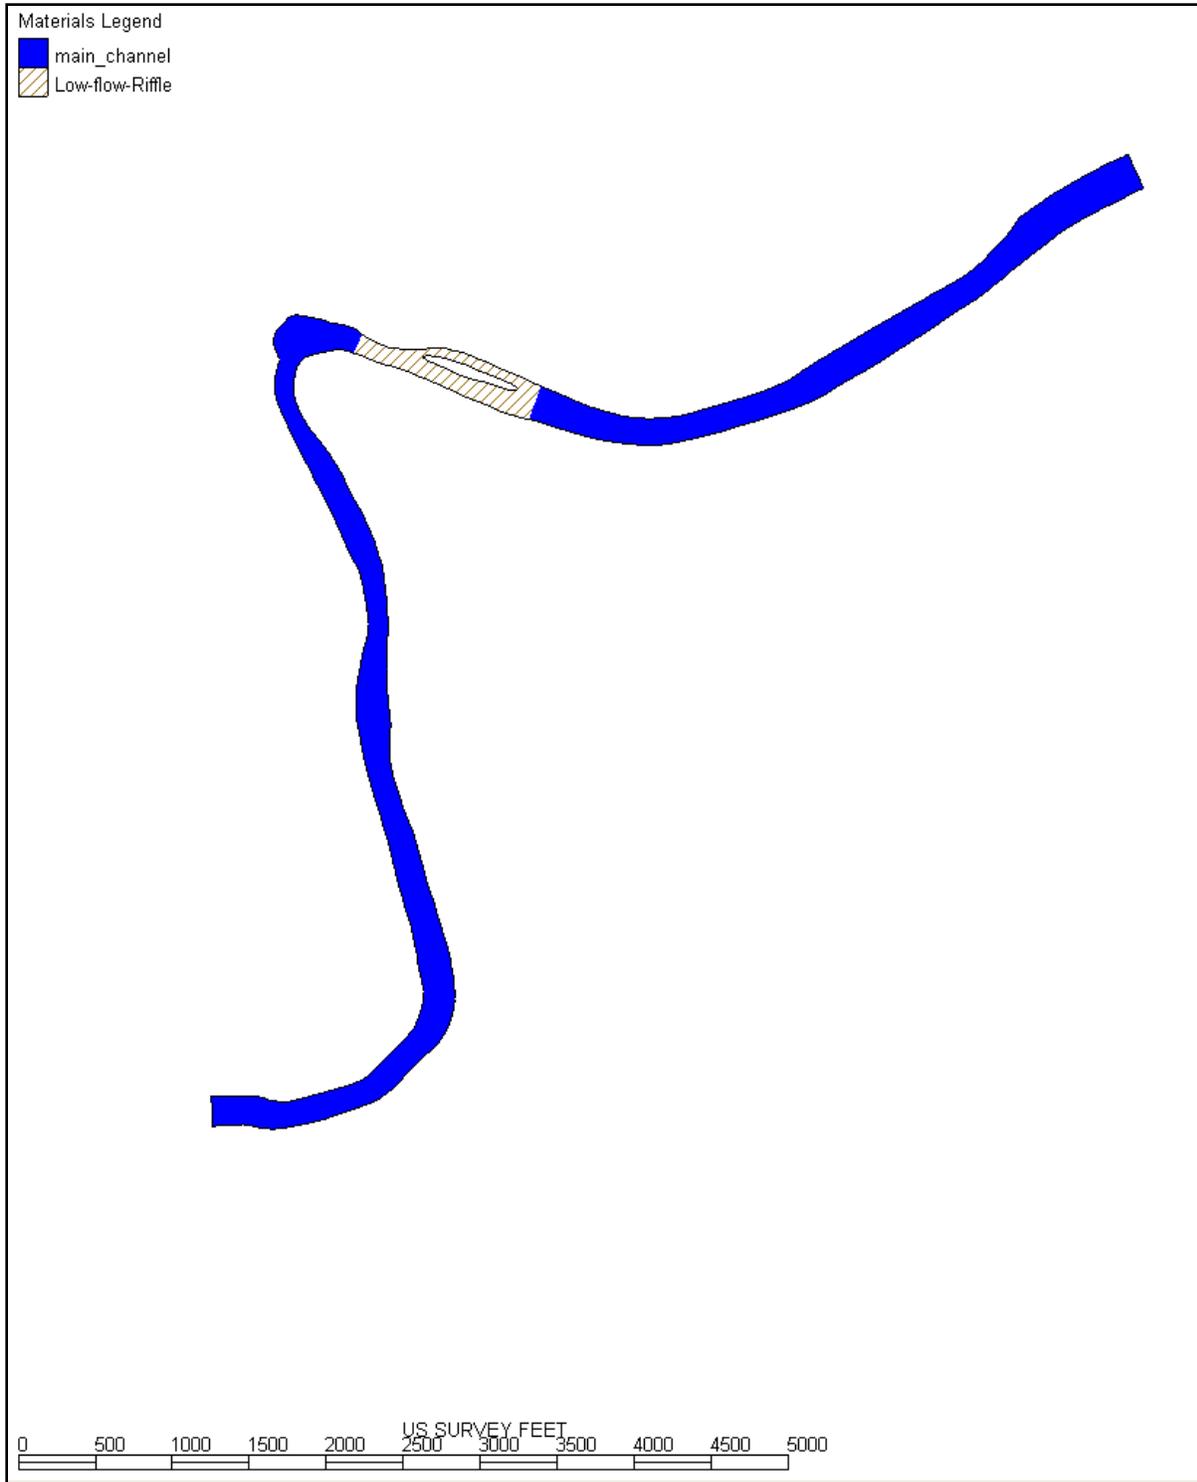
Figure 13: Material type distribution in low flow grid showing location of new riffle material

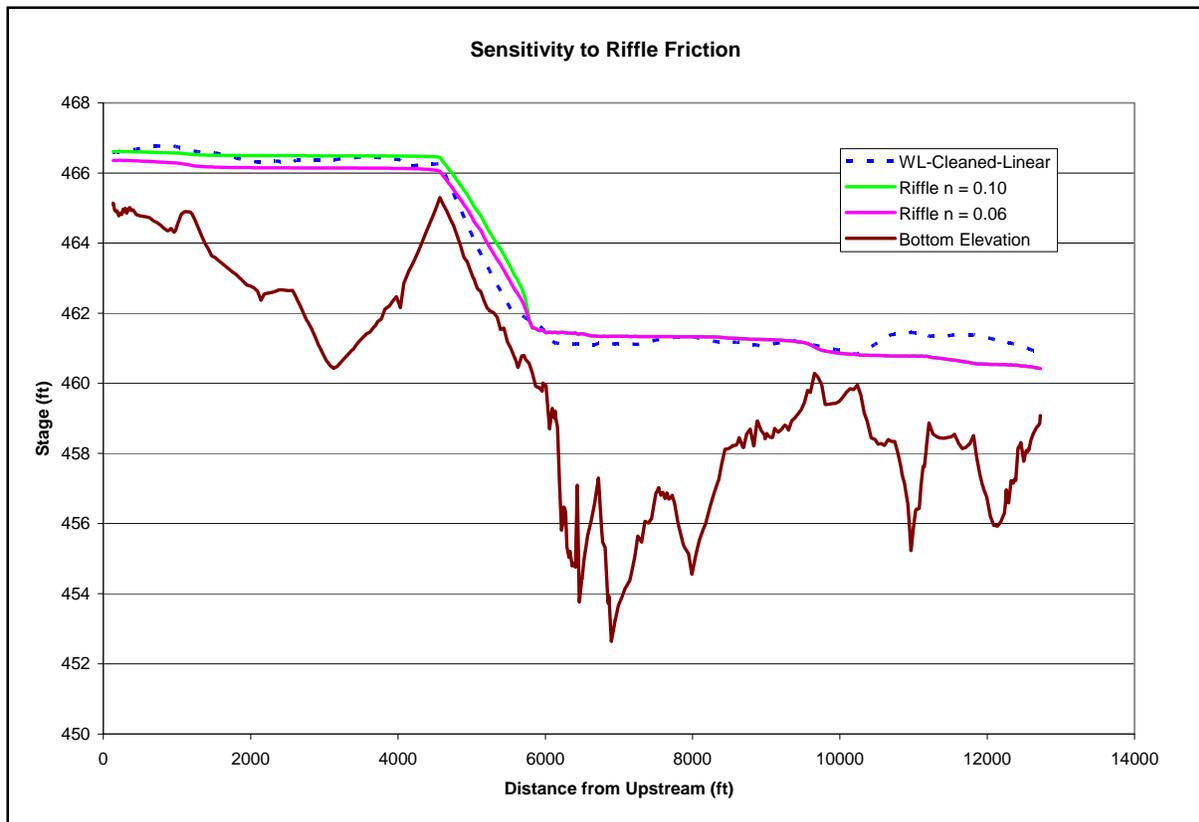
Figure 14: Final calibration and sensitivity to Manning's n-value in shallow riffle

The calibration simulation used an inflow of 186 cfs, the average river flow during the first three days of the water level and thalweg survey. Since the downstream water levels reflect the increased flow on October 17<sup>th</sup>, the downstream boundary was set 0.5 feet below the survey measurement. This adjustment was based on a review of the stage-discharge curve at the Milford gage. The calibration adjusted the Manning's n-value in the riffle section in order to match the water surface elevations measured on October 13, 14, and 15. Figure 14 presents the results of the final two calibration simulations, with Manning's n-values of 0.06 and 0.10 in the shallow riffle zone. Model results with an n-value of 0.06 minimize the root mean square error (RMSE) between predicted and measured water surface elevations. The RMSE for  $n = 0.06$  was calculated at 0.31 feet. Figure 14 shows that a Manning's n-value of 0.10 for the low flow riffle increases water surface elevations by up to 0.25 feet compared to the final calibration simulation with  $n = 0.06$ . Table 3 presents a summary of Manning's n-values for various channel substrates (FHWA 1986). For depths of less than 0.5 feet and a substrate of 2 inch gravel, the table suggests a Manning's n-value of 0.066. This is similar to the value used in the calibration simulation.

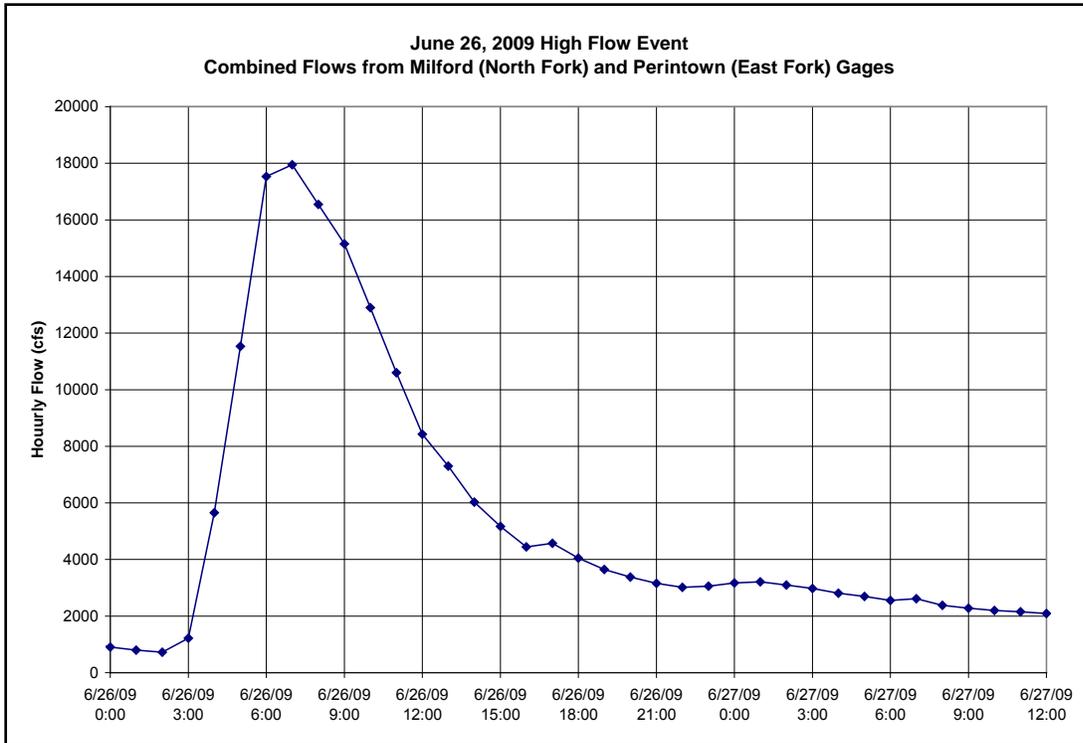
Figure 15: Little Miami River flow on June 26, 2009

The second flow calibration was conducted with water surface elevations surveyed on June 26, 2009. Flow in the Little Miami River varied considerably on June 26, 2009, from a low of 721 cfs at 2:00 AM to a peak at 7:00 AM of 17,950 cfs. Flows declined quickly to 8,430 cfs at 12:00 noon, and then more gradually to 4,000 cfs by 6:00 PM. A field survey was conducted on June 26, 2009 to measure elevated water surface elevations caused by the high flow event. Measurements were taken at five points between 10:45 AM and 2:04 PM. The hourly flow, derived by combining measurements at the Milford and Perintown USGS gages, is shown in Figure 15.

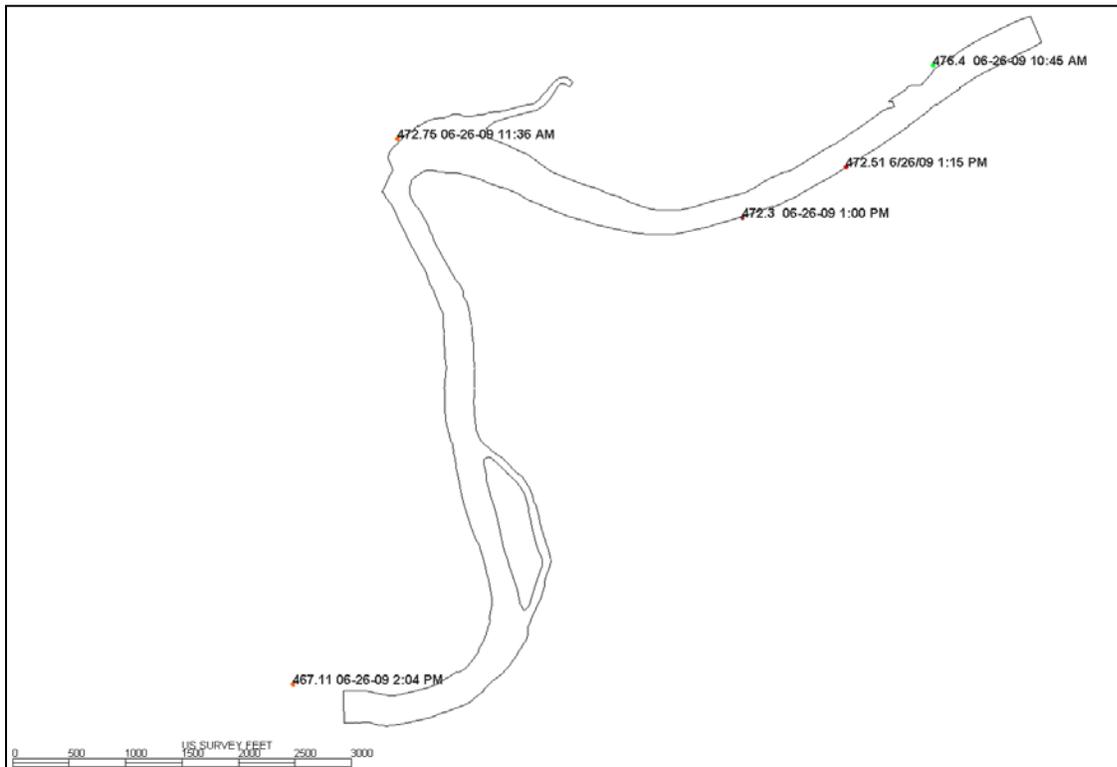
Figure 16: Location and elevation of water level survey points on June 26, 2009

The location and timing of the water level survey points are presented in Figure 16. The survey began on the north bank near the railroad bridge, with the first point being measured at 10:45 AM. Water levels at the Horseshoe Bend were recorded at 11:36 AM. Two locations on the south bank in the upper half of the model reach were surveyed at 1:00 PM and 1:14PM. The final survey point near the downstream end of the project reach was taken at 2:04 PM.

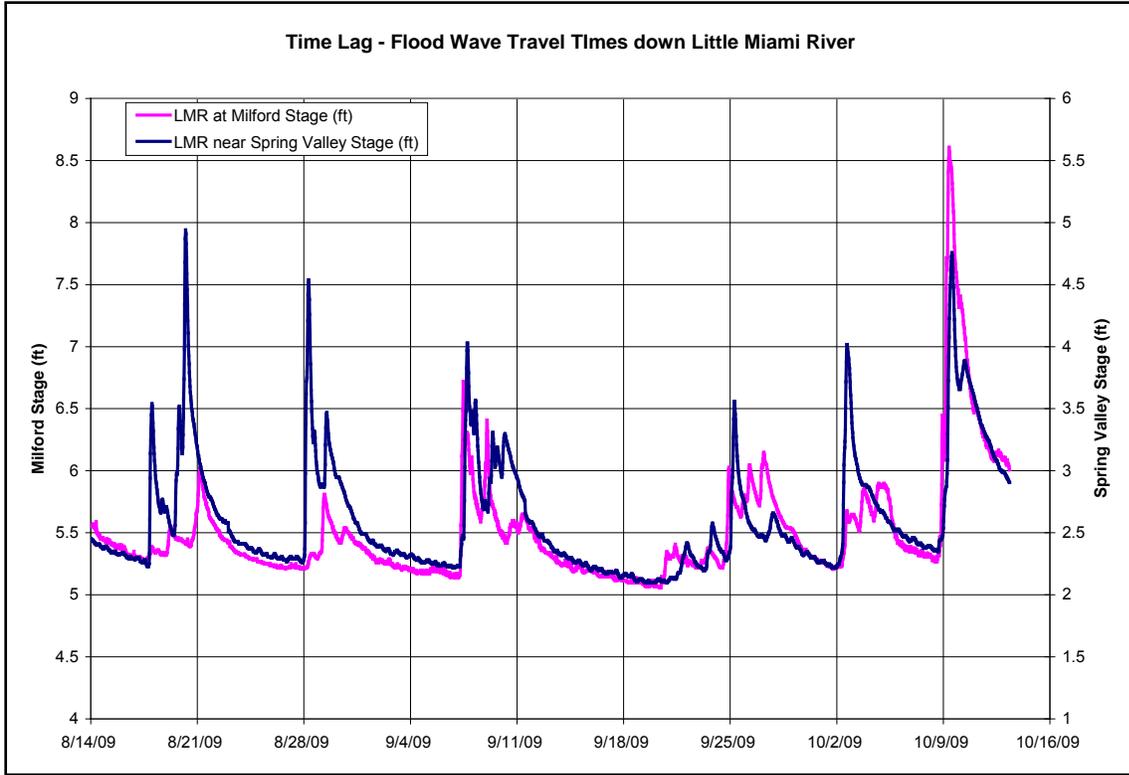
Figure 17: Stage records used to determine lag time for measured flows

The measured river flows were lagged before being applied as upstream boundary conditions in the numerical model. In order to determine an appropriate lag time between the combined flows measured at the upstream gages and the flow at the upstream end of the model (railroad bridge), records of measured flows at two gages on the north fork of the Little Miami River were analyzed. Data from the USGS website were downloaded for a 60 day period (8-14-2009 to 10-13-2009) at Milford (USGS gage 03245500) and Spring Valley (USGS gage 03242050). Measured stage at these two gages, recorded every 30 minutes, was compared graphically (Figure 17). The lag time between local peaks in the stage record were compared to determine the travel time between the two gages, located approximately 47.8 miles apart. An example of this analysis is presented in Figure 18.
