*Phase II Report*

**Geomorphic and  
Two-Dimensional Hydraulic  
Modeling Evaluation of the  
Little Miami River in the Eastern  
Corridor Segment II/III Study Area**

December 2009

NewFields River Basin Services, LLC

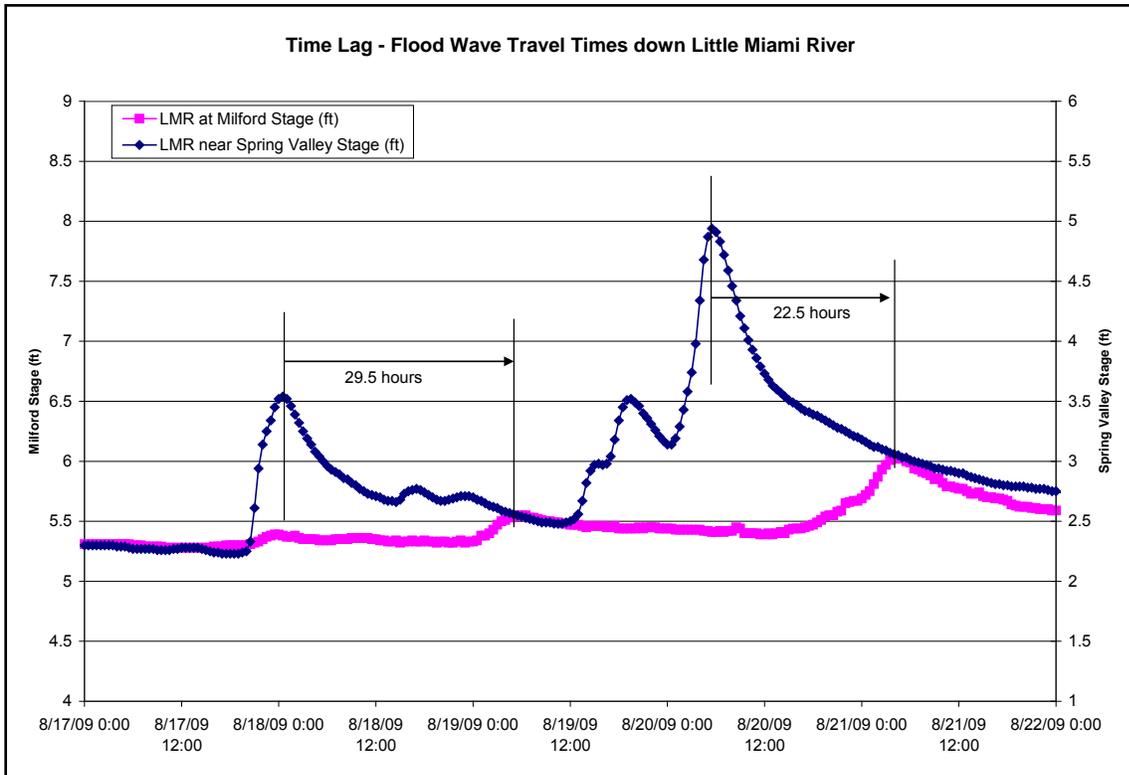
Figure 18: Example of lag time calculations

The measured river flows were lagged before being applied as upstream boundary conditions in the numerical model. In order to determine an appropriate lag time between the combined flows measured at the upstream gages and the flow at the upstream end of the model (railroad bridge), records of measured flows at two gages on the north fork of the Little Miami River were analyzed. Data from the USGS website were downloaded for a 60 day period (8-14-2009 to 10-13-2009) at Milford (USGS gage 03245500) and Spring Valley (USGS gage 03242050). Measured stage at these two gages, recorded every 30 minutes, was compared graphically (Figure 17). The lag time between local peaks in the stage record were compared to determine the travel time between the two gages, located approximately 47.8 miles apart. An example of this analysis is presented in Figure 18.

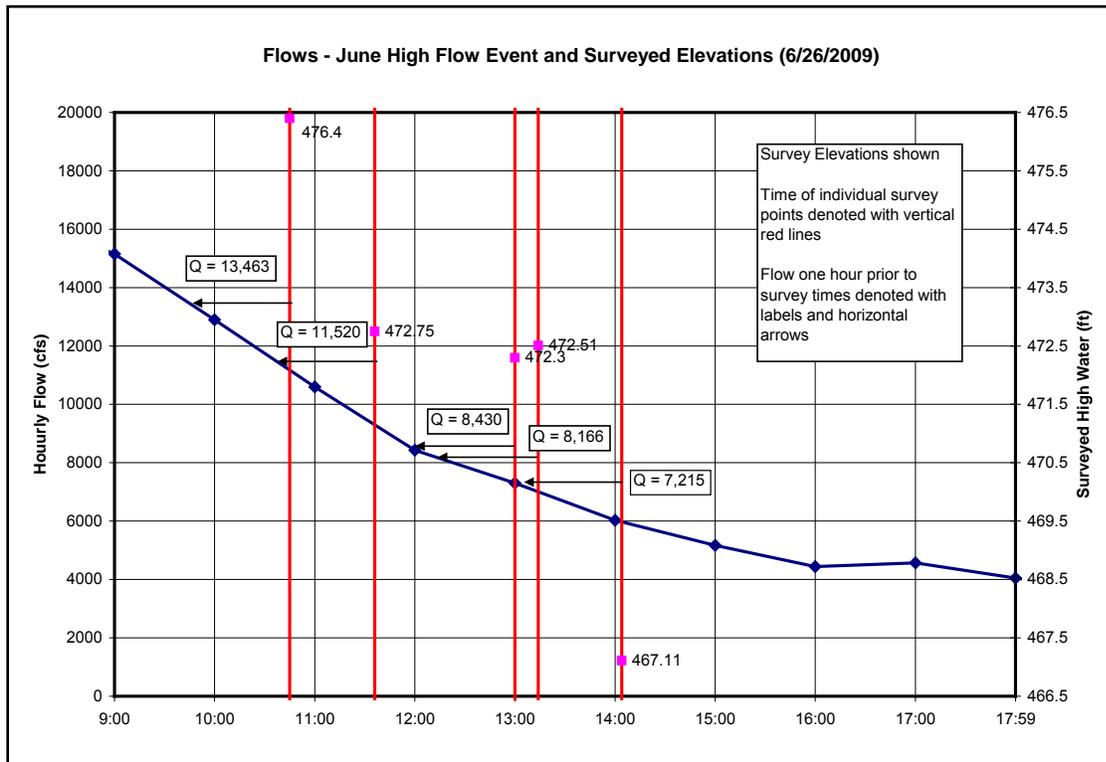
Figure 19: Calibration inflows and water surface elevation survey times

Model inflows used in the calibration simulations were linearly interpolated from hourly flows, assuming a one hour lag between the measured flows to account for travel time to the model boundary, as shown in Figure 19. Once the flows were determined, the stage-discharge curve derived for the Milford gage, presented in Figure 20, was used to estimate an appropriate increase in the downstream stage. The change in stage for a given increase in flow at the model boundary was assumed to equal the change in stage at Milford for the same increase in flow. For example, the stage-discharge equation at Milford predicts an increase in water level of 0.61 feet for an increase in flow from 7215 cfs to 8430 cfs. This same increase was applied at the downstream stage boundary for the same increase in flow. Table 5 summarizes the flow and stage boundary conditions used in the calibration simulations. Steady state runs were conducted as opposed to routing the flood hydrograph through the model because of the lack of information on the variation in downstream stage with flow. The assumption that the stage-discharge relationship at Milford is representative of the stage-discharge relationship at the model boundary (relative to a different datum) was necessary to proceed with the analysis.

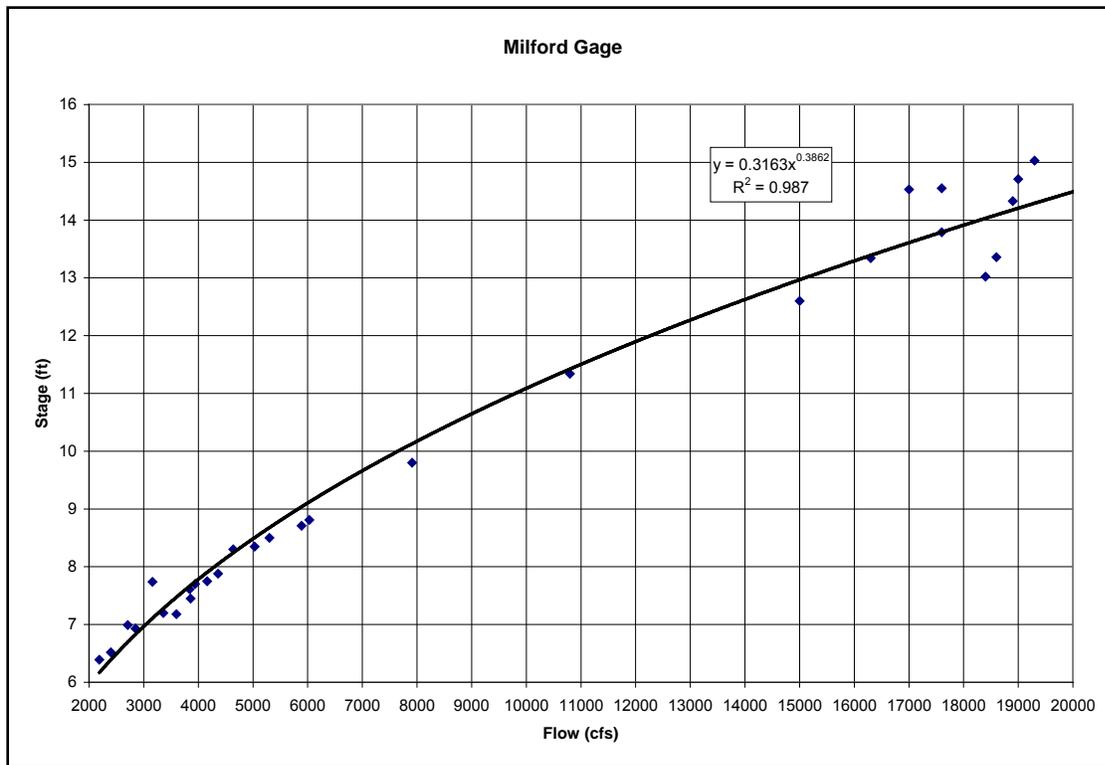
Figure 20: Stage discharge curve for Milford Gage, Little Miami River

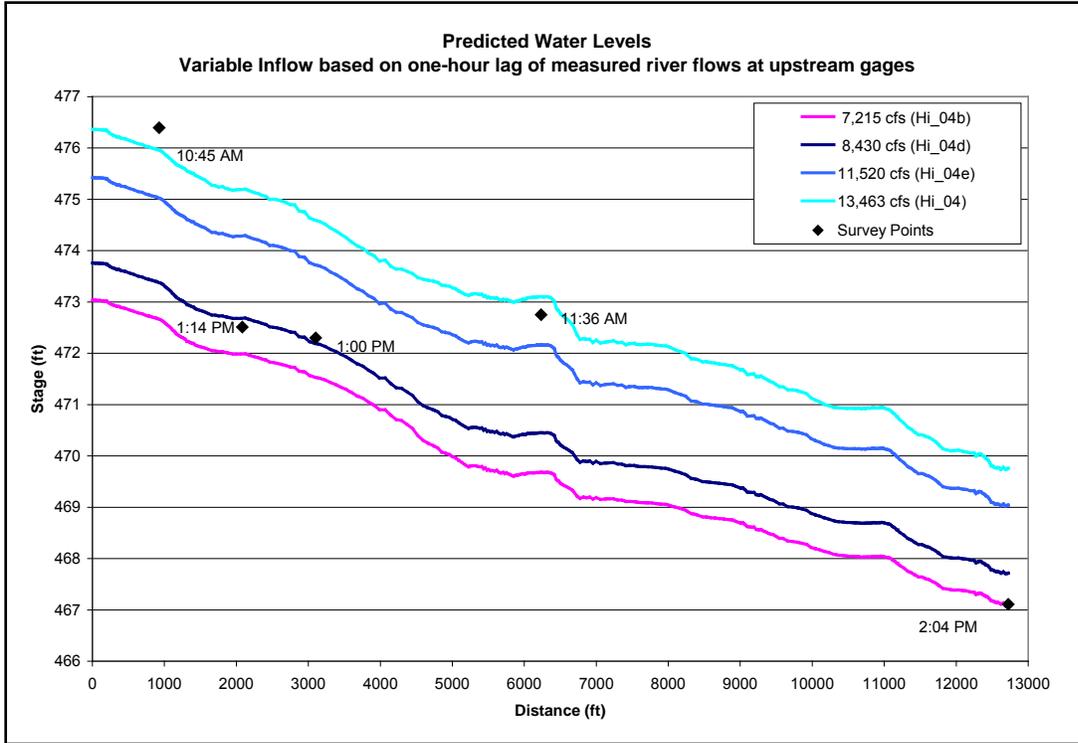
Figure 21: Calibration results - predicted water profiles and calibration survey points

Results of the four calibration simulations are presented in Figure 21 along with the surveyed water surface elevations. Considering the limited data and the assumptions required to determine boundary flows and stages, the calibration results appear reasonable. These results indicate that the model parameters for friction and eddy viscosity applied in Phase 1 of the modeling study were appropriate. Therefore, no adjustments to Manning's  $n$  were made in this calibration. The model grid was adjusted during the calibration effort for the June 26 flow event. An iterative approach was used to reduce the model grid based on predicted water depths such that the model correctly represented the proper flow width. A final review of the model's sensitivity to the eddy viscosity parameter was conducted. The final calibration simulation used a Peclet number of 20 to automatically specify the eddy viscosity on an element by element basis, a default recommended value (USACE 2009). Figure 22 indicates that for a reasonable range in Peclet numbers, the predicted water surface elevations varied by less than 0.5 feet.

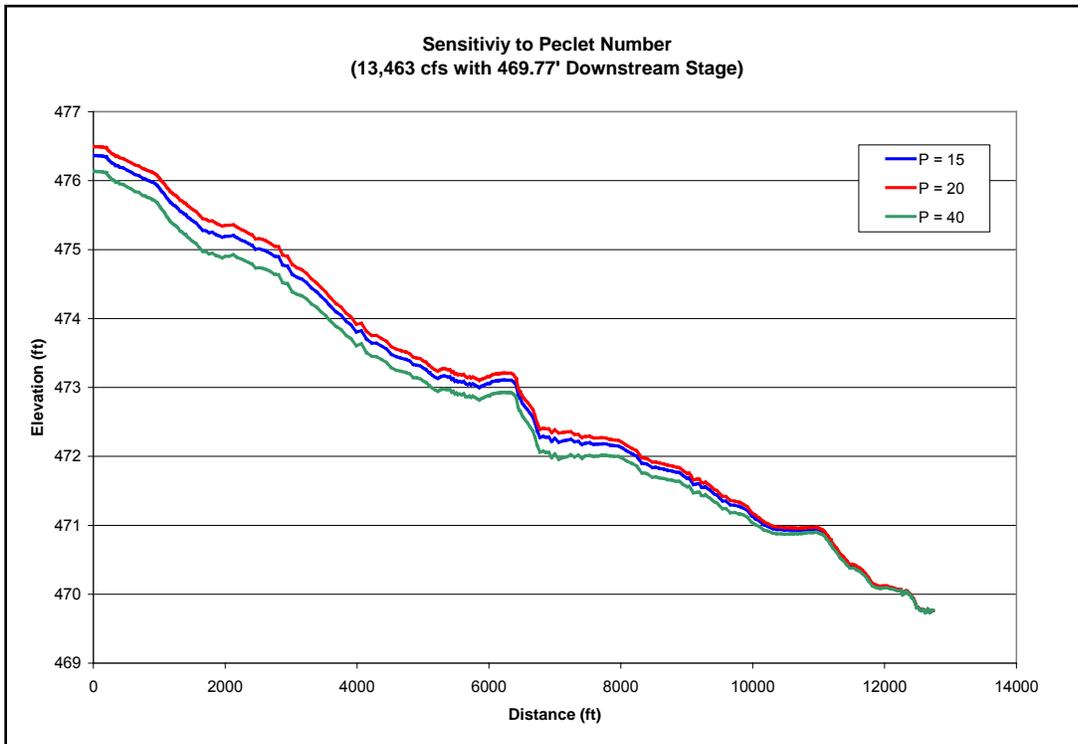
Figure 22: Sensitivity to Peclet Number (eddy viscosity)

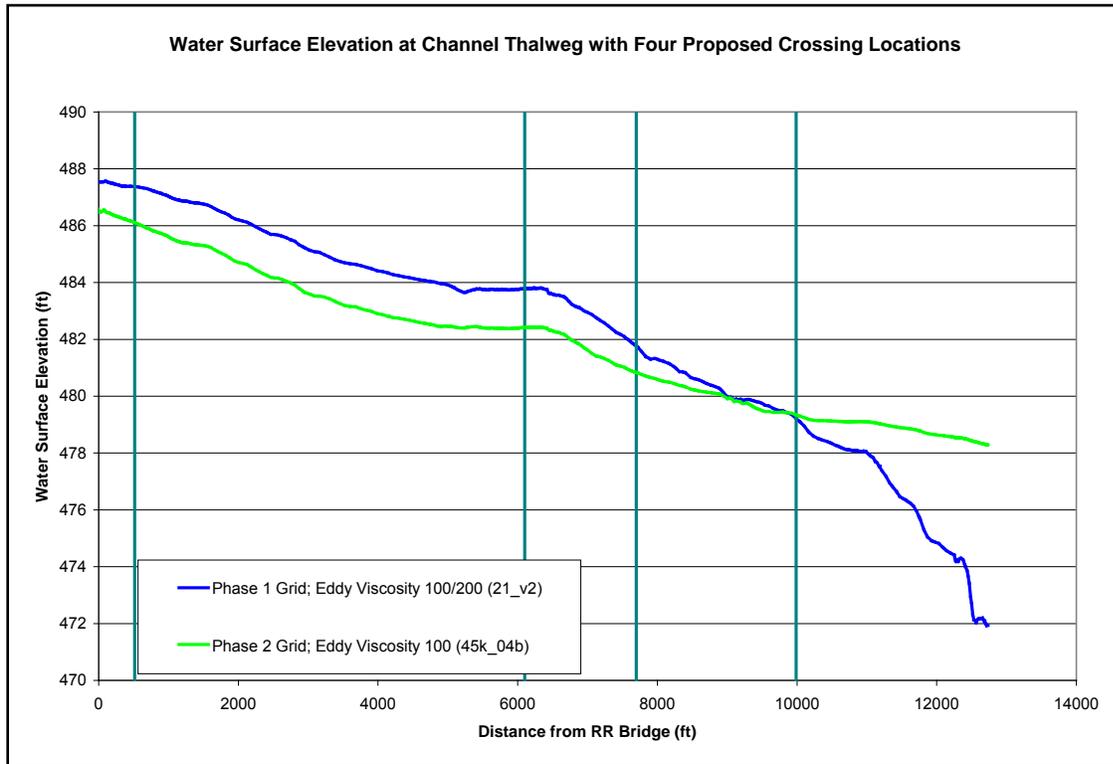
Figure 23. Comparison of Phase 1 and Phase 2 predicted water levels along the channel thalweg

Figure 23 presents a comparison of predicted water levels along the channel thalweg for both the Phase 1 and Phase 2 grids (for 45,000 cfs). The expansion of the grid to cover more of the adjacent floodplain, coupled with the increased downstream stage, yielded a more gently sloping water level. Even with the increased stage at the downstream boundary, predicted water levels in Phase 2 are below those reported in Phase 1. Figure 24 presents flow velocities along the channel thalweg for the same simulations shown in Figure 23. The high flow velocities predicted at the downstream boundary in Phase 1 are muted in Phase 2 because of the increased stage at the boundary. The increased lateral width of the floodplain also decreases the predicted centerline velocity from those presented in Phase 1. Peak channel centerline velocities are approximately 8 feet per second in the calibrated model for the 45,000 cfs flow scenario. Overflow onto the floodplain occurs in the upper portion of the model reach through low points in the natural river levee. The increased coverage of the floodplain in the Phase 2 grid can be seen by comparing Figures 25 and 26. These reflect the width of the river at a flow of 45,000 cfs.

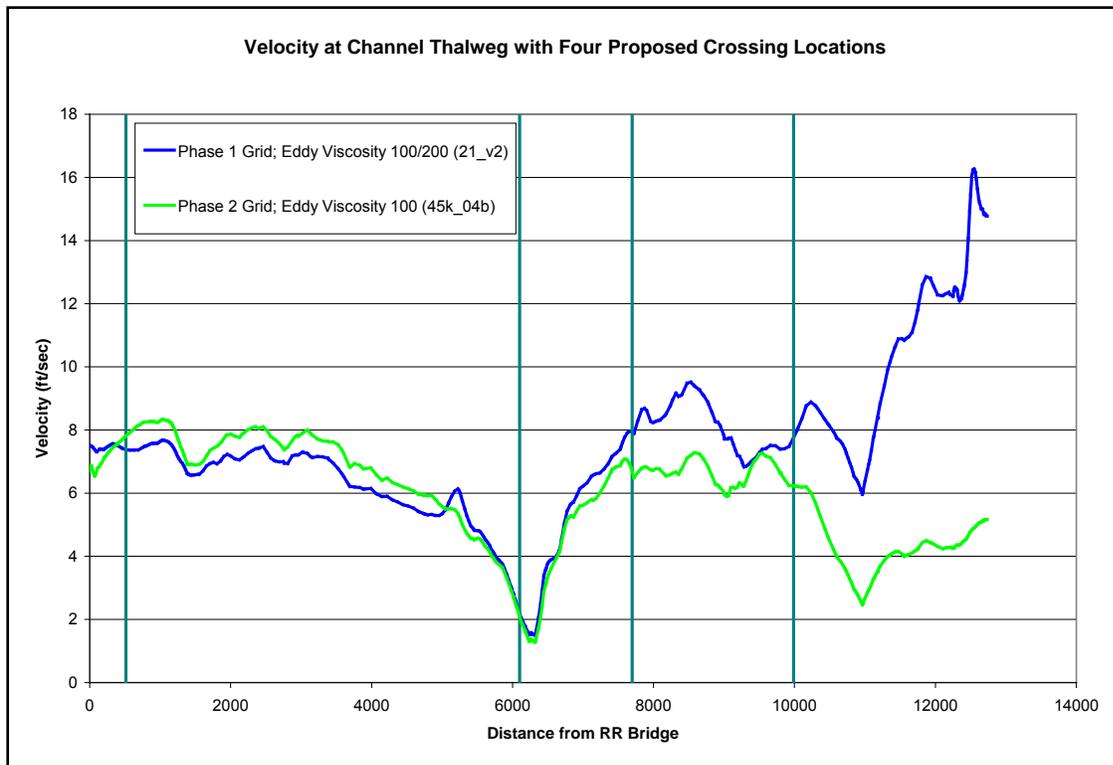
Figure 24. Comparison of Phase 1 and Phase 2 predicted velocity along the channel thalweg

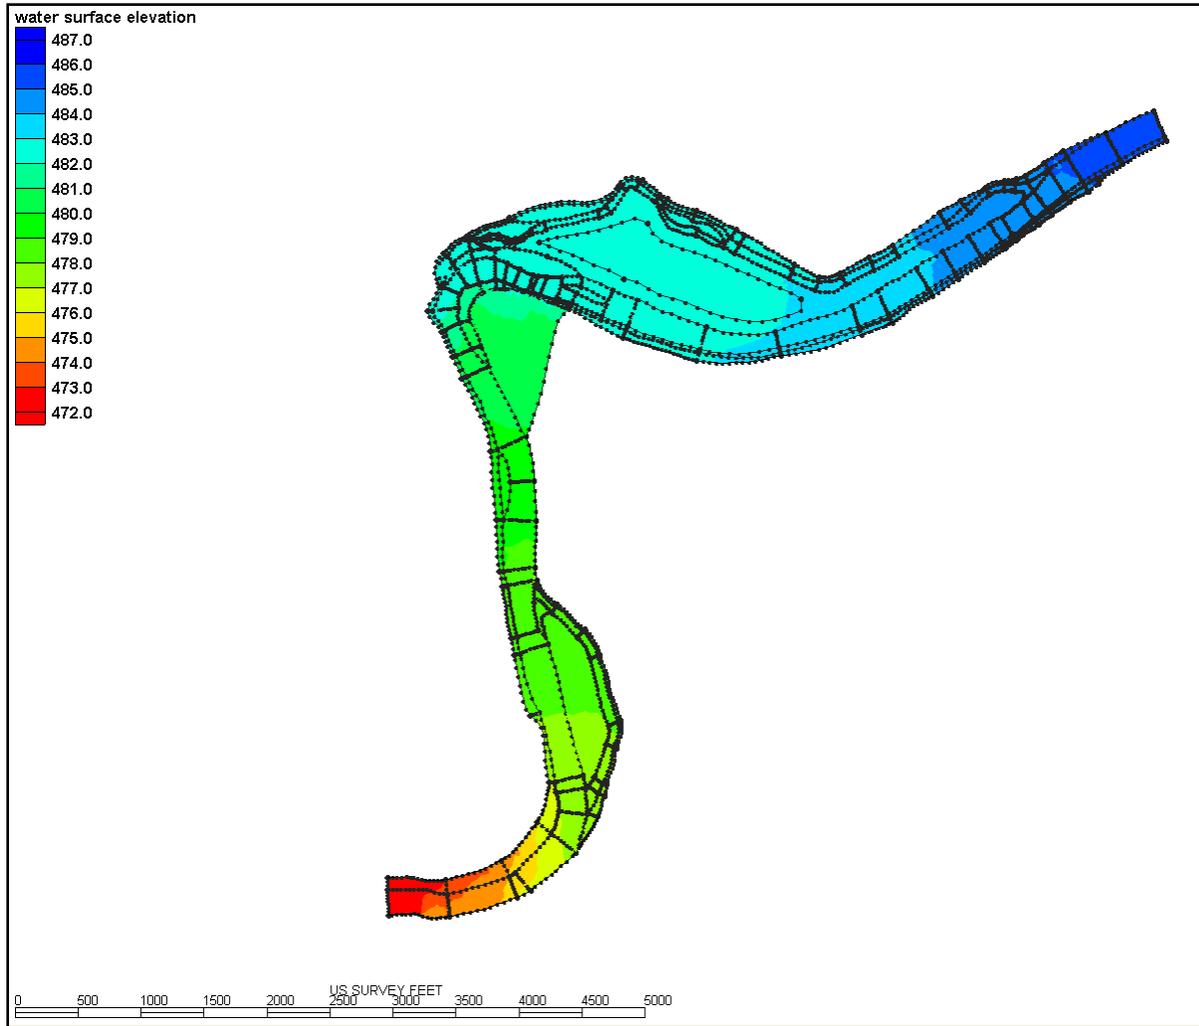
Figure 25. Phase 1 model grid – river elevation and floodplain width at 45,000 cfs

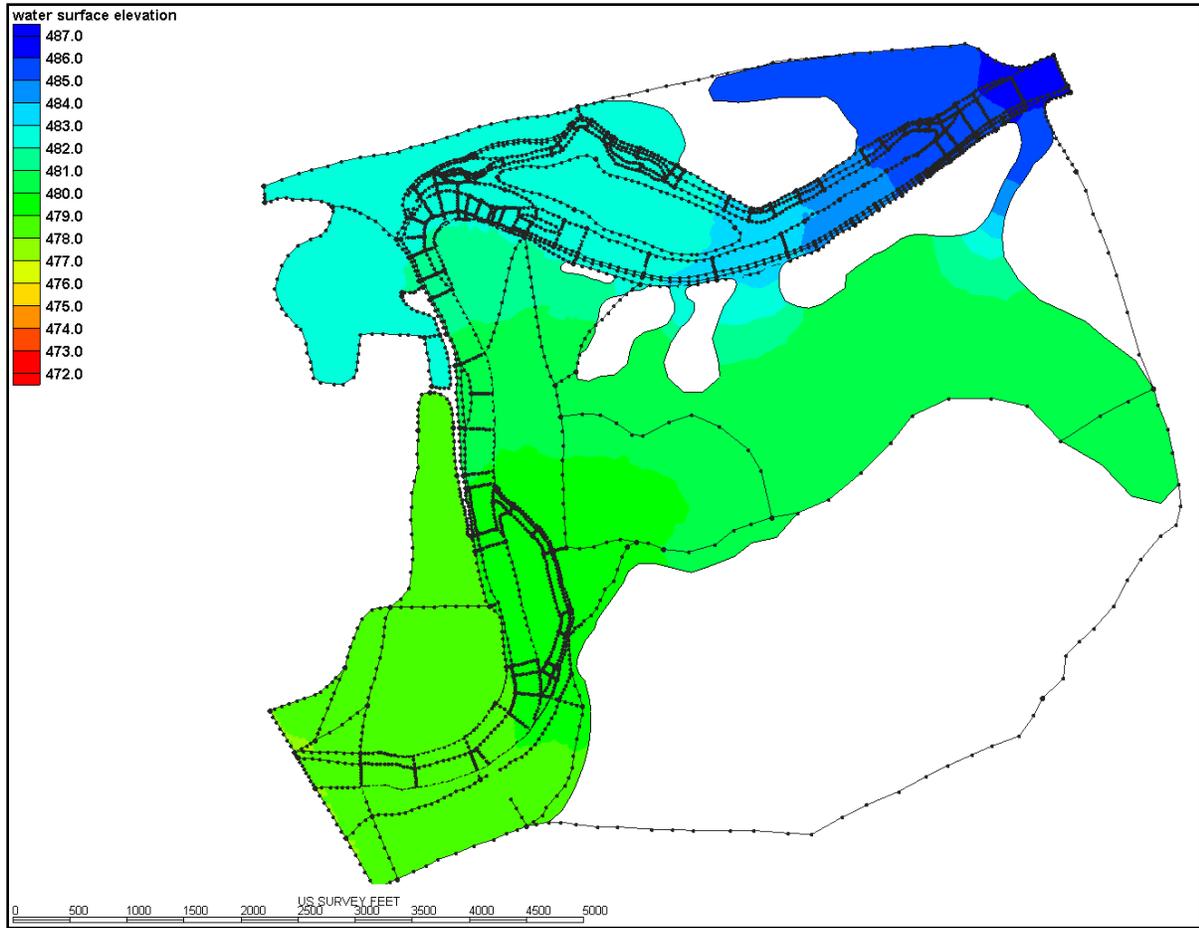
Figure 26: Phase 2 model grid – River elevation and floodplain width at 45,000 cfs

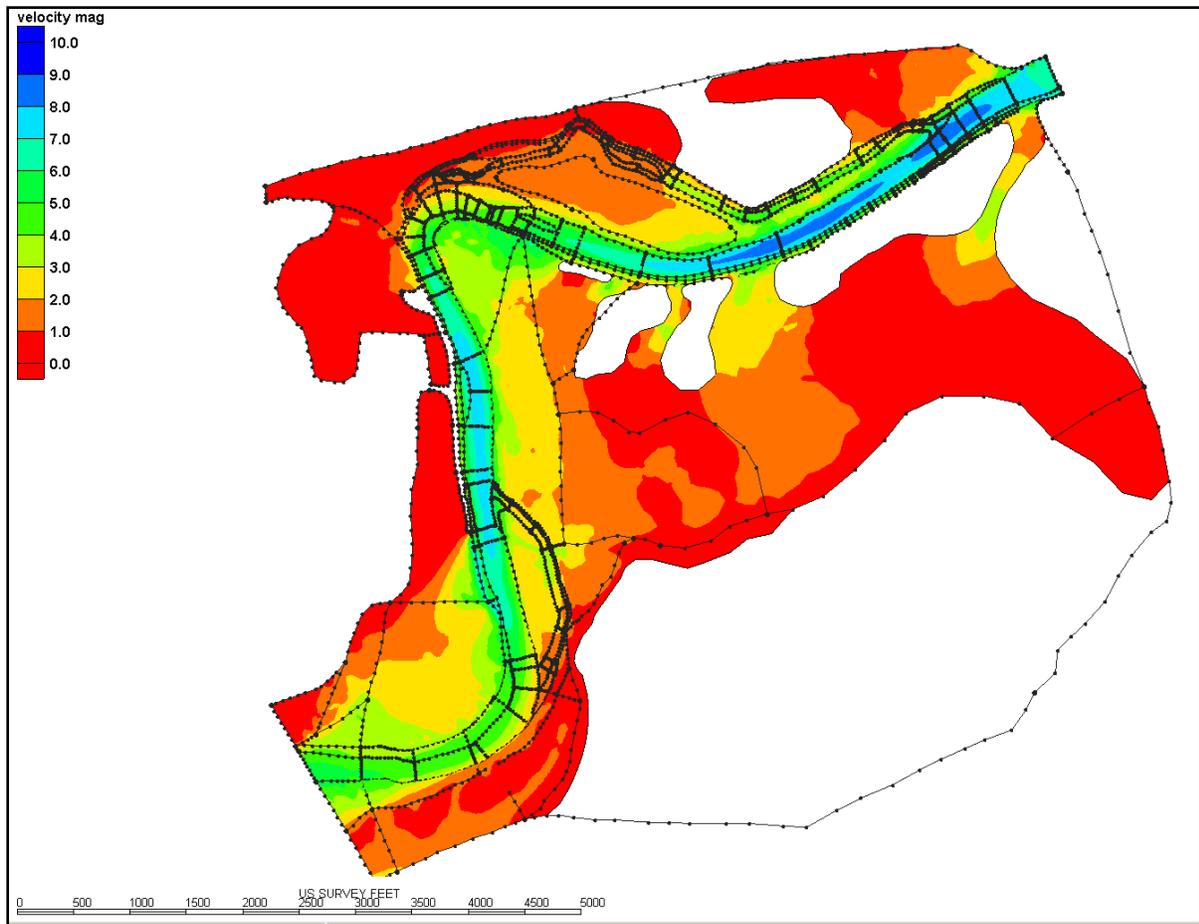
Figure 27. Predicted velocity contours for 45,000 cfs flow (Phase 2 grid)

Predicted velocities in the model grid are presented in Figure 27. Flow velocities on the floodplain are generally less than 2 feet per second. At the upstream crossing near the railroad bridge, channel centerline velocities are 8 feet per second. Flow vectors are primarily aligned parallel to the channel banks, where velocities are generally between 4 and 5 feet per second. At the downstream crossing, peak centerline velocities are about 6 feet per second, with lower velocities at the channel banks. Velocities are primarily aligned parallel to the river banks, but some flow does re-enter the channel in this area from the floodplain.

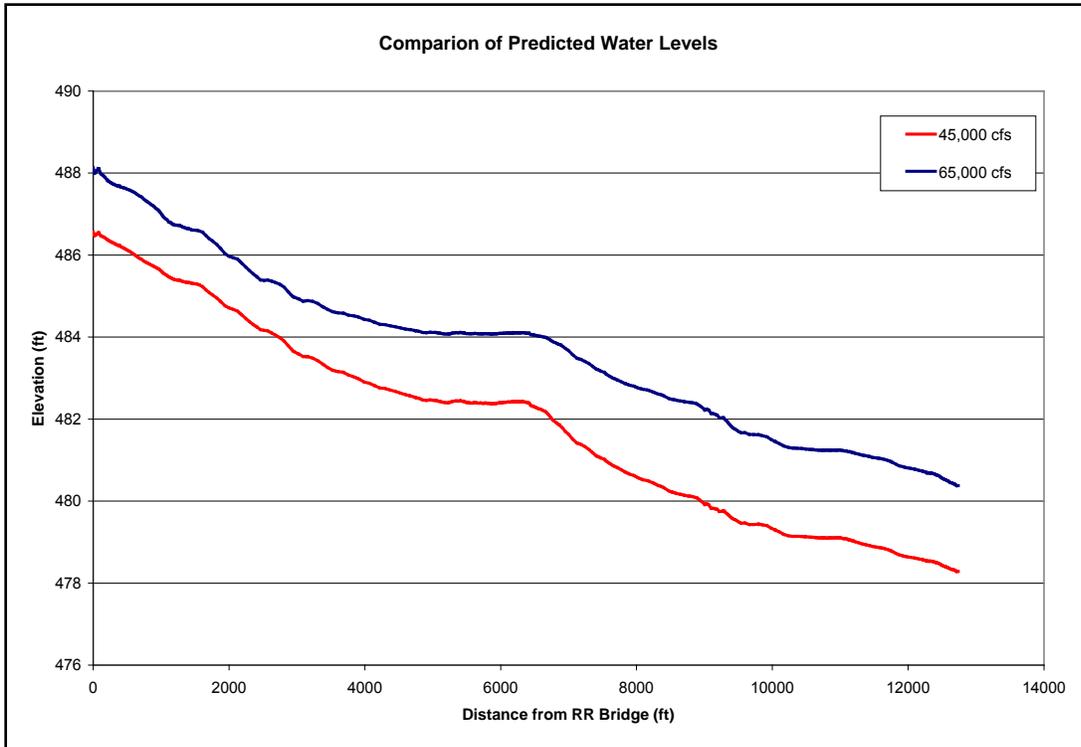
Figure 28: Channel centerline water surface elevations for high flow simulations

The largest flow modeled in Phase 2 was 65,000 cfs. The downstream stage was set at 480 feet for this simulation. Figures 28 and 29 compare model predicted water surface elevations and velocities along the channel centerline for 45,000 cfs and 65,000 cfs conditions. The boundary elevation was two feet higher for the 65,000 cfs simulation; the difference in water level between this run and the 45,000 cfs run decreases in the upstream direction to 1.5 feet at the railroad bridge. The channel centerline velocities are very similar for these two high flow simulations, particularly in the lower half of the project reach below the Horseshoe Bend. The majority of the increased flow is carried by the floodplain, leaving conditions in the river channel similar

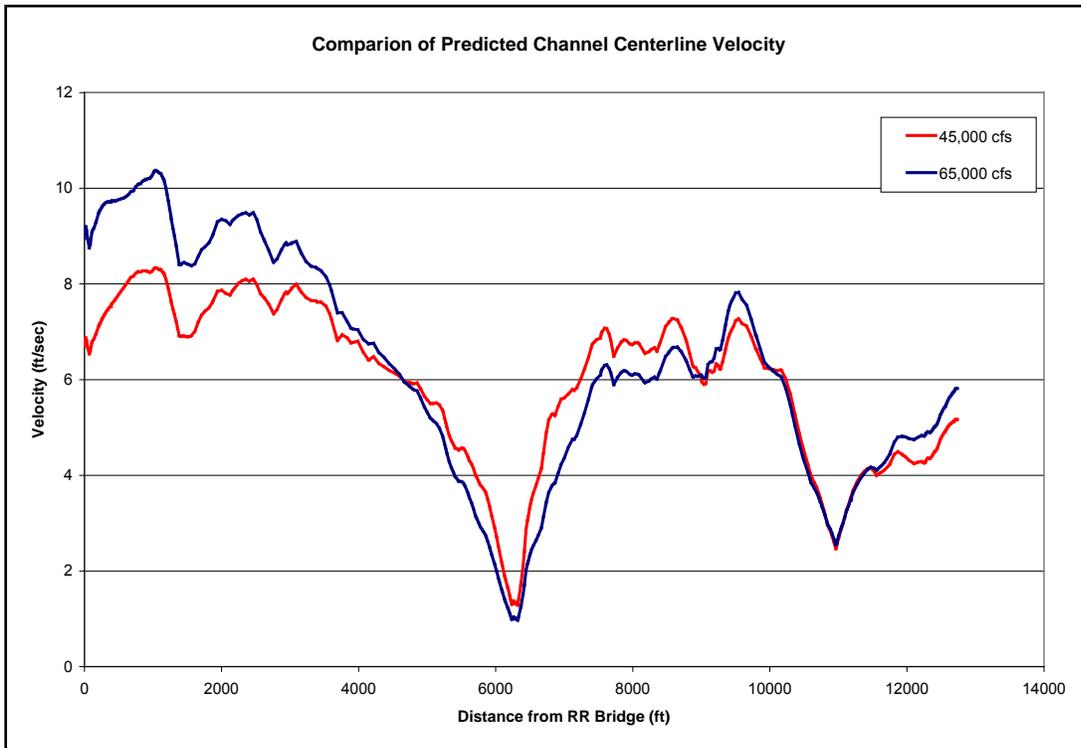
Figure 29. Channel centerline velocity for high flow simulations

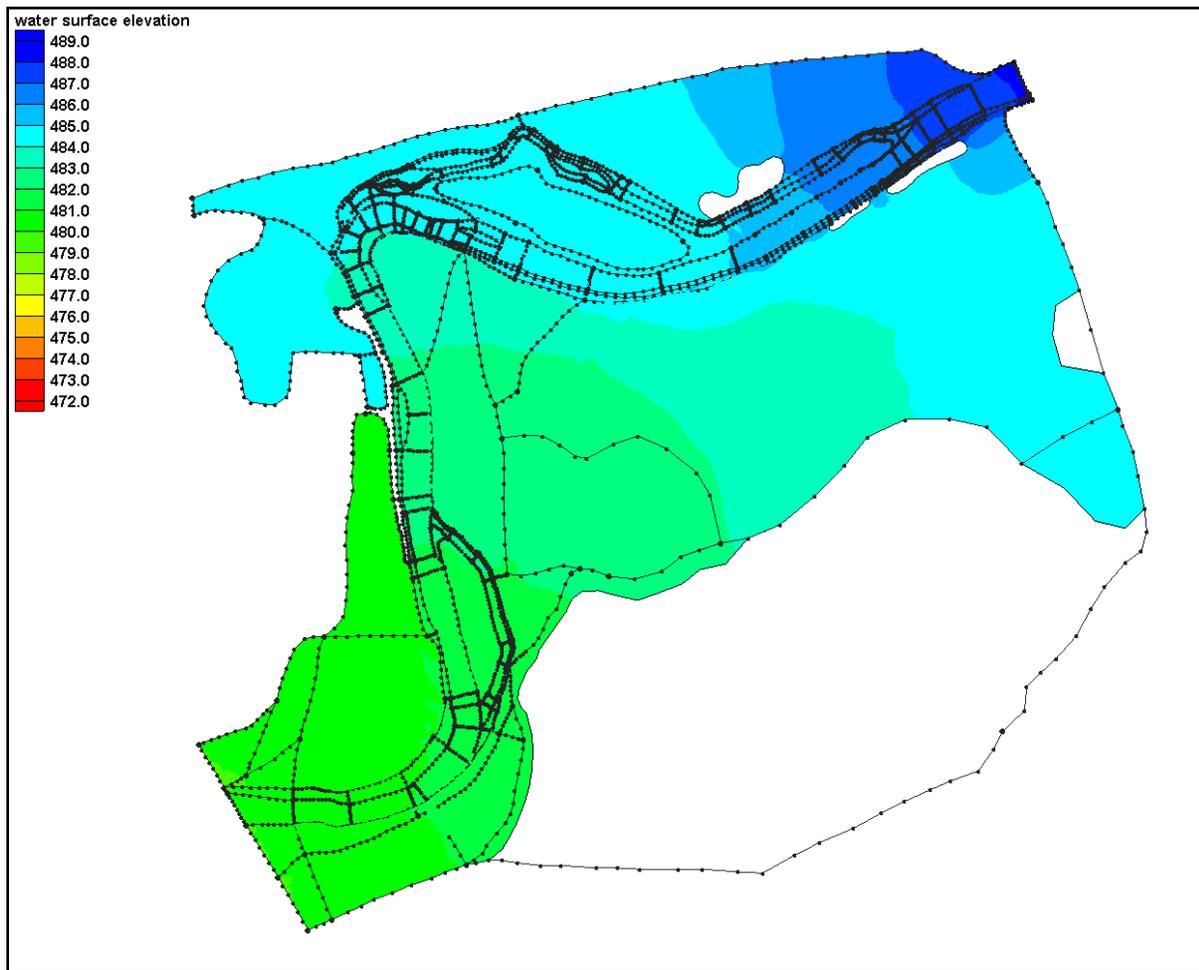
Figure 30. Phase 2 model grid – river elevation and floodplain width at 65,000 cfs

Figures 30 and 31 show the predicted water levels and velocities, respectively, throughout the model grid for the 65,000 cfs simulation. The additional flow inundates more of the natural floodplain area on the south bank. Predicted velocities on the floodplain increase slightly with the increased flow, as does the velocity over the natural banks as water leaves the channel and spills onto the floodplain.

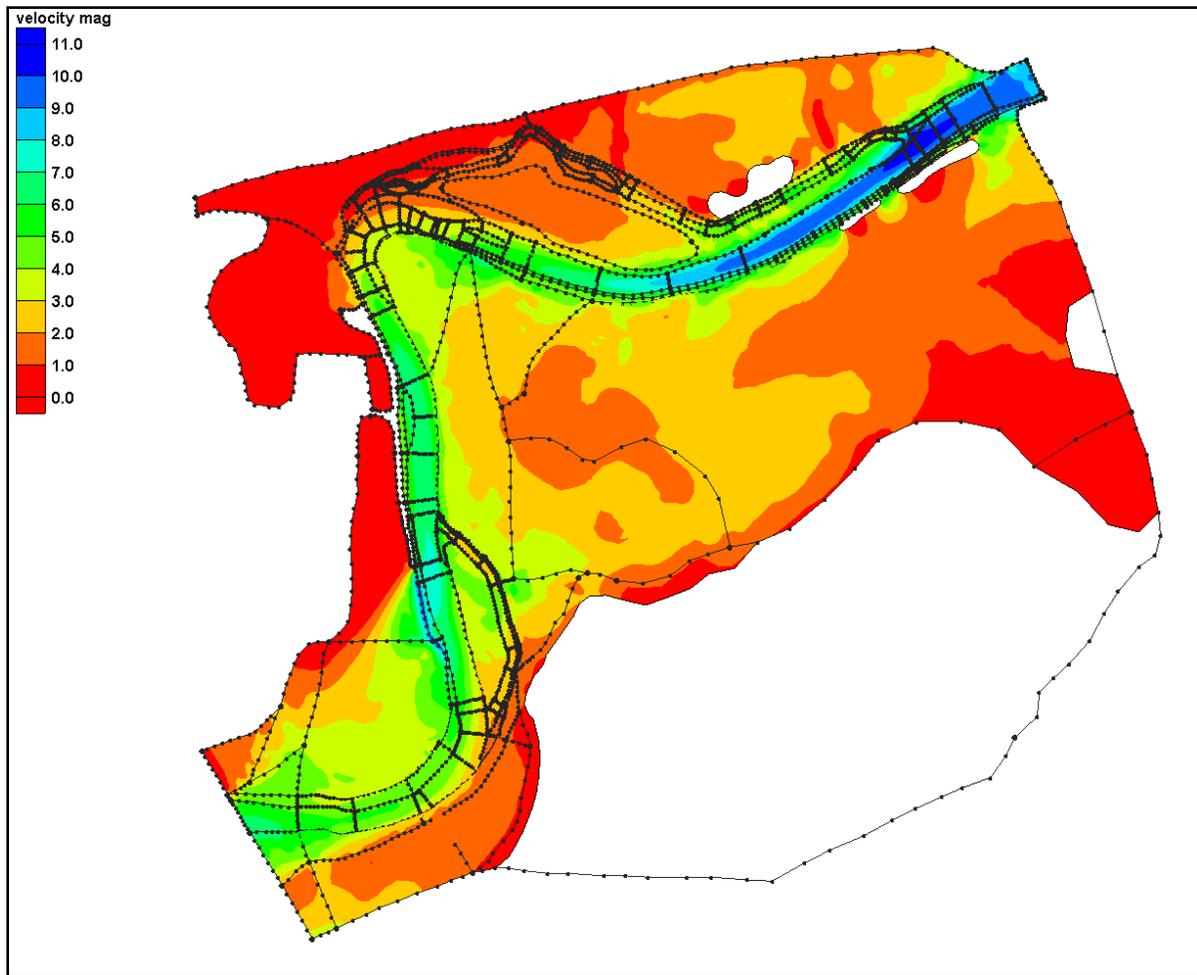
Figure 31: Predicted velocity contours for 65,000 cfs flow (Phase 2 grid)

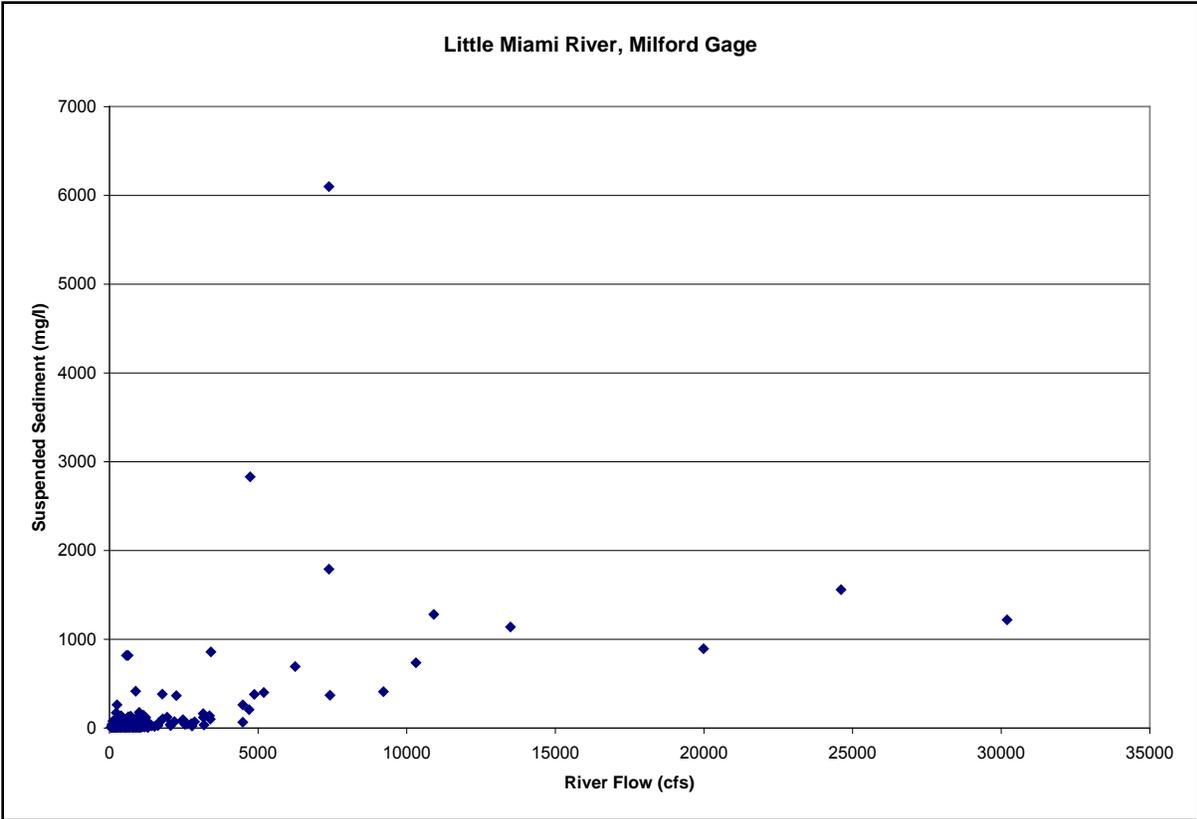
Figure 32. Suspended sediment and flow measurements at Milford Gage

Paired suspended sediment concentration and flow data at Milford were downloaded from the USGS and included a total of 194 measurements collected between January 8, 1975 and September 13, 2000. The peak flow recorded during the collection period for this dataset was 30,194 cfs; however the majority of suspended sediment samples were collected during relatively low flows. Only six samples were taken with flows exceeding 10,000 cfs, and 131 of 194 samples were collected at flows less than 1,000 cfs. This complicates the specification of sediment boundary conditions for the high flow simulations. Figure 32 shows the sediment concentration and discharge dataset. Absent additional data, boundary suspended concentrations were set at 1,000 mg/l for the 45,000 and 65,000 cfs simulations.

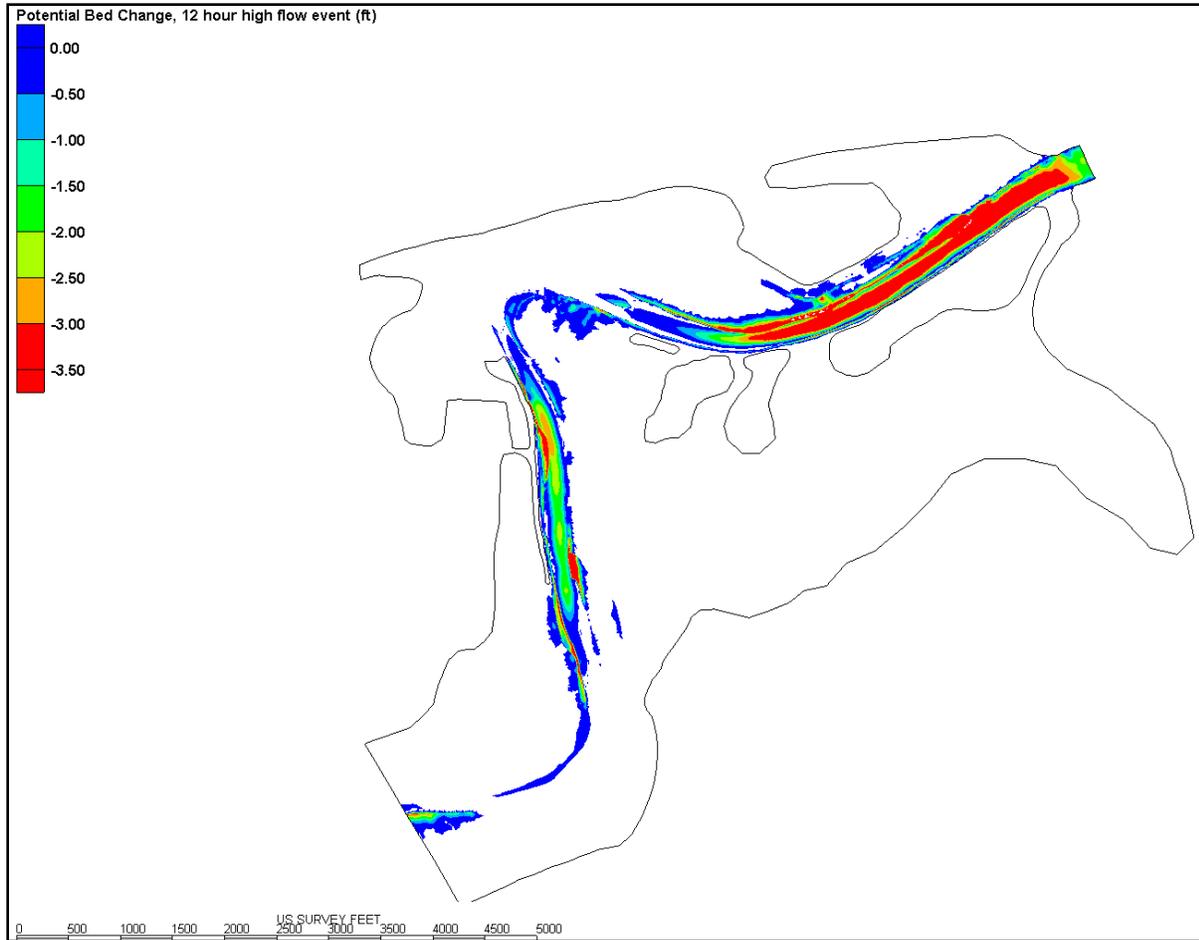
Figure 33. Potential Bed Change Contours for 45,000 cfs (12 hour run with fine sand substrate)

For the high flow simulations (both 45,000 cfs and 65,000 cfs), the model predicts the potential for significant erosion in several regions of the project reach. Based on predicted shear stresses and flow velocities, the greatest potential for erosion occurs in the two long, straight reaches of the channel upstream and downstream of the horseshoe bend (Reaches 4 and 6/7). Contours of potential bed change for the 45,000 cfs simulation are presented in Figure 33. It is extremely important to note that these model results assume that the entire bed is comprised of fine sand. Since the channel bed is actually composed of significantly coarser bed sediment (generally gravel with median particle diameters between 7.6 mm and 18.6 mm), especially at the low flow riffle just upstream of the Horseshoe Bend, model predictions of erosion areas should be interpreted as areas with excess sediment transport capacity that are unlikely to be depositional, rather than areas experiencing ongoing bed scour<sup>1</sup>. This interpretation is supported by the scour chain investigations and bank erosion measurements conducted by Stantec (2009a). Figures 33 and 34 both illustrate sediment transport dynamics in the vicinity of Horseshoe Bend that are conducive to the development of meander cutoffs as described in Section 2.3. During overbank flow conditions, the reach upstream of the Horseshoe Bend appears to be a transport reach while the Horseshoe Bend itself appears to be more depositional. Therefore, as sediment deposits in and adjacent to the Horseshoe Bend it is likely that this could eventually create elevation gradients that would force the main channel to shift during a future high flow.

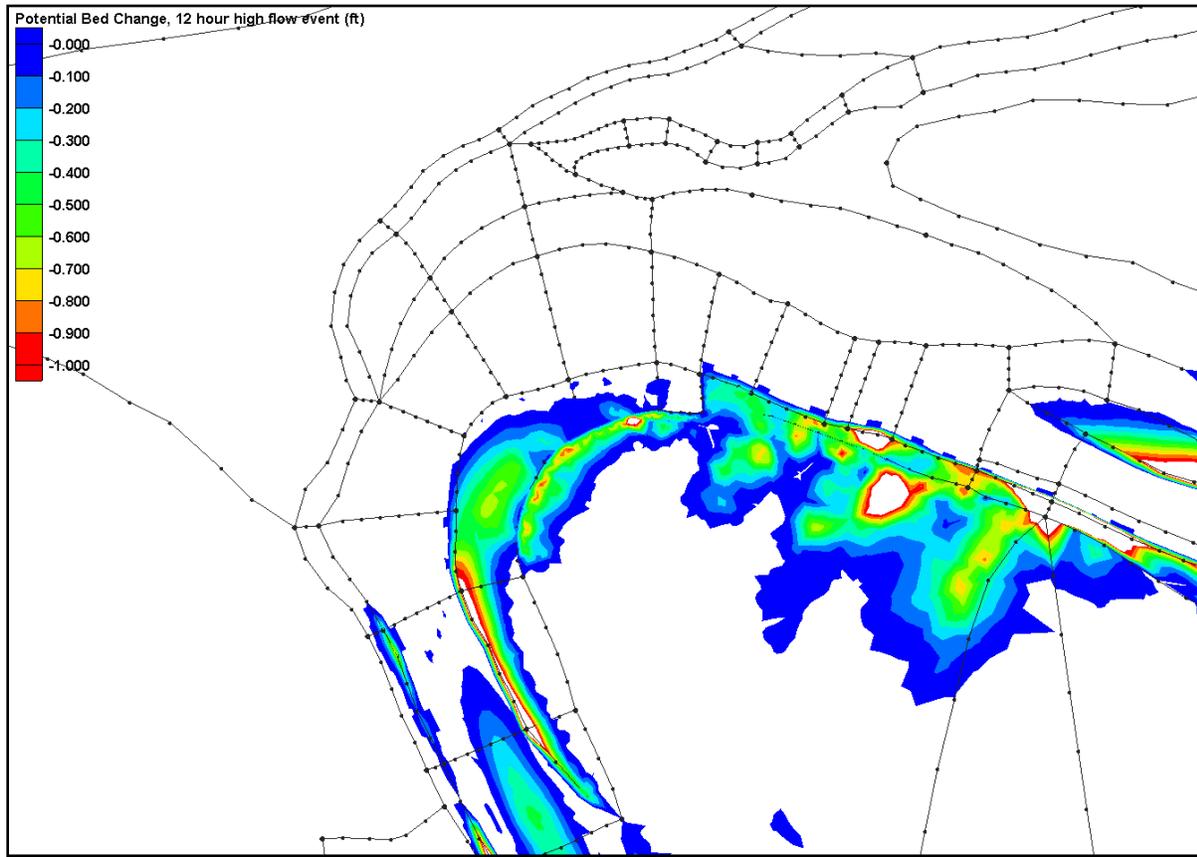
Figure 34. Erosion Patterns in the vicinity of Horseshoe Bend (45,000 cfs)
