*Phase II Report*

**Geomorphic and  
Two-Dimensional Hydraulic  
Modeling Evaluation of the  
Little Miami River in the Eastern  
Corridor Segment II/III Study Area**

December 2009

NewFields River Basin Services, LLC

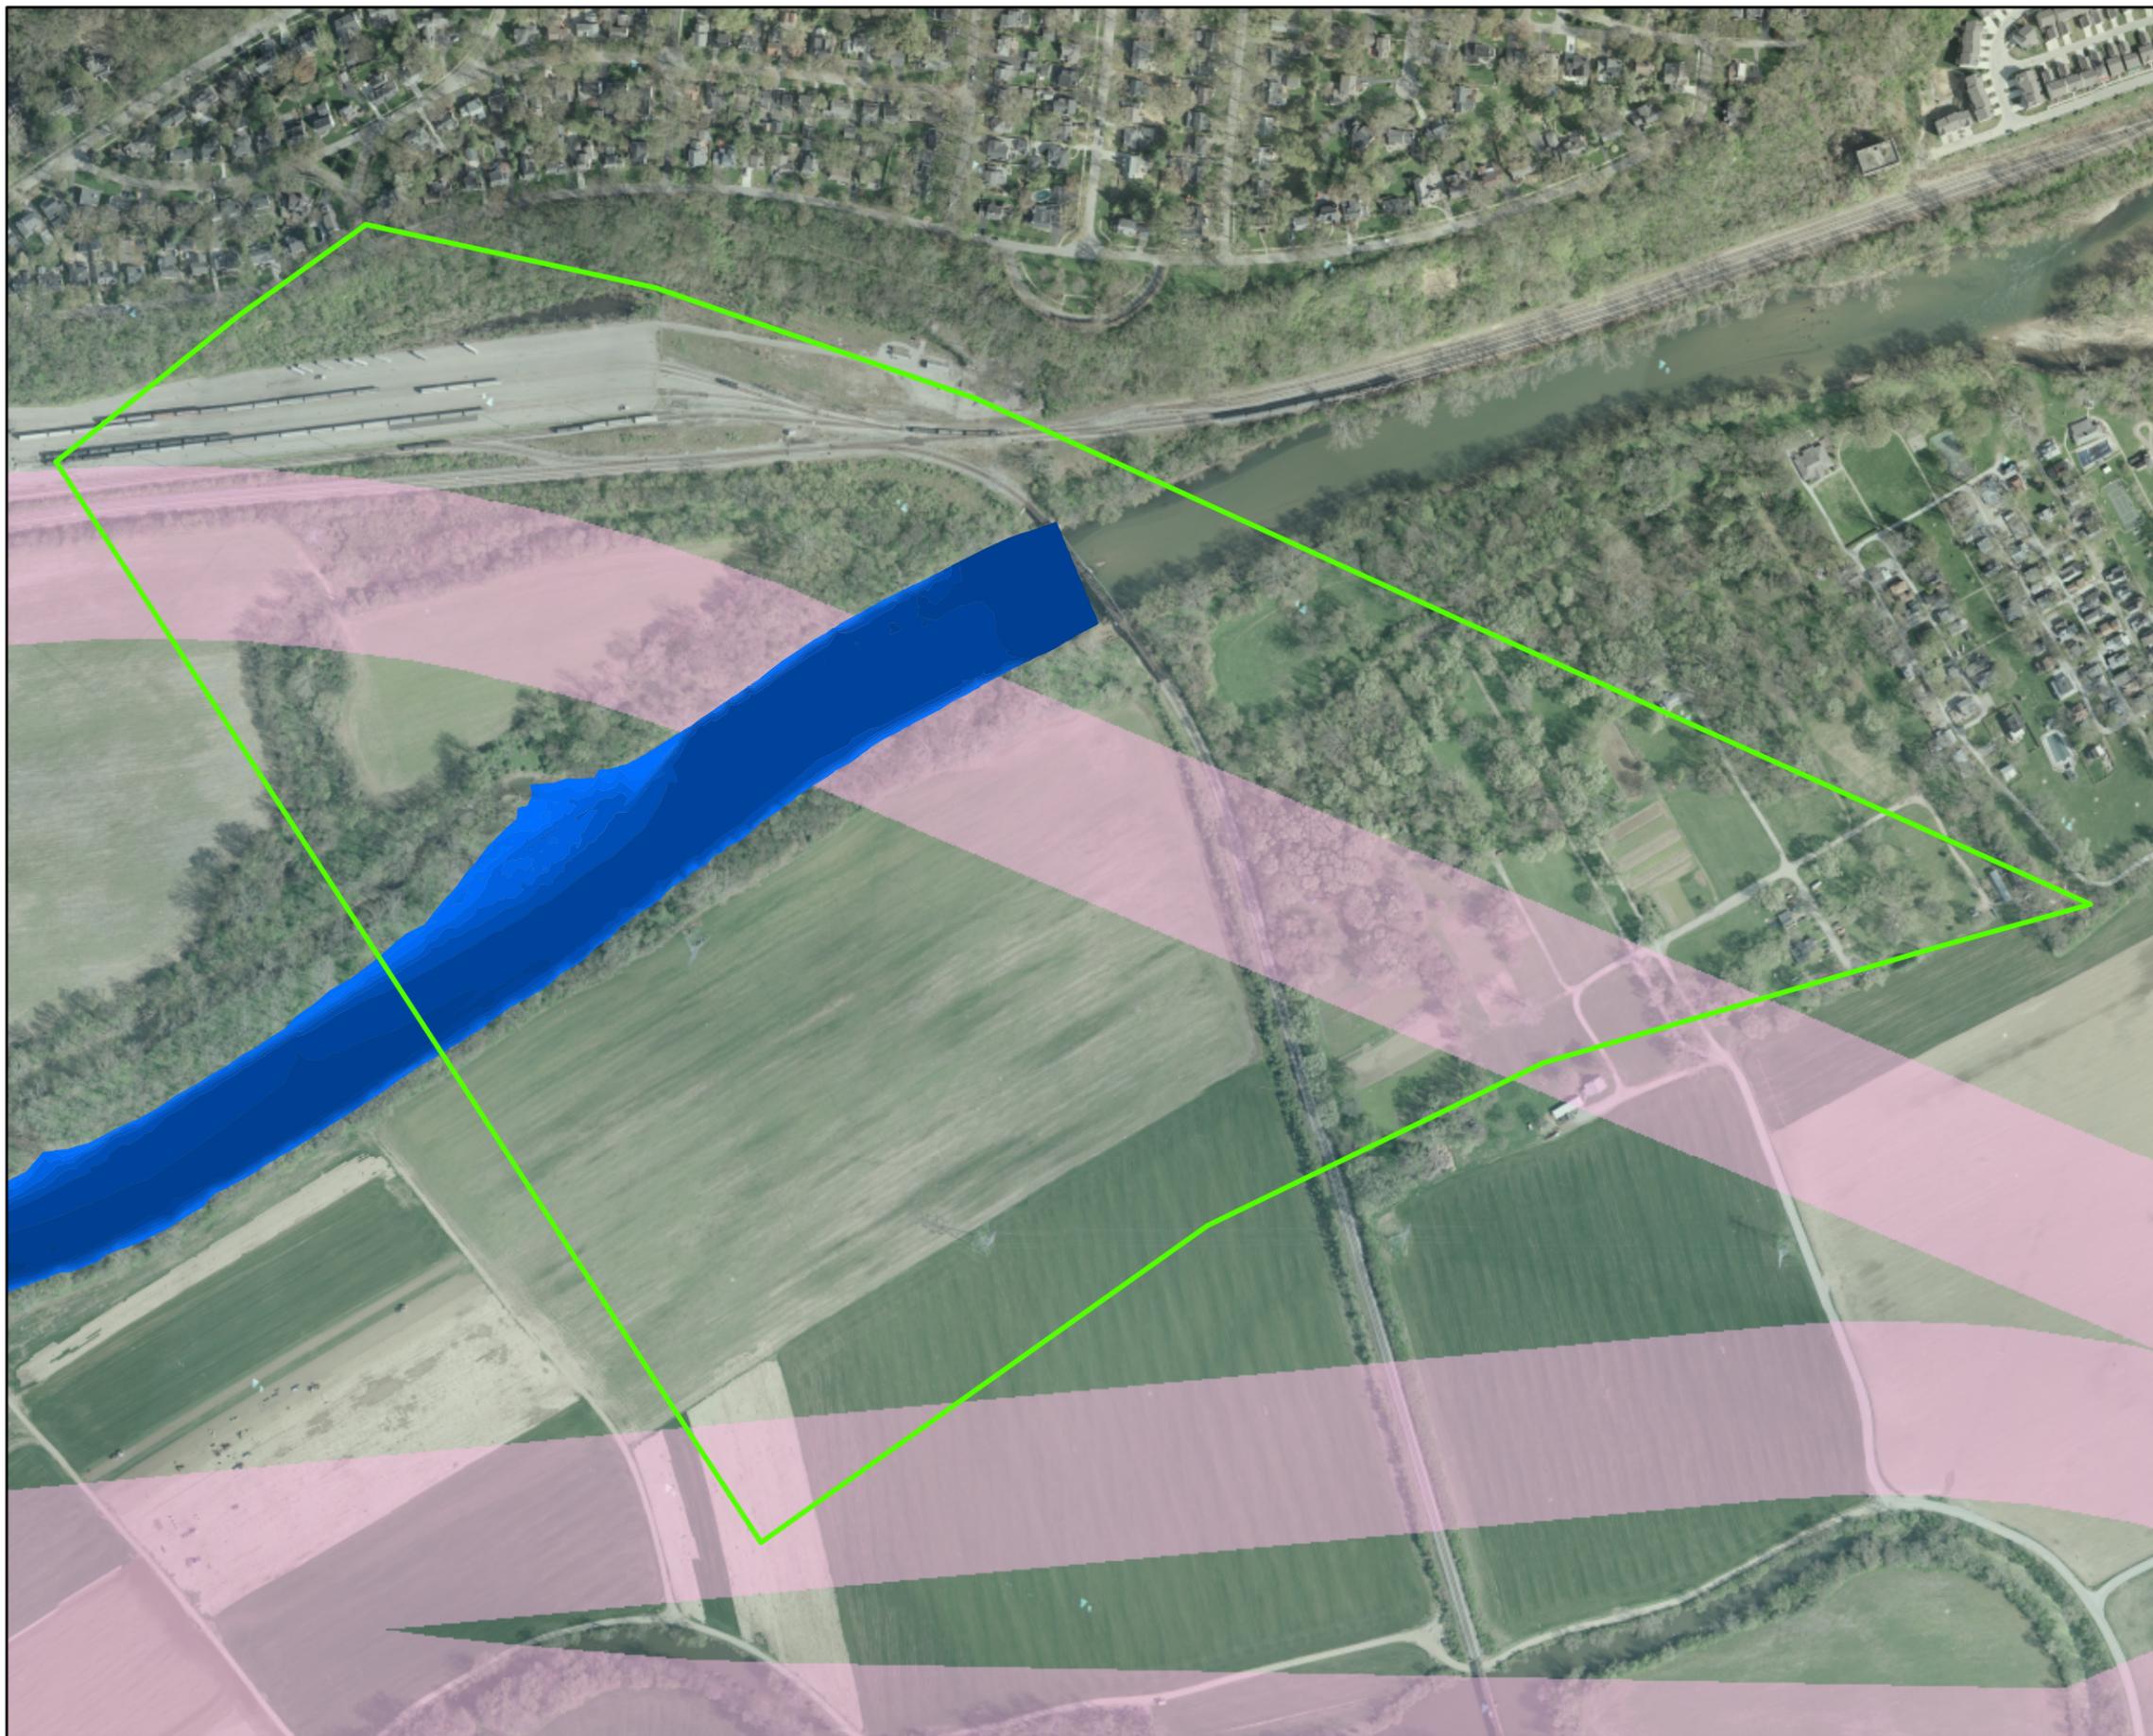
**FIGURE A2**  
**DISTRIBUTION OF DEPTH AT**  
**10,000 CFS GEOMORPHIC REACH 4**  
 Little Miami River Geomorphic and  
 Hydraulic Modeling Evaluation, Phase II

Appendix A (Figures A1 – A19) includes plan views of depth, velocity, and shear stress conditions in Geomorphic Reach 4 and Geomorphic Reach 6/7 for 10,000 cfs, 45,000 cfs, and 65,000 cfs flow simulations. Hydraulic model results for 10,000 cfs in Geomorphic Reach 4 (Figures A2-A4) show that the entire flow is contained in the channel, and that depths are uniform in the upstream half of the reach. Flow depth varies more in the downstream half of Geomorphic Reach 4 along the right bank. Velocity and shear stress patterns generally follow depth patterns, with less stable conditions in the downstream half of the reach. However, velocities and shear stresses are not high enough to cause significant channel change at this flow. At 10,000 cfs, the best location for a clear span bridge in Geomorphic Reach 4 is in the upstream half of the reach. In Geomorphic Reaches 6 and 7, hydraulic model results for 10,000 cfs (Figures A5-A7) show a meandering thalweg in Geomorphic Reach 6 and in the upstream half of Geomorphic Reach 7. There is also a high flow channel at the Clear Creek confluence. Velocities are mostly uniform in Geomorphic Reach 6 and in the upstream half of Geomorphic Reach 7. Velocities are higher and more diverse in the downstream half of Geomorphic Reach 7. At 10,000 cfs, conditions for a clear span bridge are best immediately upstream of the Clear Creek confluence with the Little Miami River in Geomorphic Reach 7.

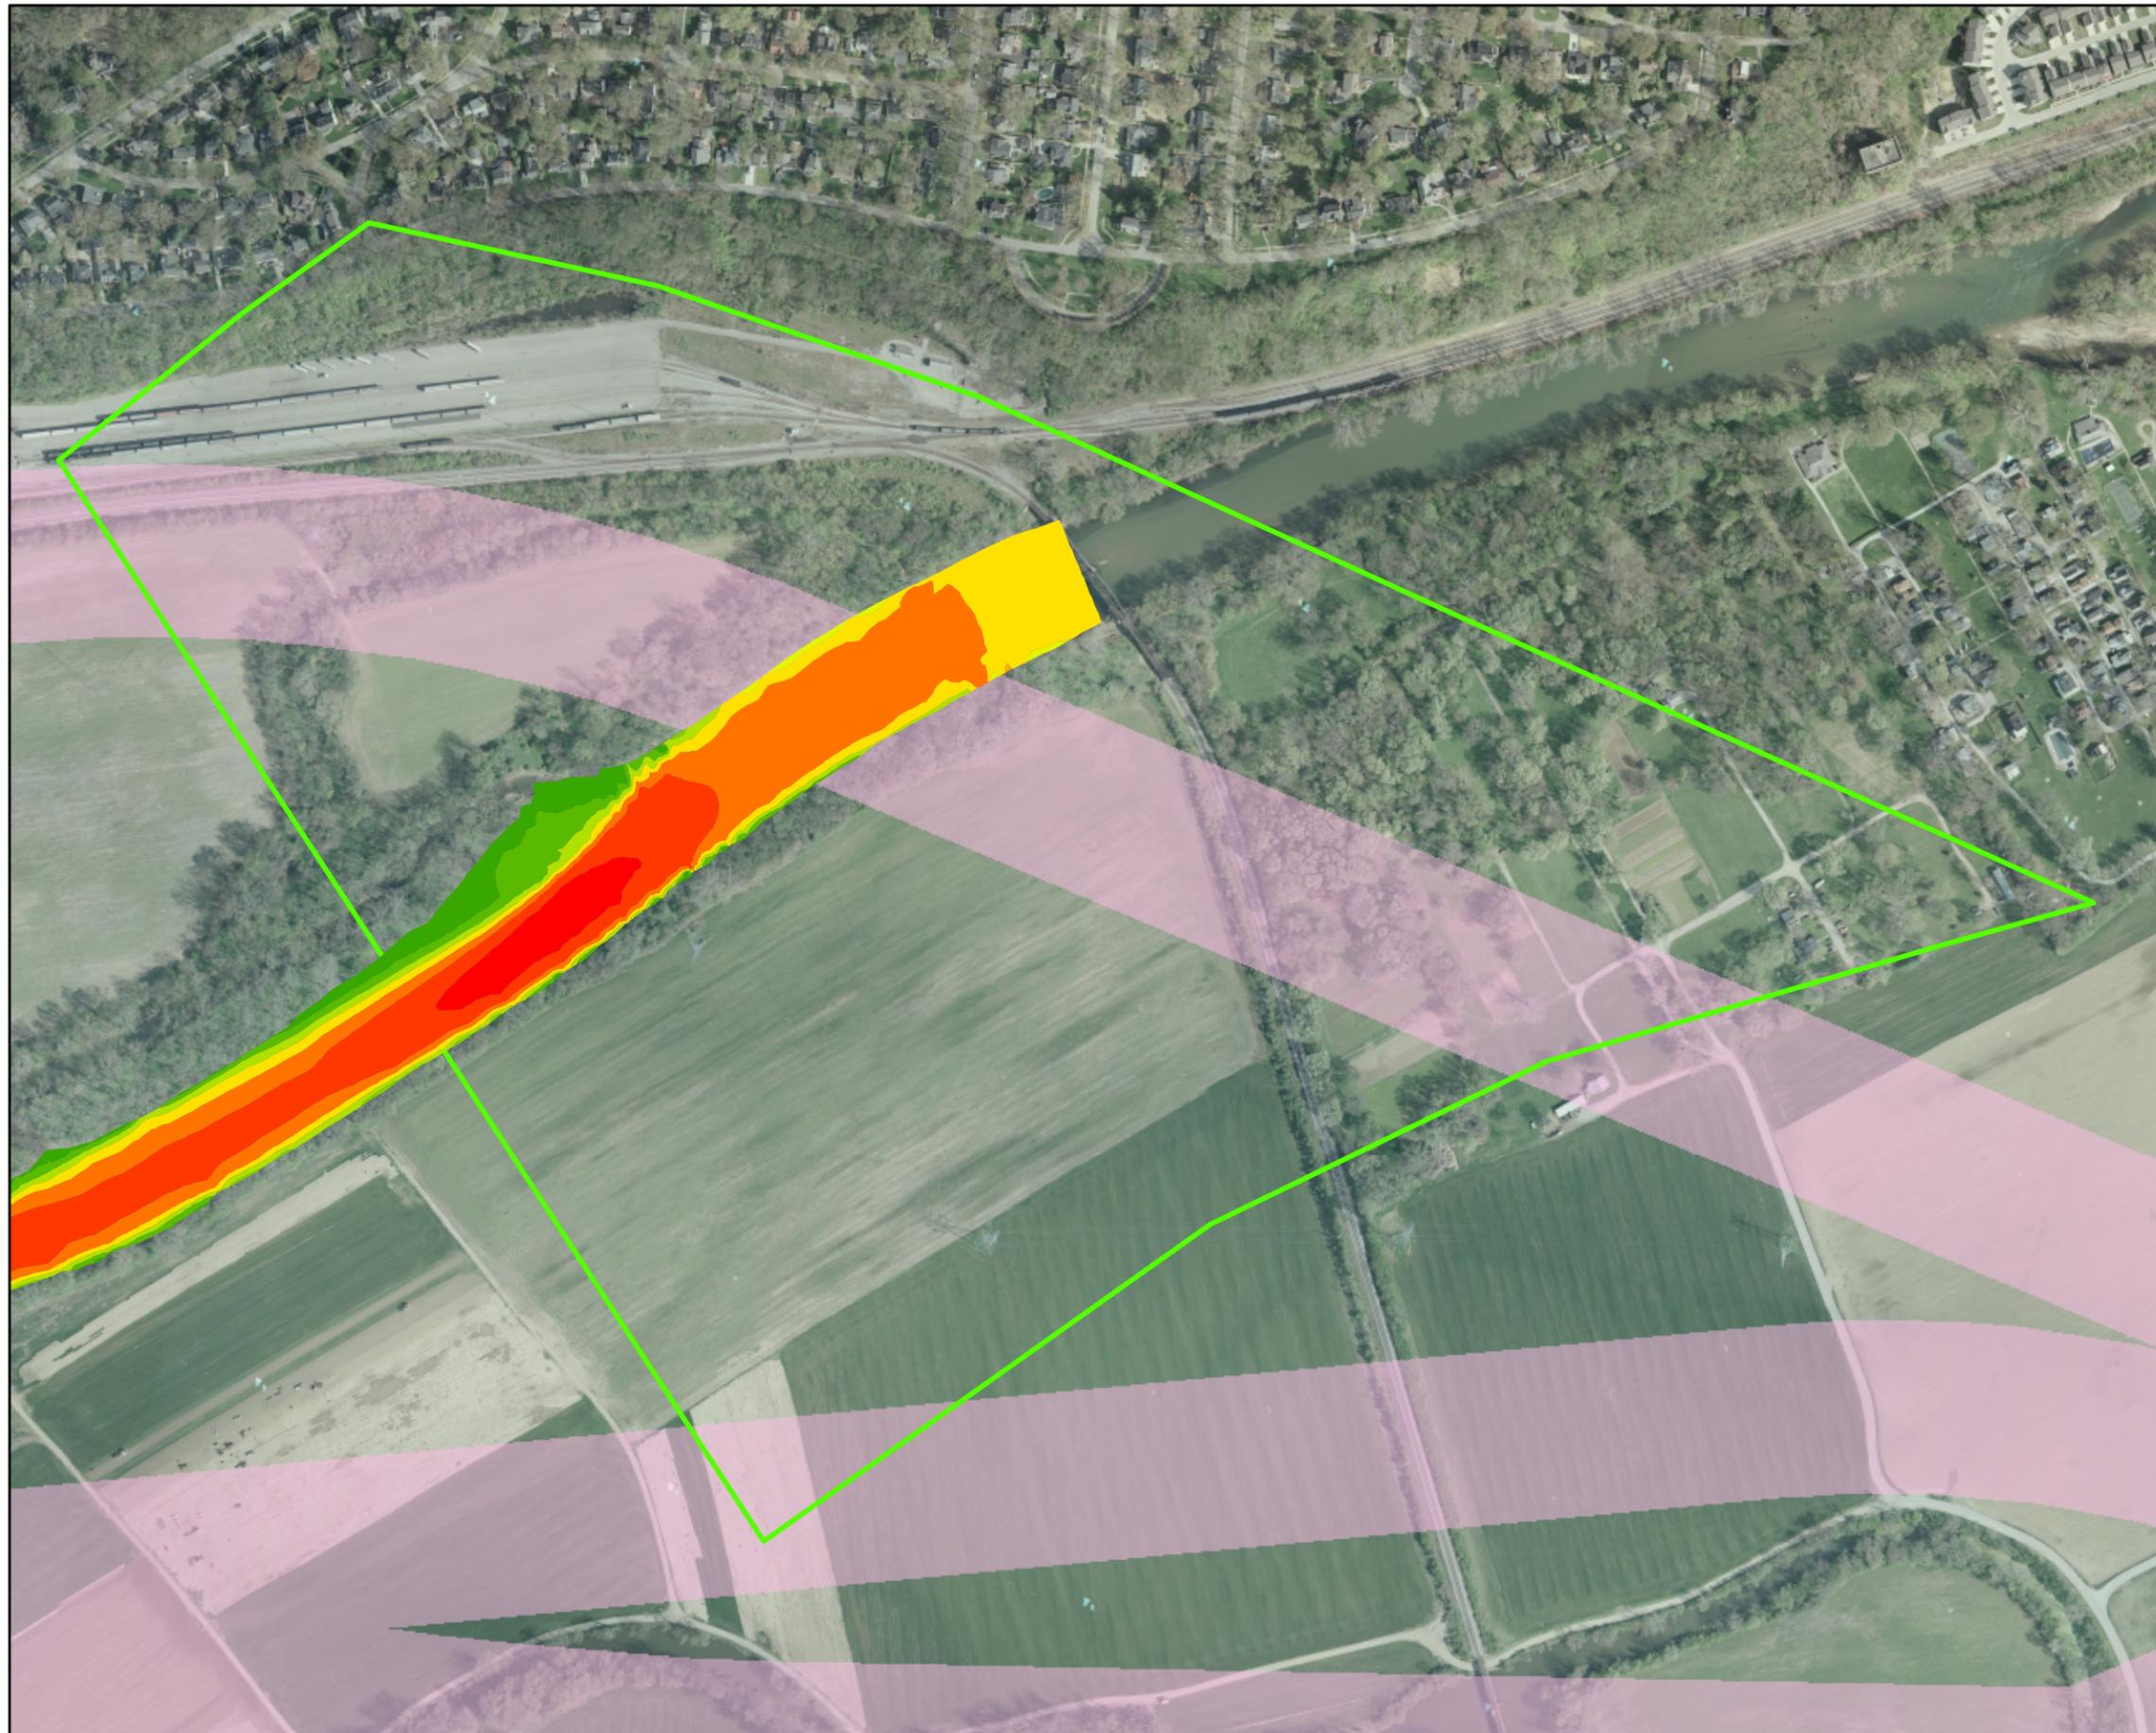
**FIGURE A3**  
**DISTRIBUTION OF VELOCITY AT**  
**10,000 CFS GEOMORPHIC REACH 4**  
 Little Miami River Geomorphic and  
 Hydraulic Modeling Evaluation, Phase II

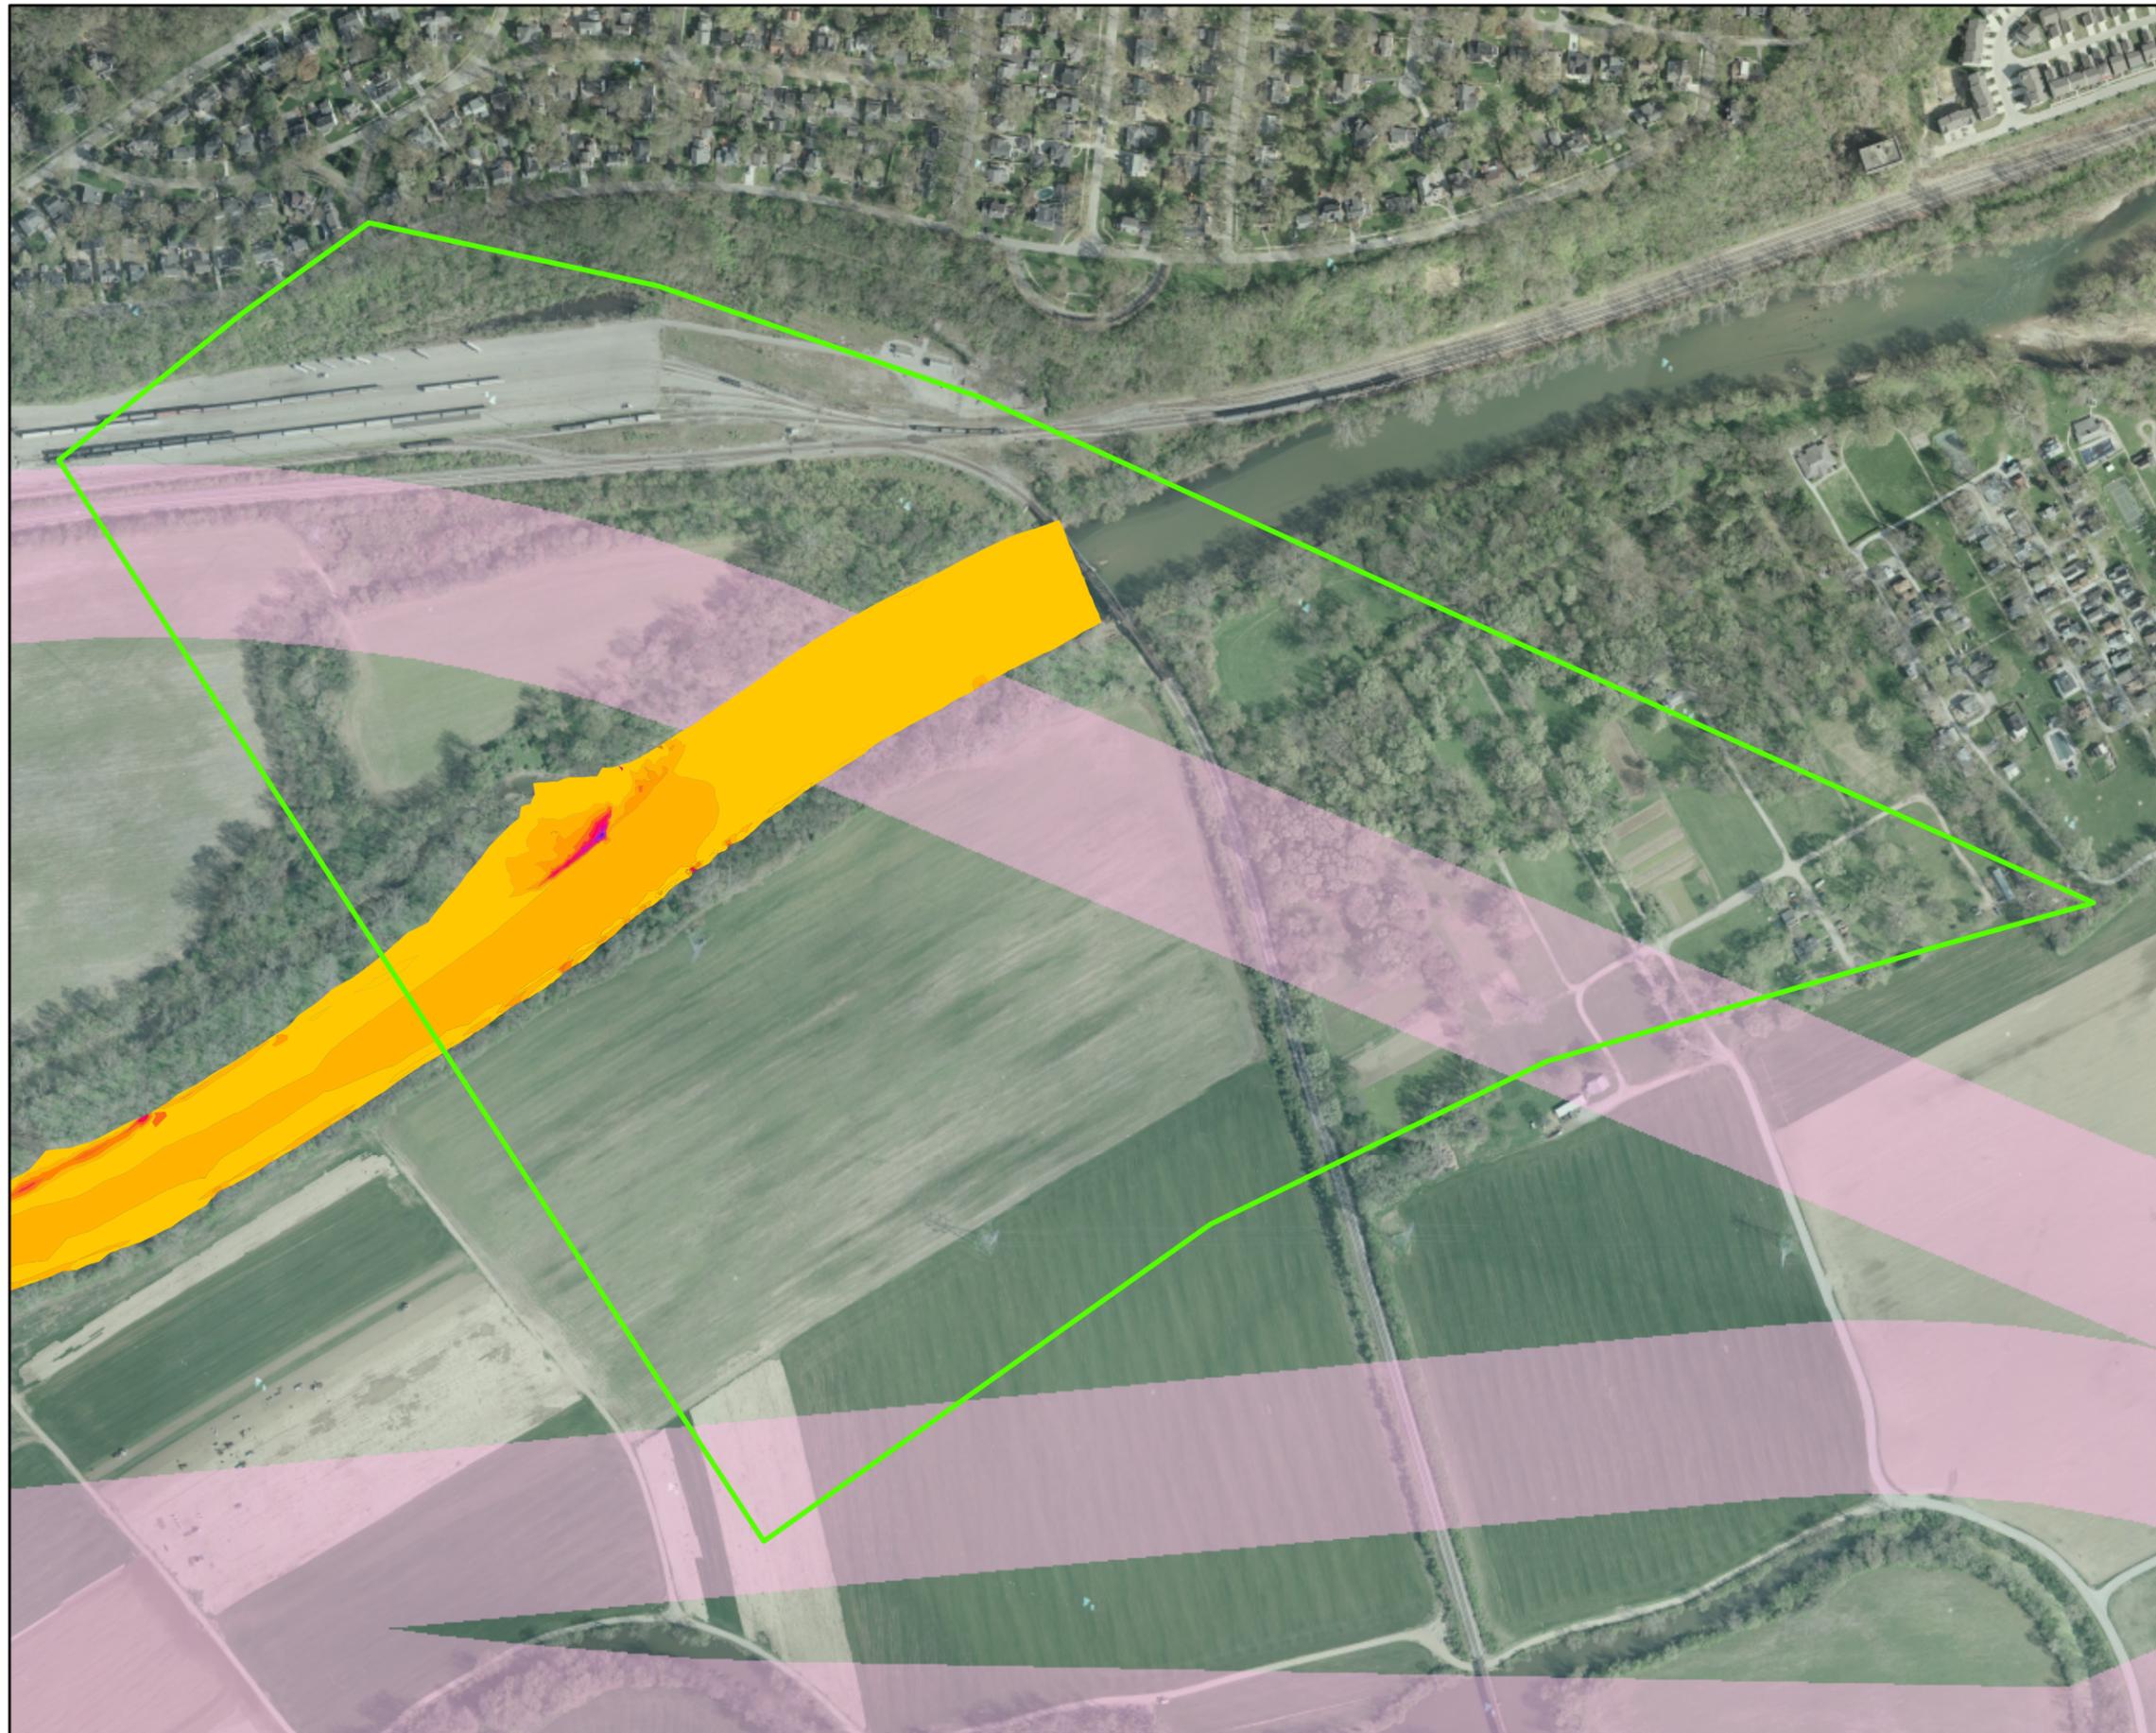
**FIGURE A4**  
**DISTRIBUTION OF BED SHEAR**  
**STRESS AT 10,000 CFS**  
**GEOMORPHIC REACH 4**  
 Little Miami River Geomorphic and  
 Hydraulic Modeling Evaluation, Phase II

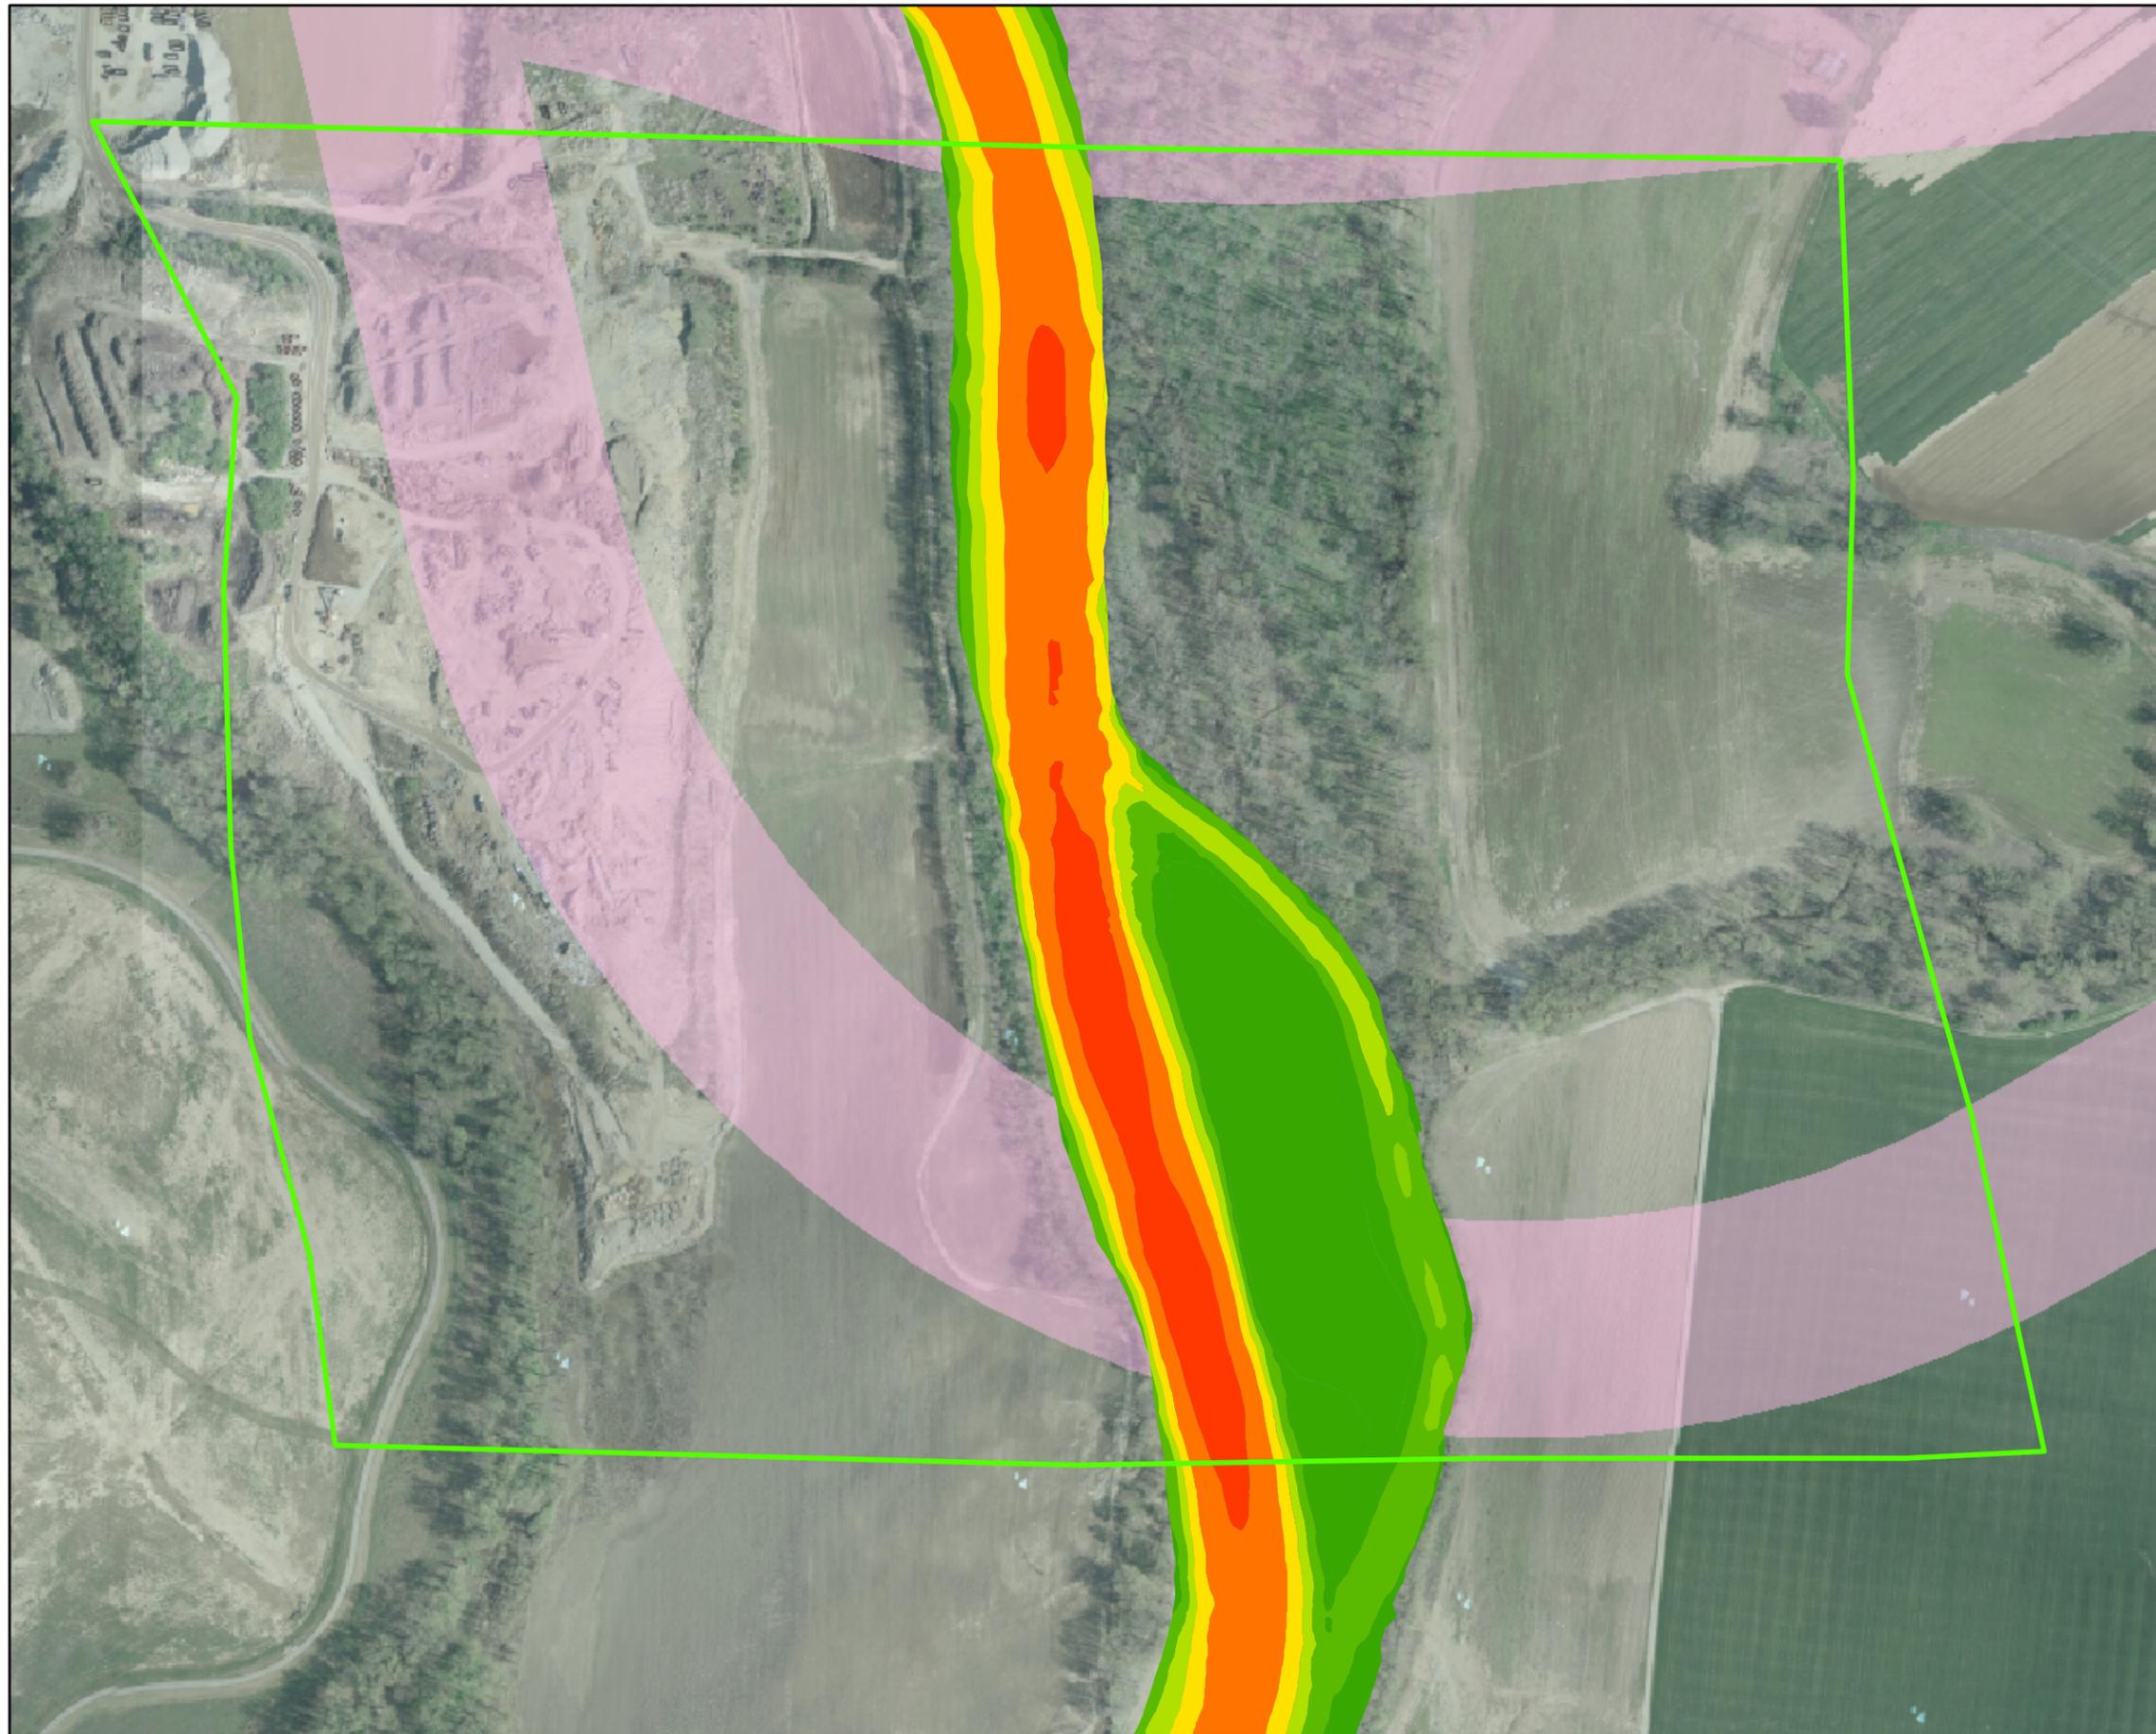
**FIGURE A6**  
**DISTRIBUTION OF VELOCITY**  
**AT 10,000 CFS**  
**GEOMORPHIC REACH 6/7**  
 Little Miami River Geomorphic and  
 Hydraulic Modeling Evaluation, Phase II

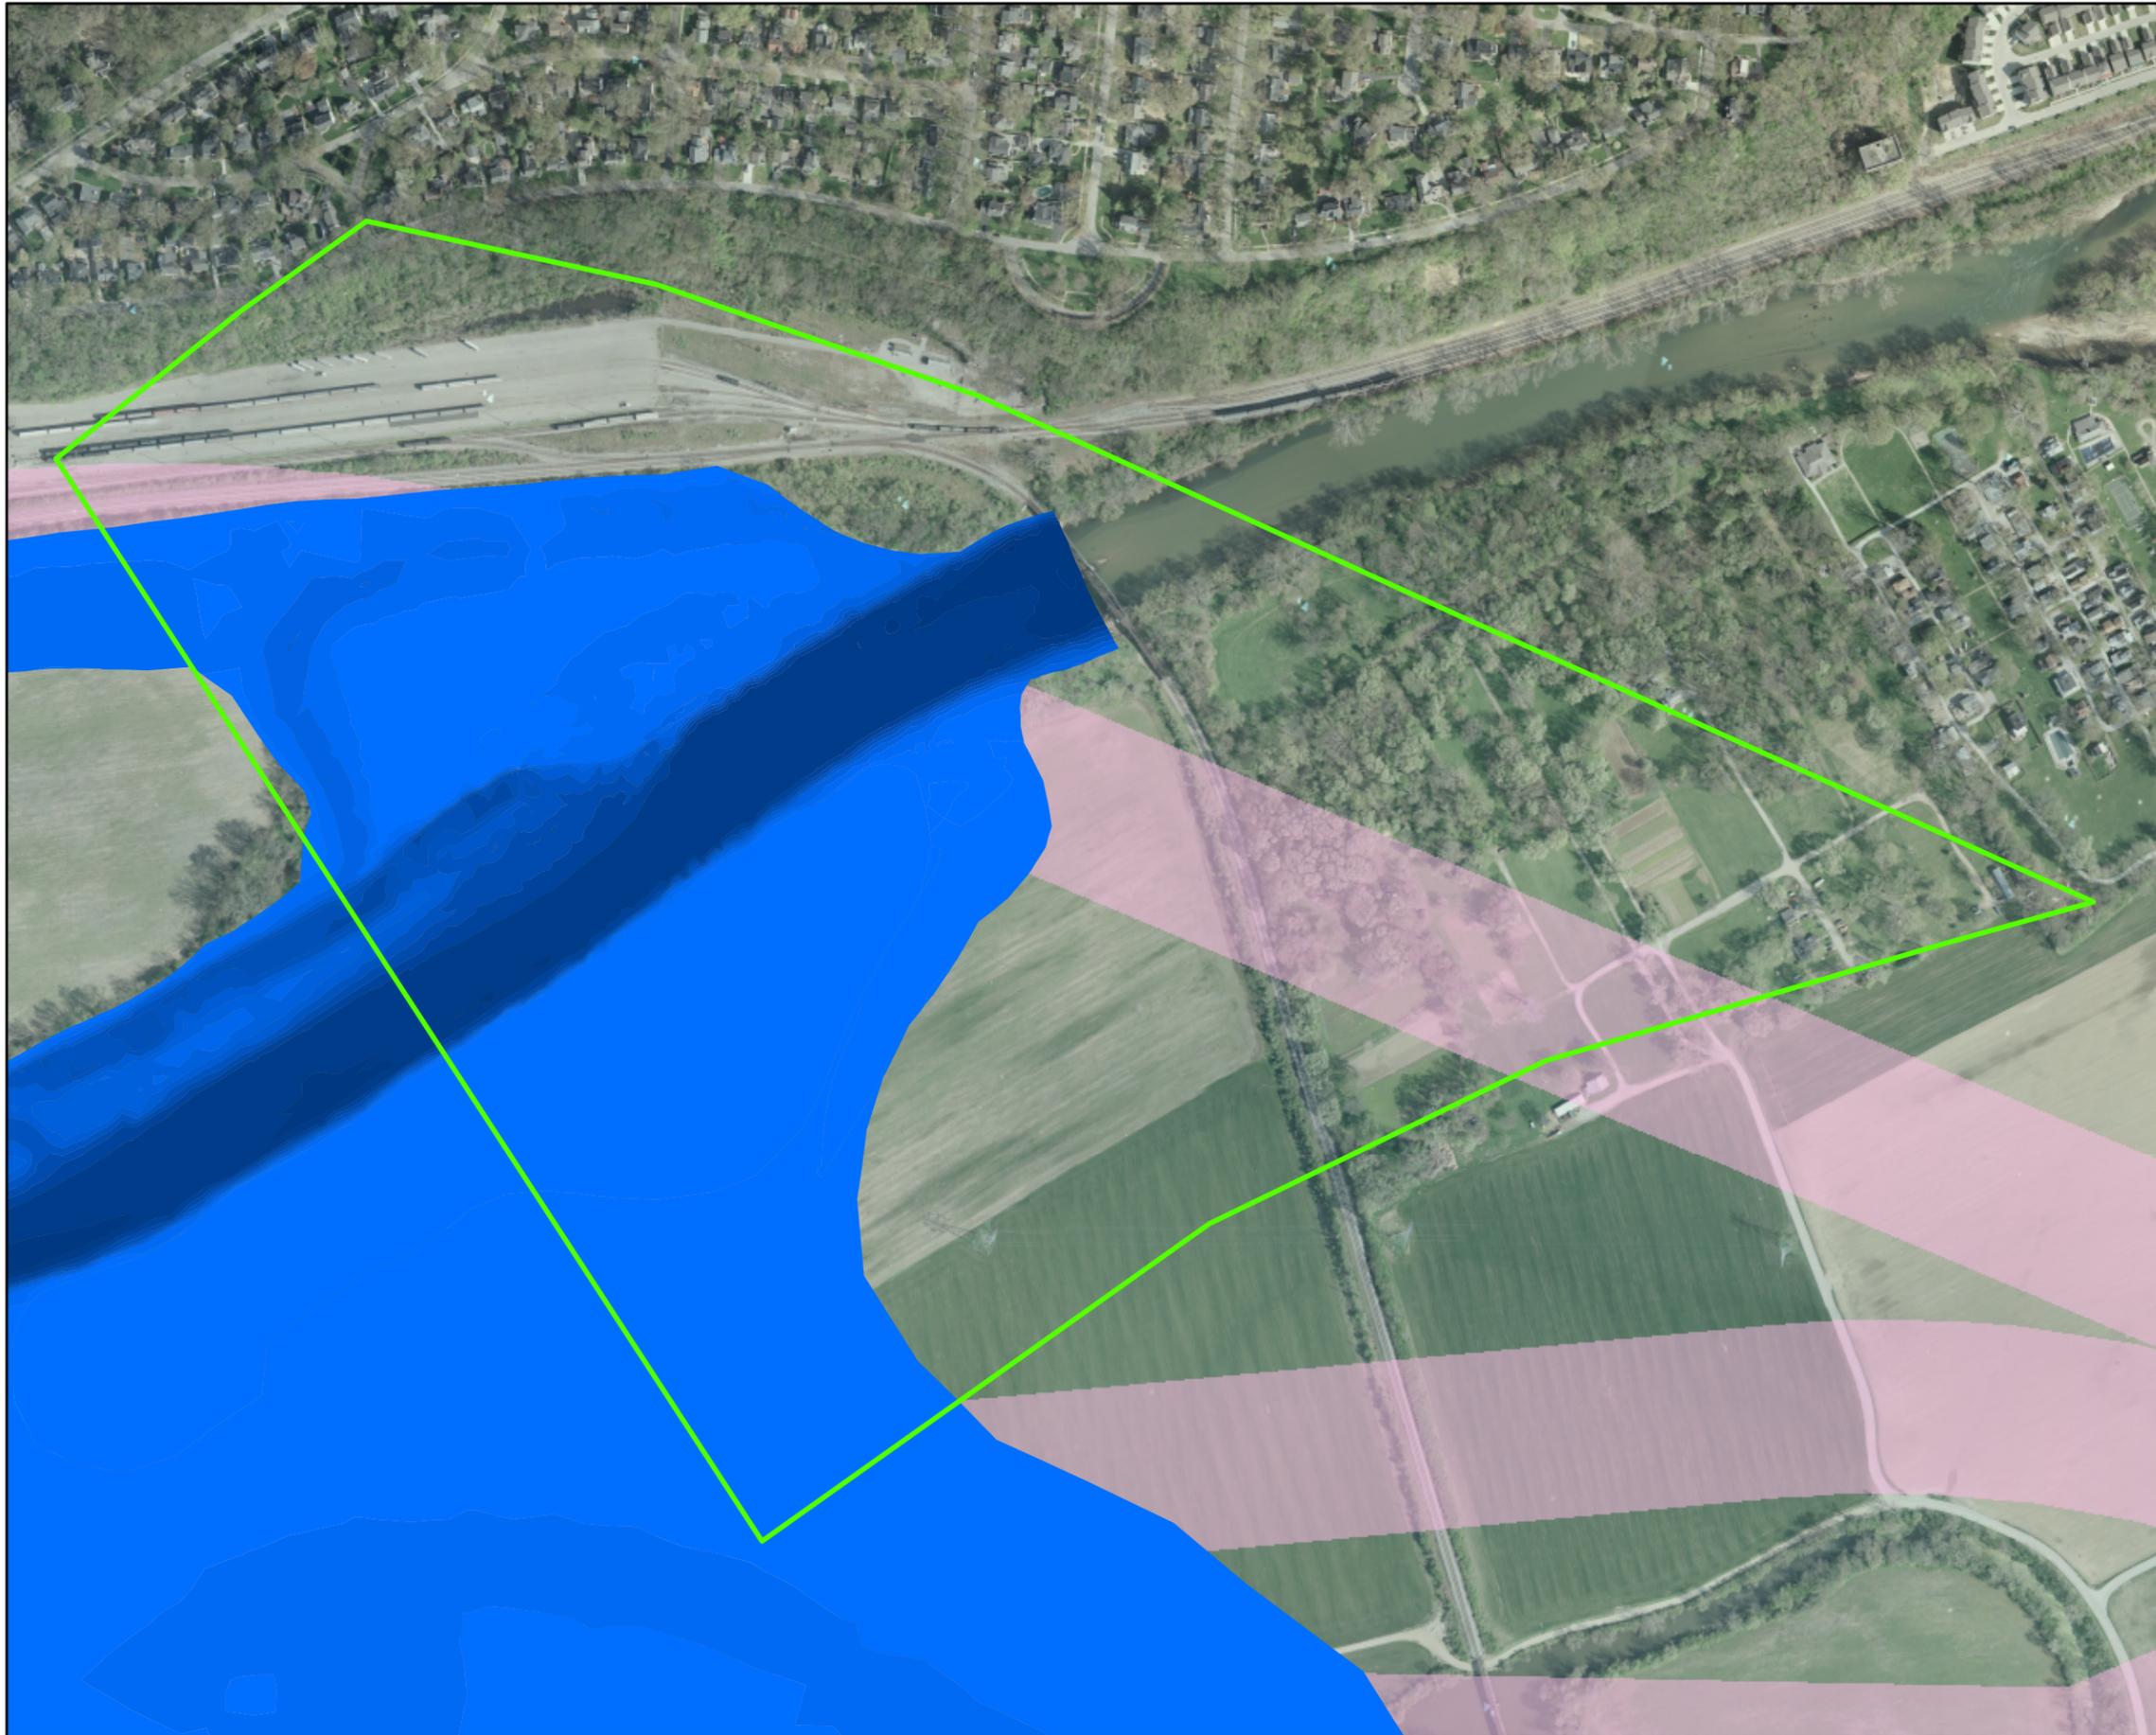
**FIGURE A8**  
**DISTRIBUTION OF DEPTH**  
**AT 45,000 CFS**  
**GEOMORPHIC REACH 4**  
 Little Miami River Geomorphic and Hydraulic Modeling Evaluation, Phase II

Hydraulic model results for 45,000 cfs in Geomorphic Reach 4 (Figures A8-A10) indicate significant overbank flow across the adjacent floodplain. Flow depth patterns appear similar to the patterns observed in the 10,000 cfs scenario. Velocities and shear stresses are lower in the upstream half of Geomorphic Reach 4 and still below stability thresholds throughout this reach. Geomorphic Reaches 6 and 7 (Figures A11-A13)
