*Phase II Report*

**Geomorphic and  
Two-Dimensional Hydraulic  
Modeling Evaluation of the  
Little Miami River in the Eastern  
Corridor Segment II/III Study Area**

December 2009

NewFields River Basin Services, LLC

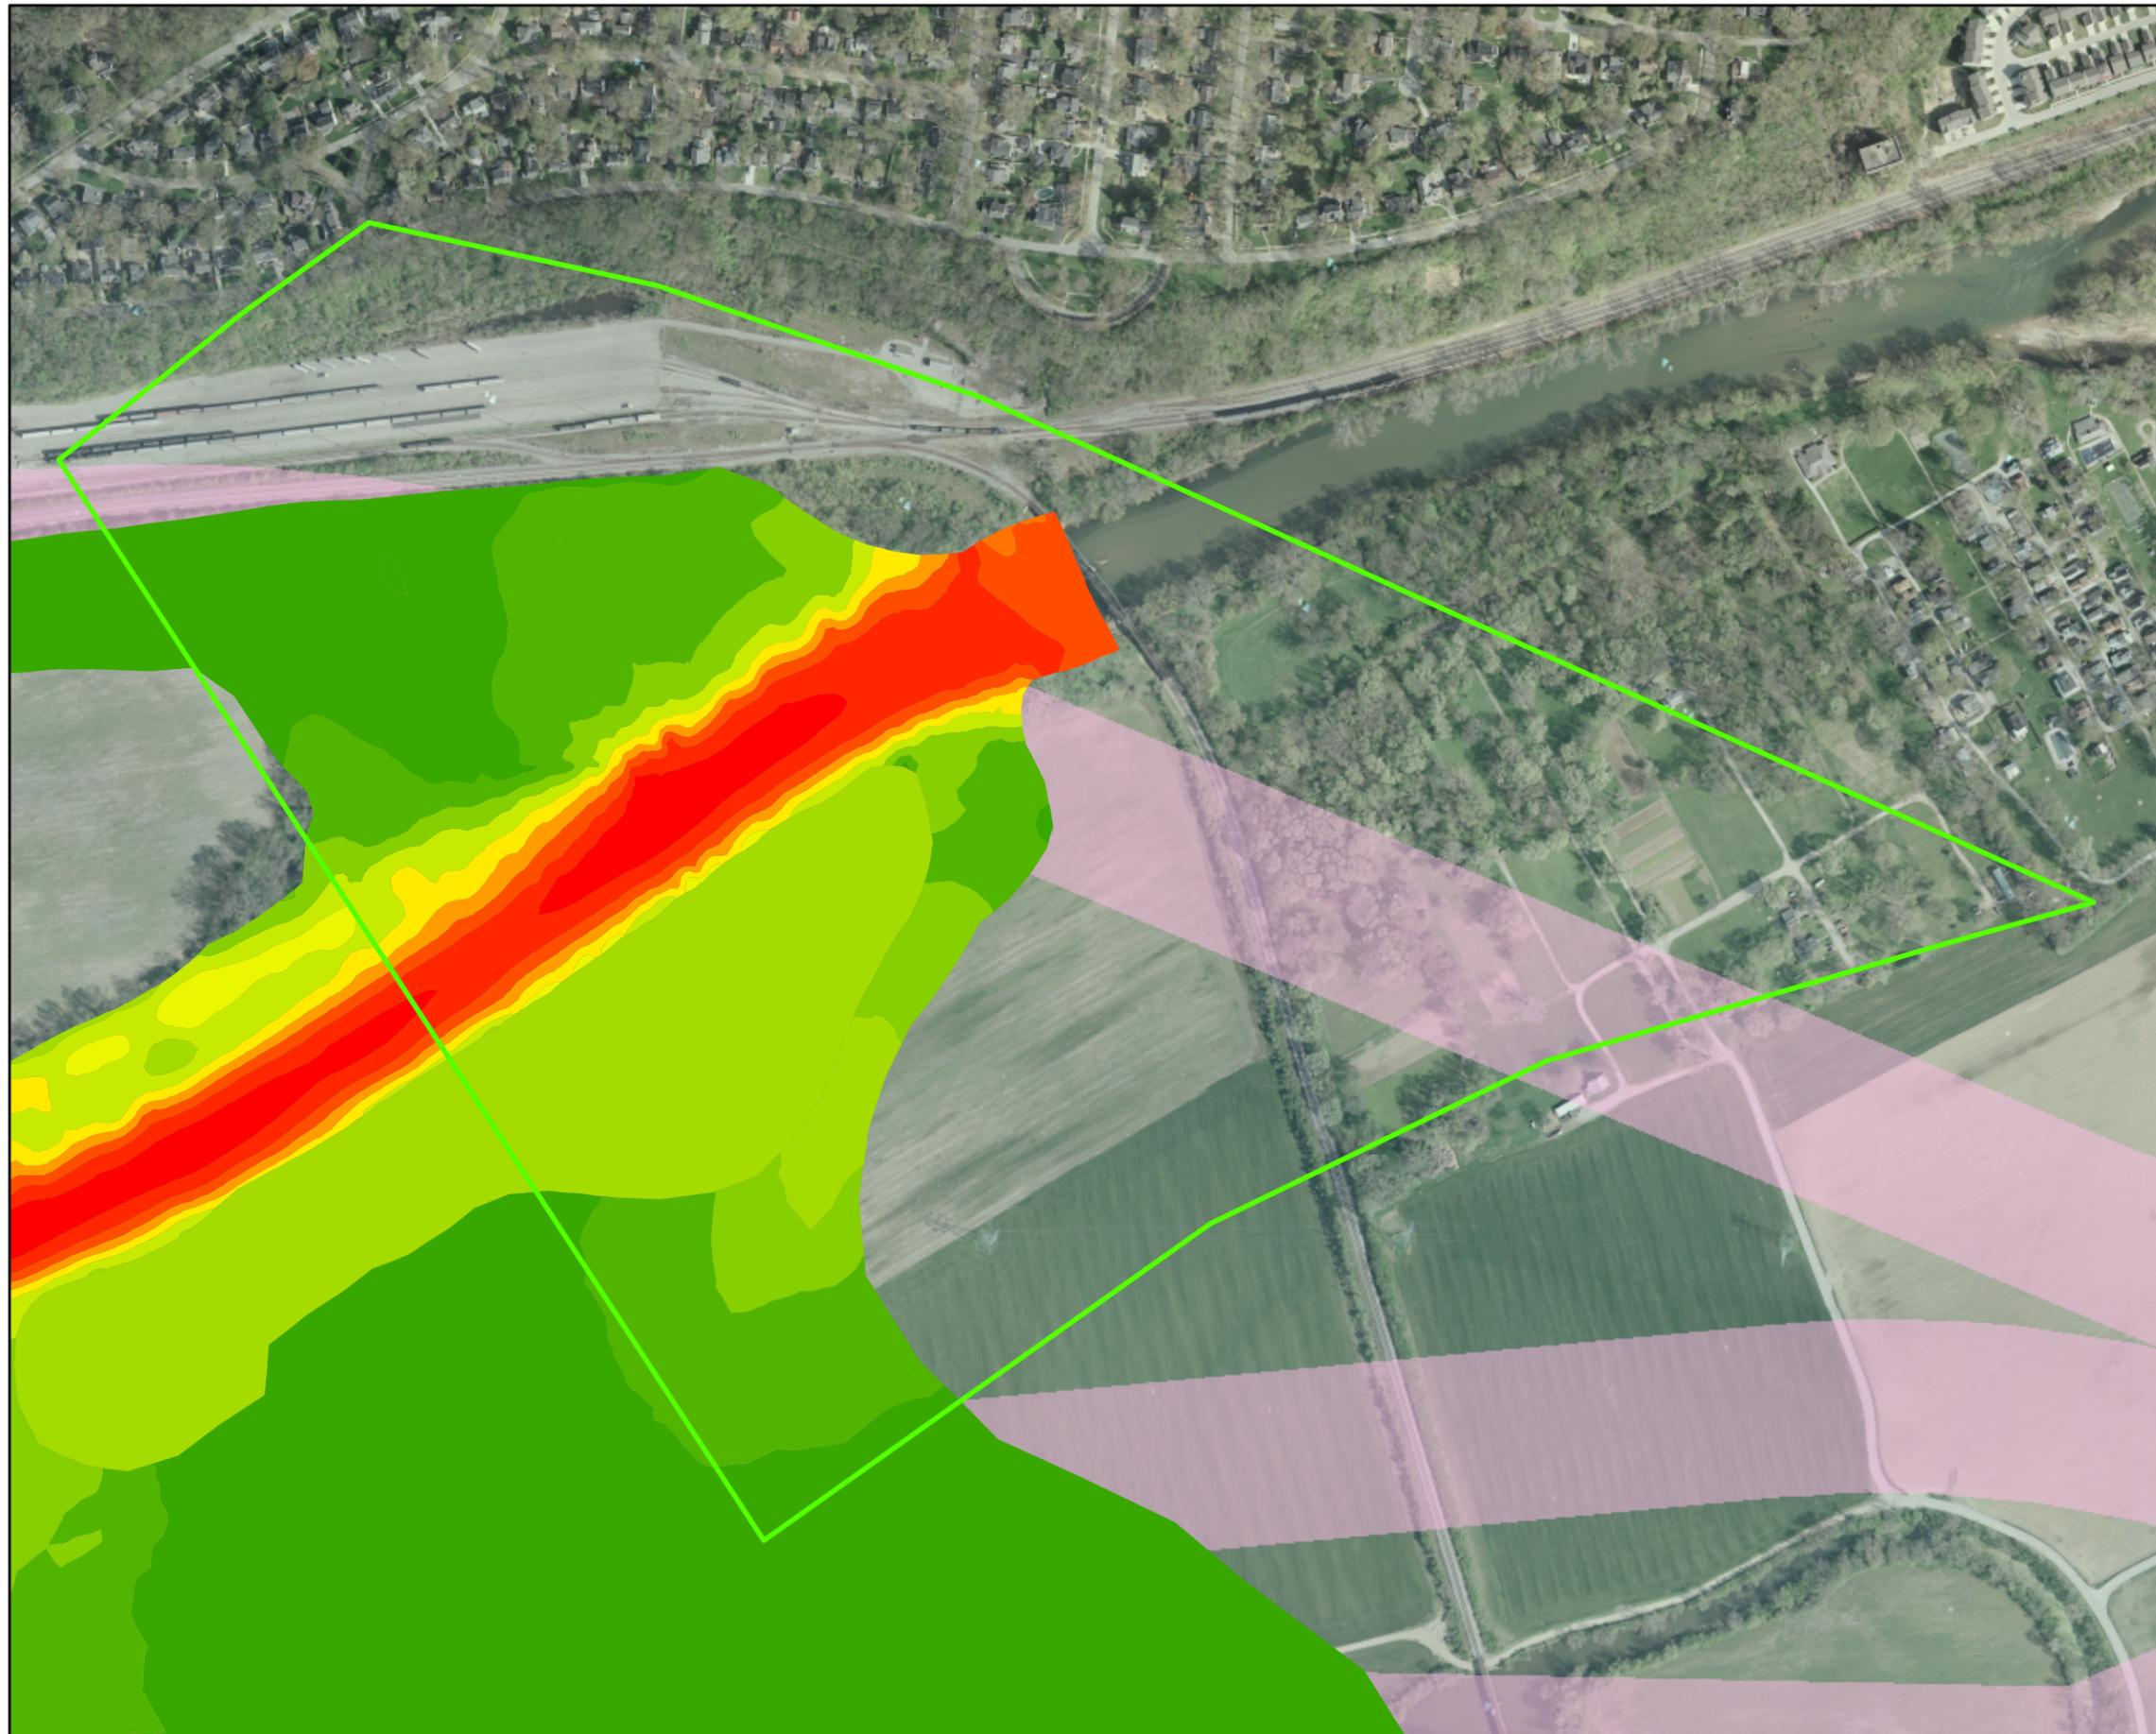
**FIGURE A9**  
**DISTRIBUTION OF VELOCITY**  
**AT 45,000 CFS**  
**GEOMORPHIC REACH 4**  
 Little Miami River Geomorphic and Hydraulic Modeling Evaluation, Phase II

Hydraulic model results for 45,000 cfs in Geomorphic Reach 4 (Figures A8-A10) indicate significant overbank flow across the adjacent floodplain. Flow depth patterns appear similar to the patterns observed in the 10,000 cfs scenario. Velocities and shear stresses are lower in the upstream half of Geomorphic Reach 4 and still below stability thresholds throughout this reach. Geomorphic Reaches 6 and 7 (Figures A11-A13)

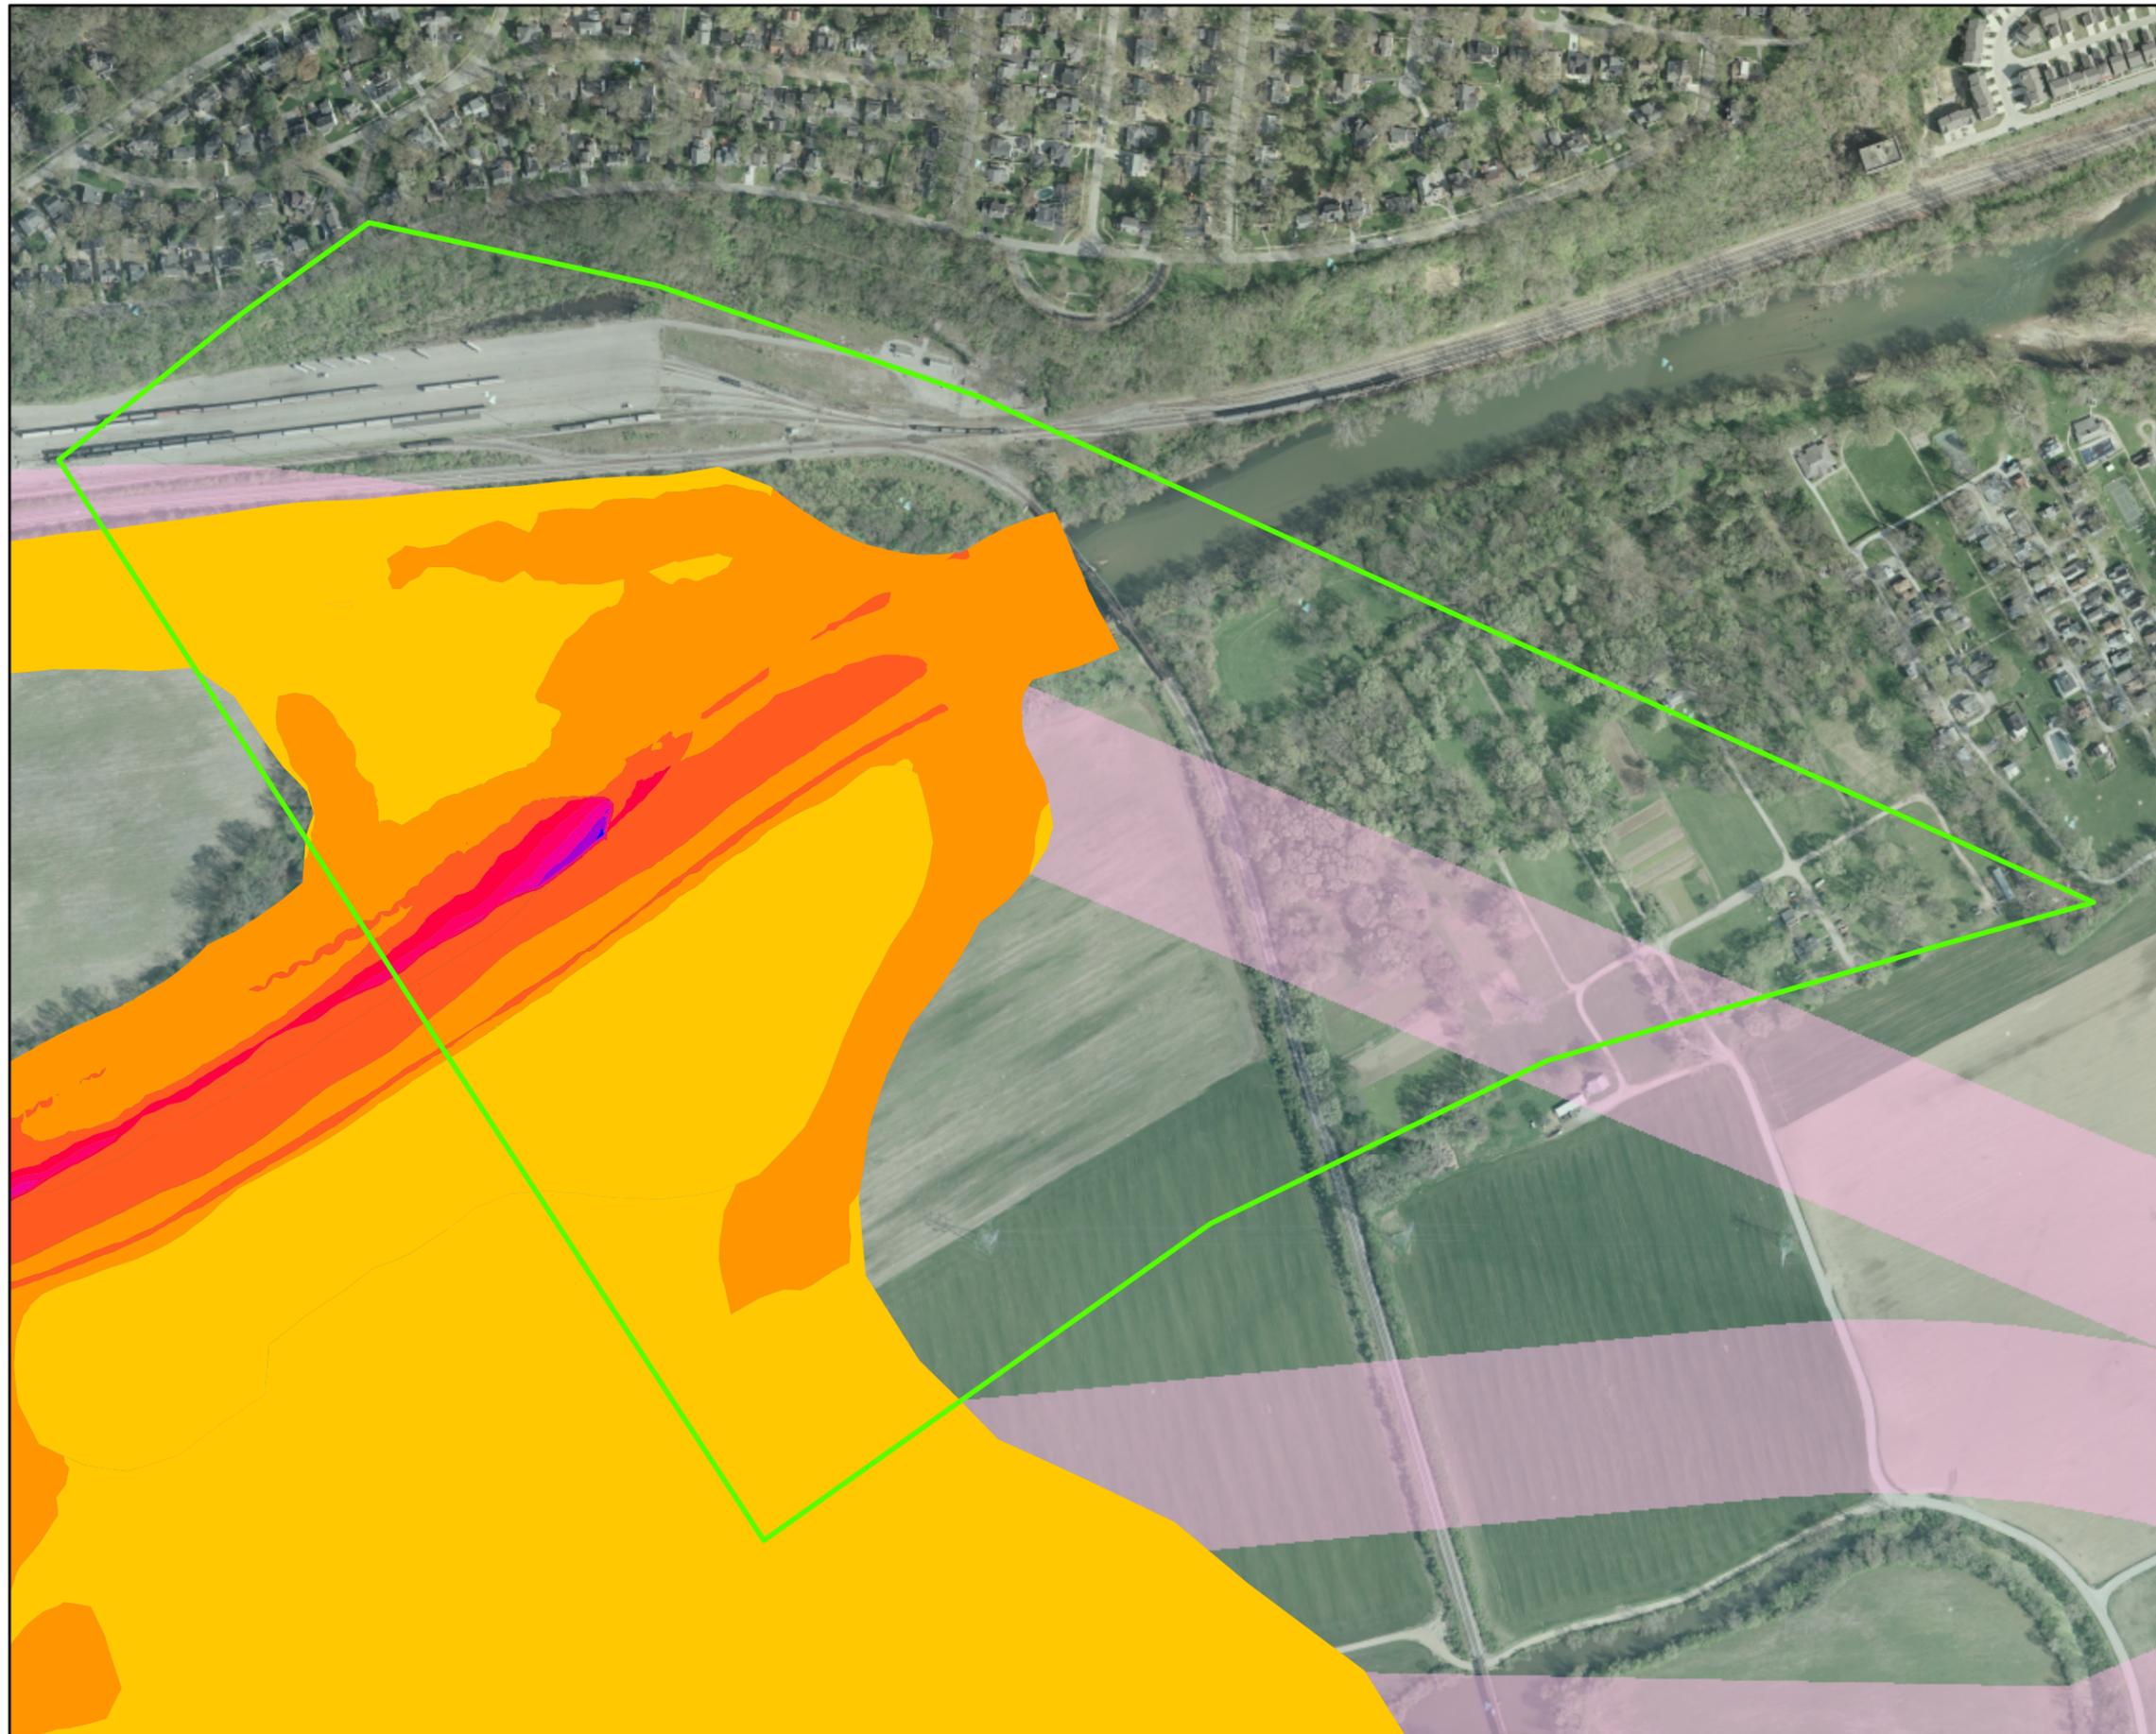
**FIGURE A10**  
**DISTRIBUTION OF BED SHEAR**  
**STRESS AT 45,000 CFS**  
**GEOMORPHIC REACH 4**  
 Little Miami River Geomorphic and  
 Hydraulic Modeling Evaluation, Phase II

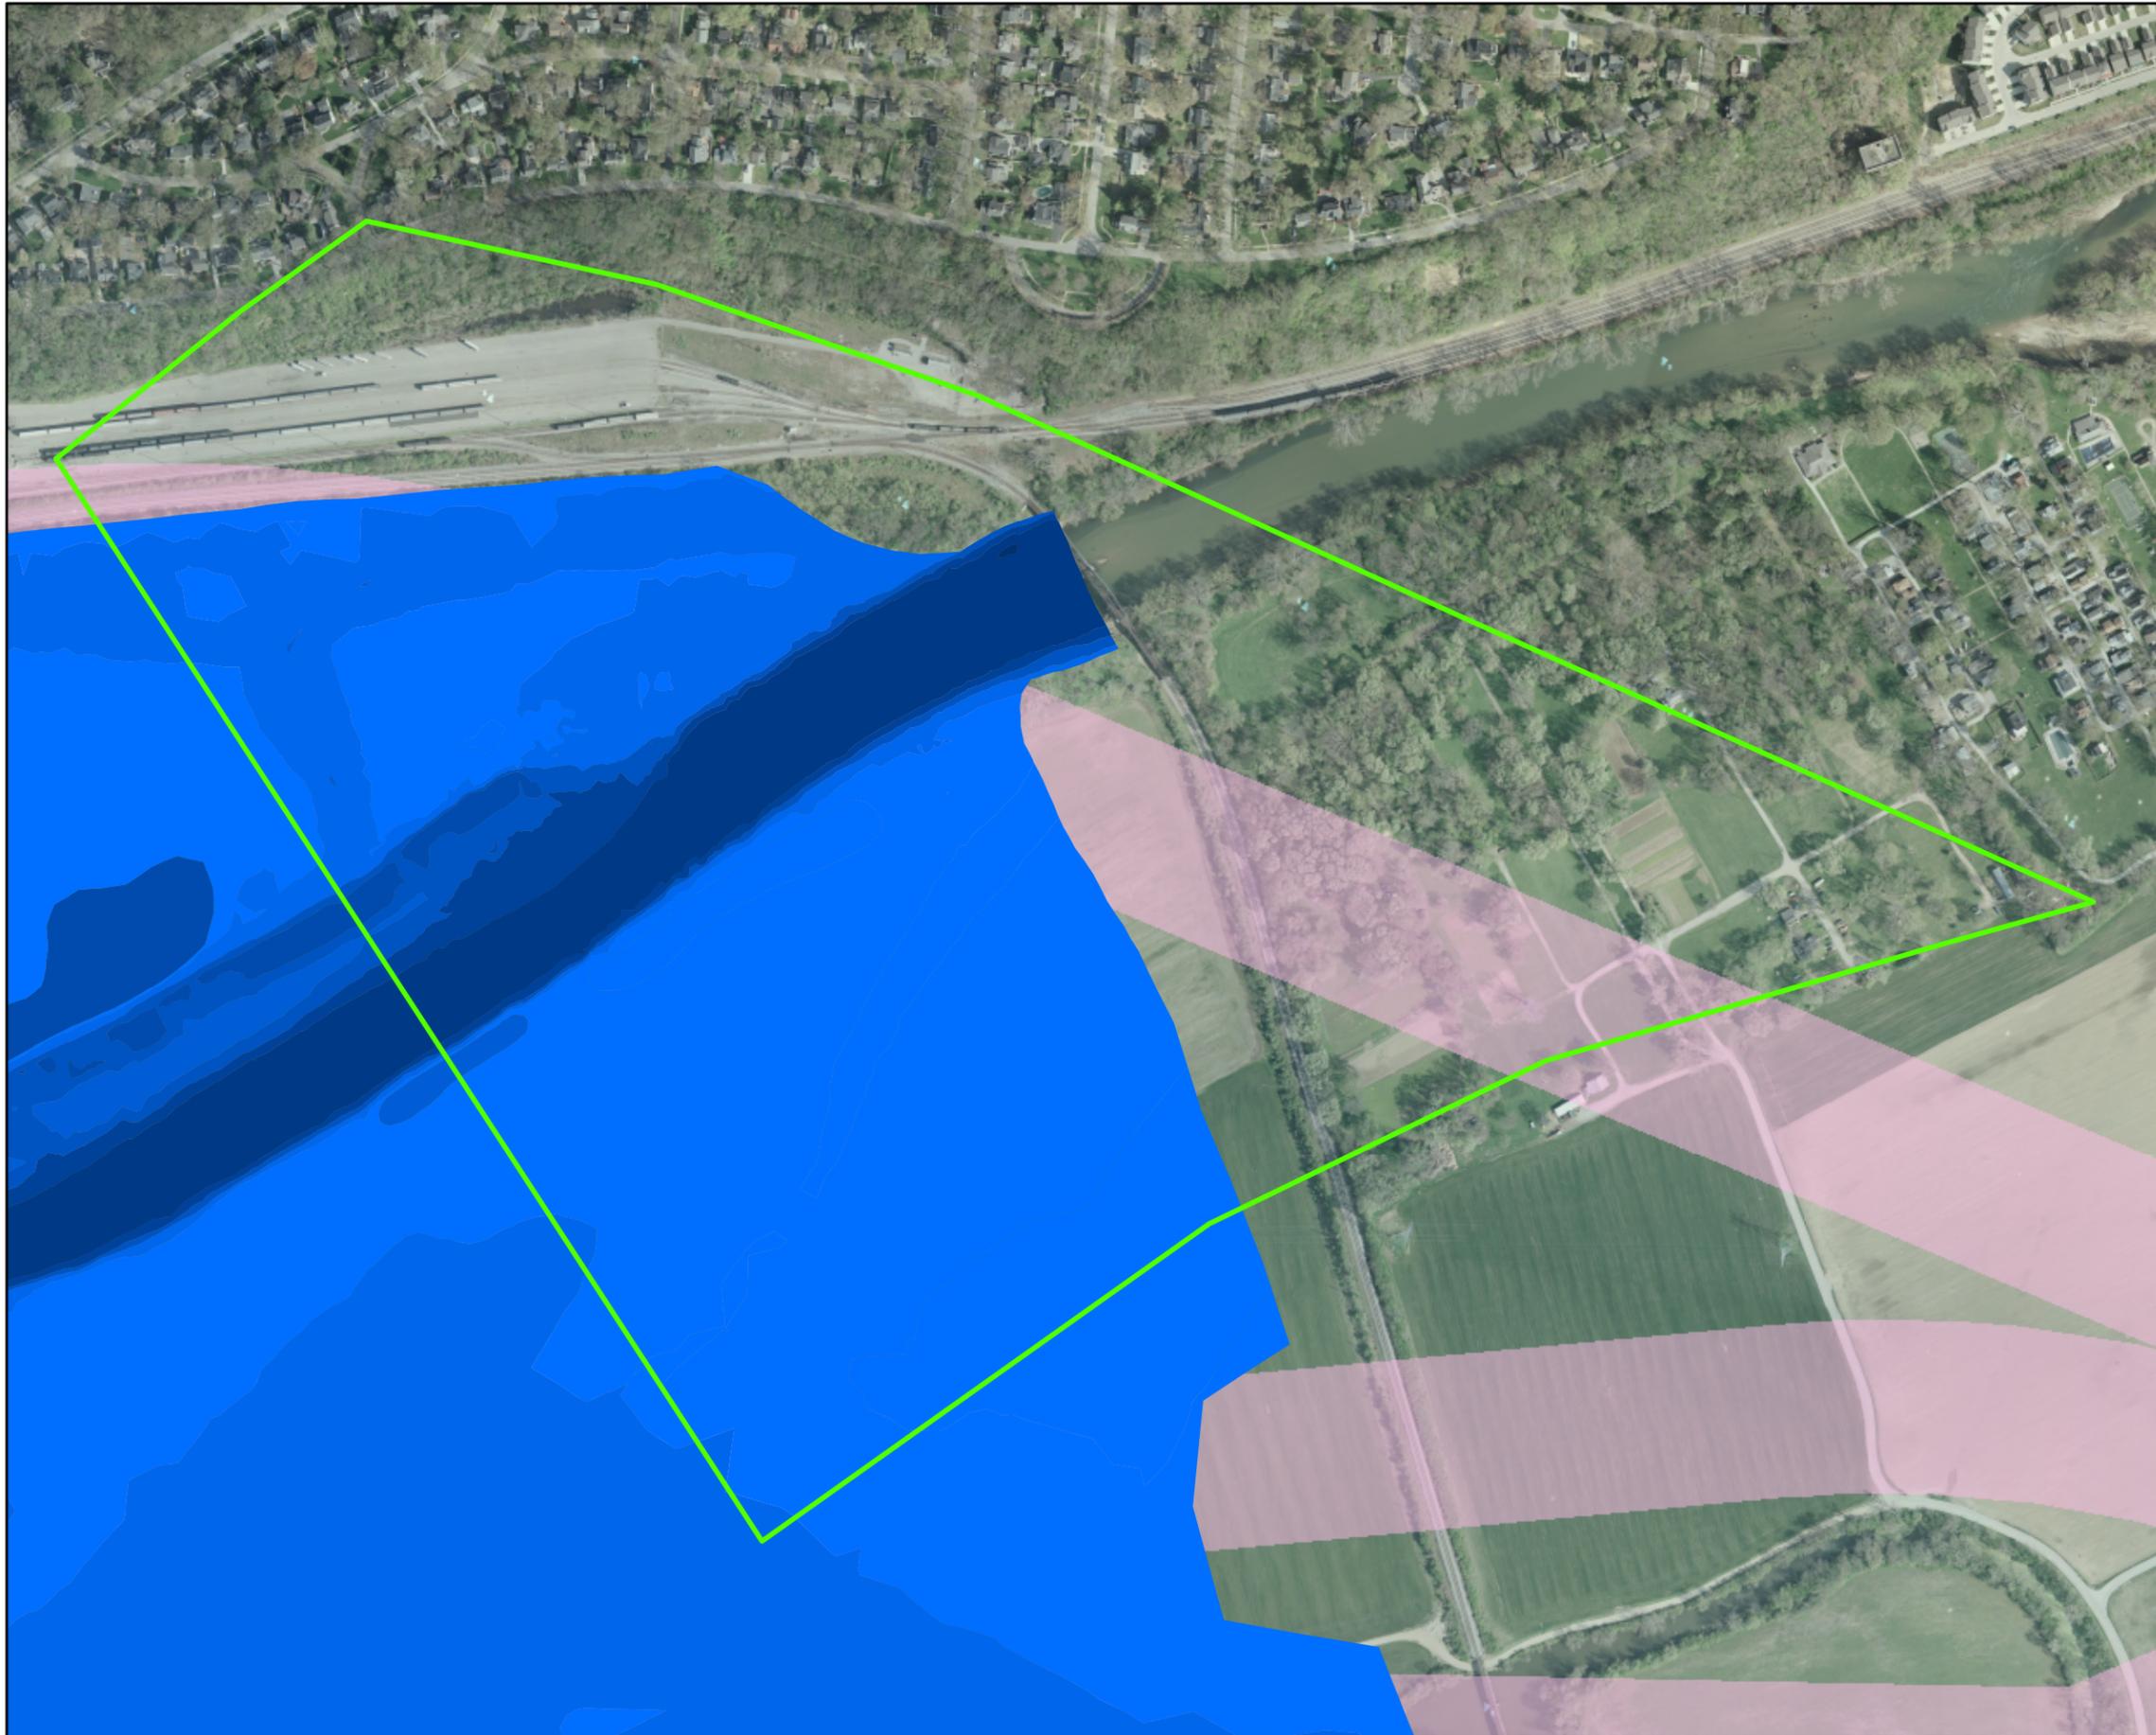
**FIGURE A14**  
**DISTRIBUTION OF DEPTH**  
**AT 65,000 CFS**  
**GEOMORPHIC REACH 4**  
 Little Miami River Geomorphic and  
 Hydraulic Modeling Evaluation, Phase II

Hydraulic model results for 65,000 cfs in Geomorphic Reach 4 (Figures A14-16) are similar to the results for 45,000 cfs. Flow depths are slightly higher but still cover essentially the same area. Velocities are approximately 2.5 ft/sec greater than at 45,000 cfs but are still relatively low, especially in the upstream half of this reach along the channel margins. Geomorphic Reaches 6 and 7 (Figures A17-A19) also exhibit similar hydraulic characteristics at 65,000 cfs, such as widespread floodplain flow, mostly uniform shear stresses, and complex velocity patterns near the Clear Creek confluence.

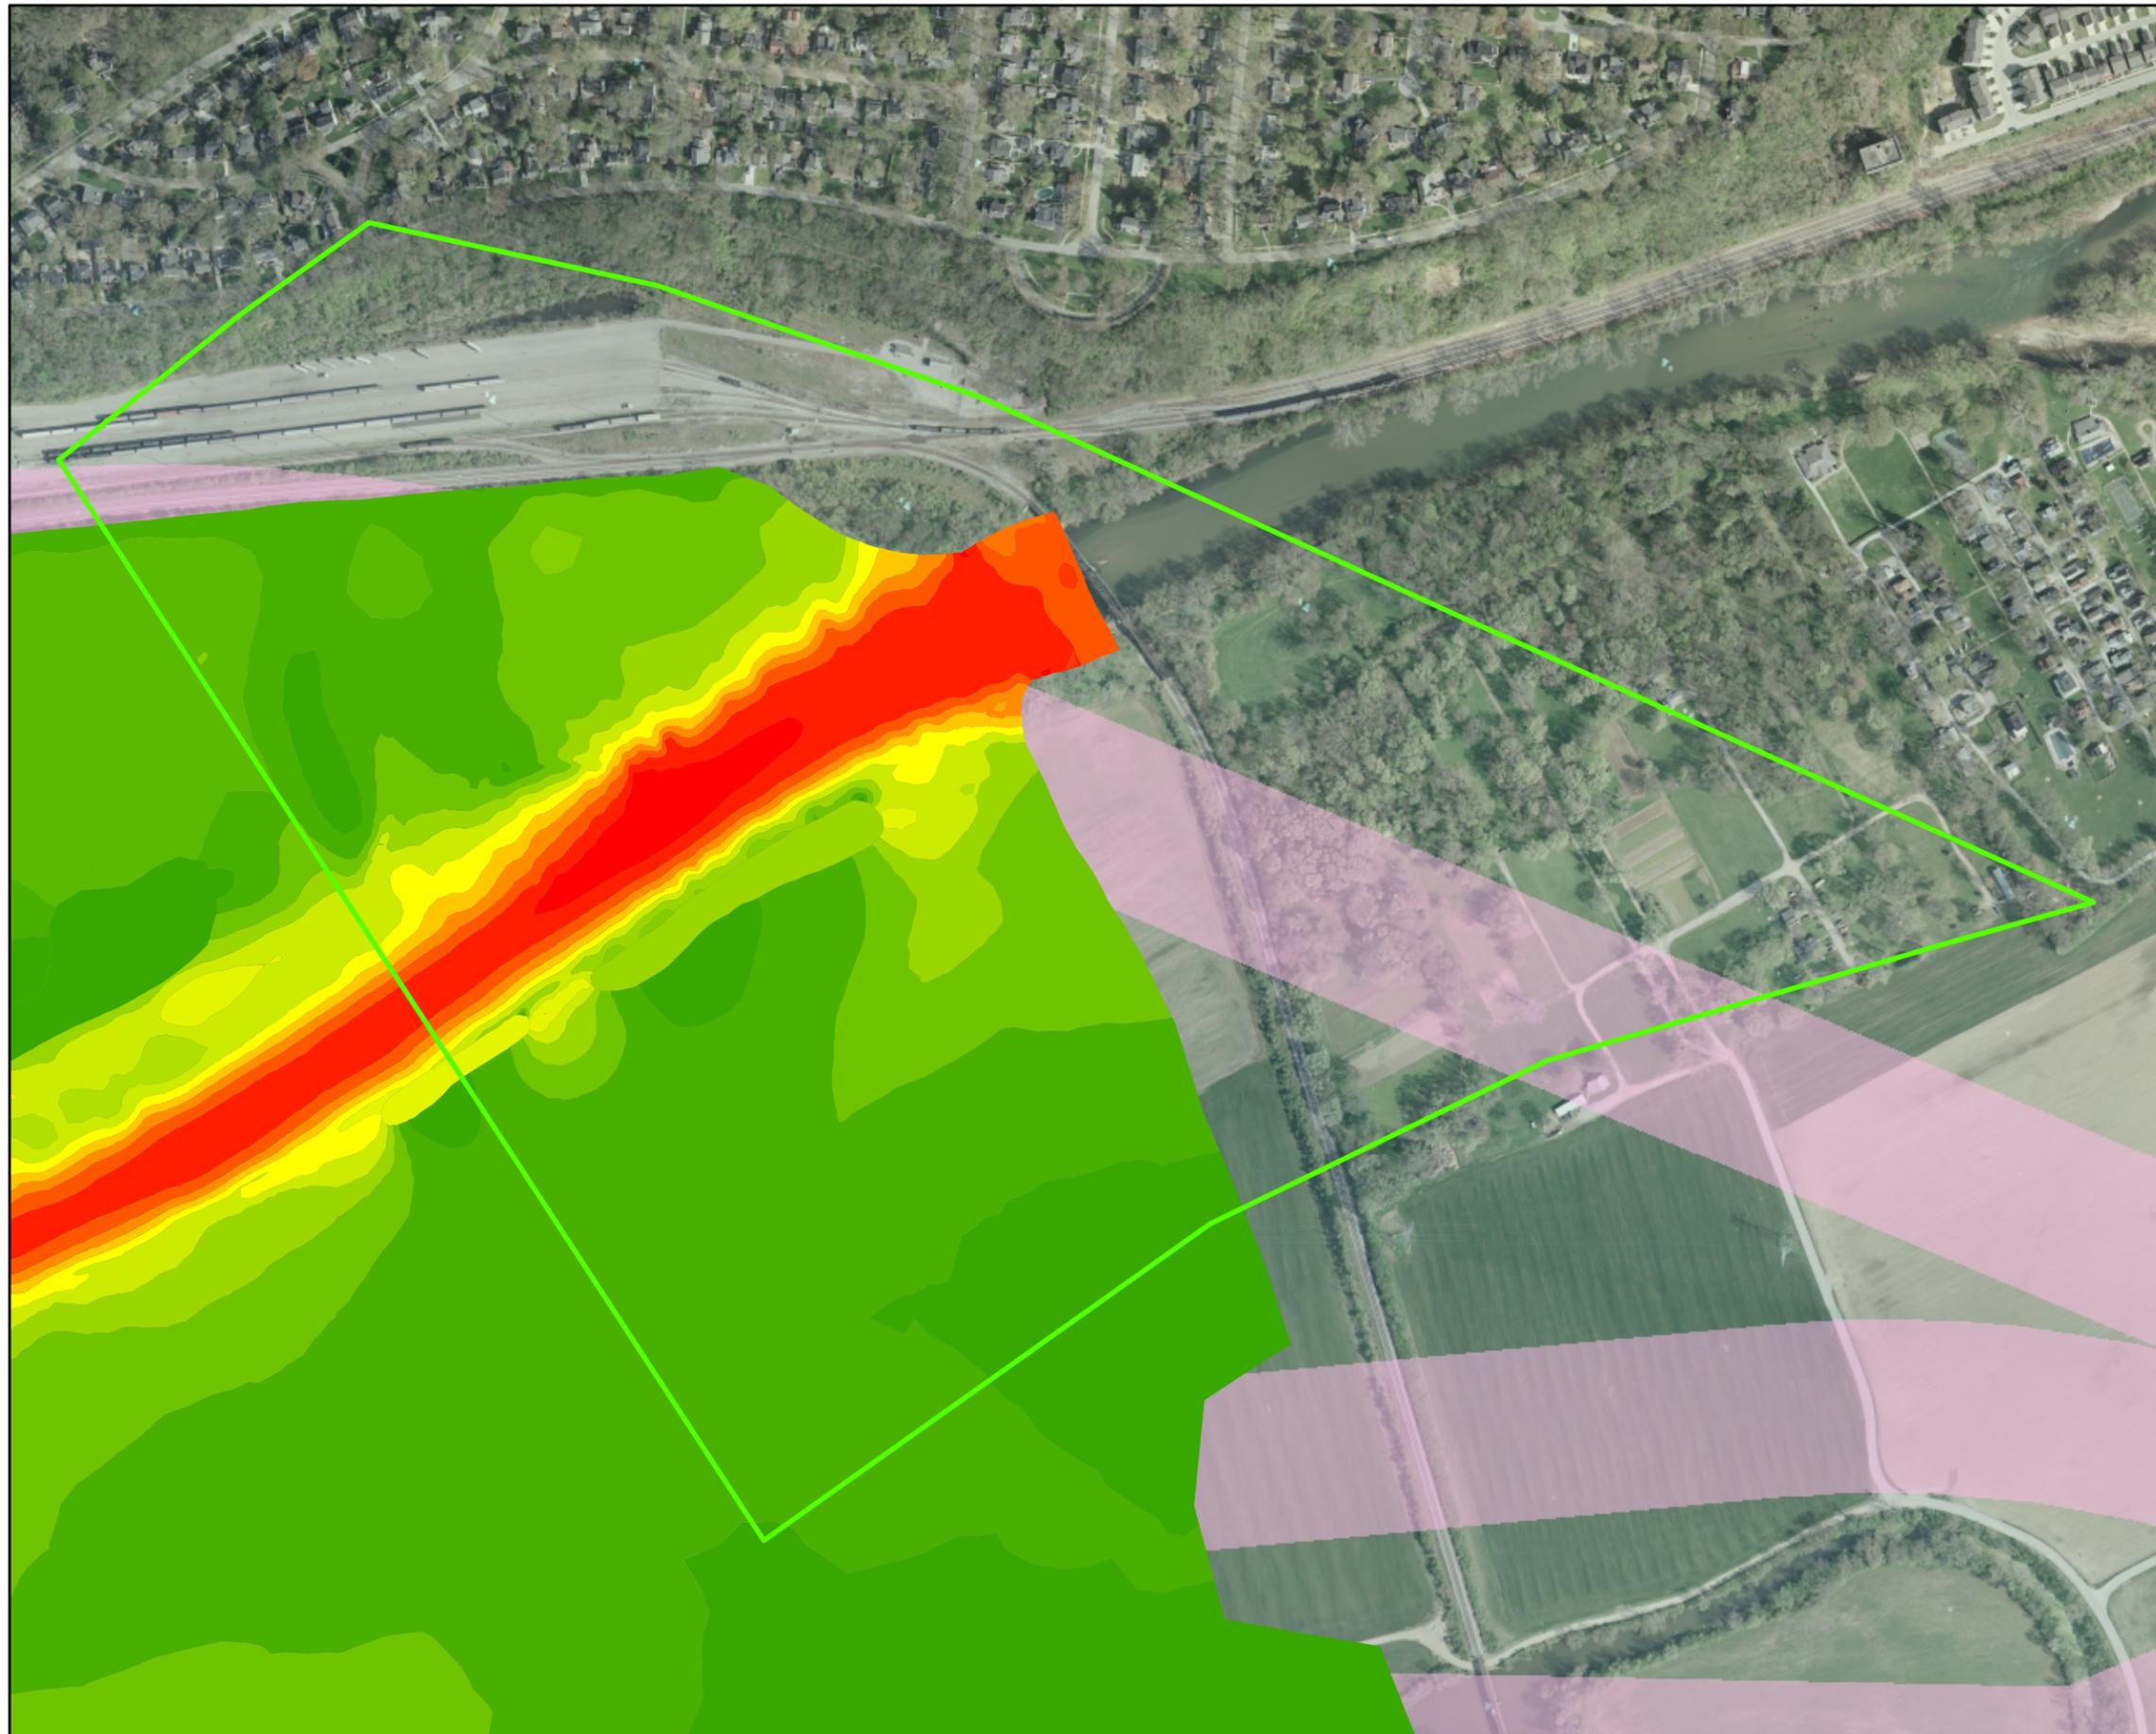
**FIGURE A15**  
**DISTRIBUTION OF VELOCITY**  
**AT 65,000 CFS**  
**GEOMORPHIC RAECH 4**  
 Little Miami River Geomorphic and  
 Hydraulic Modeling Evaluation, Phase II

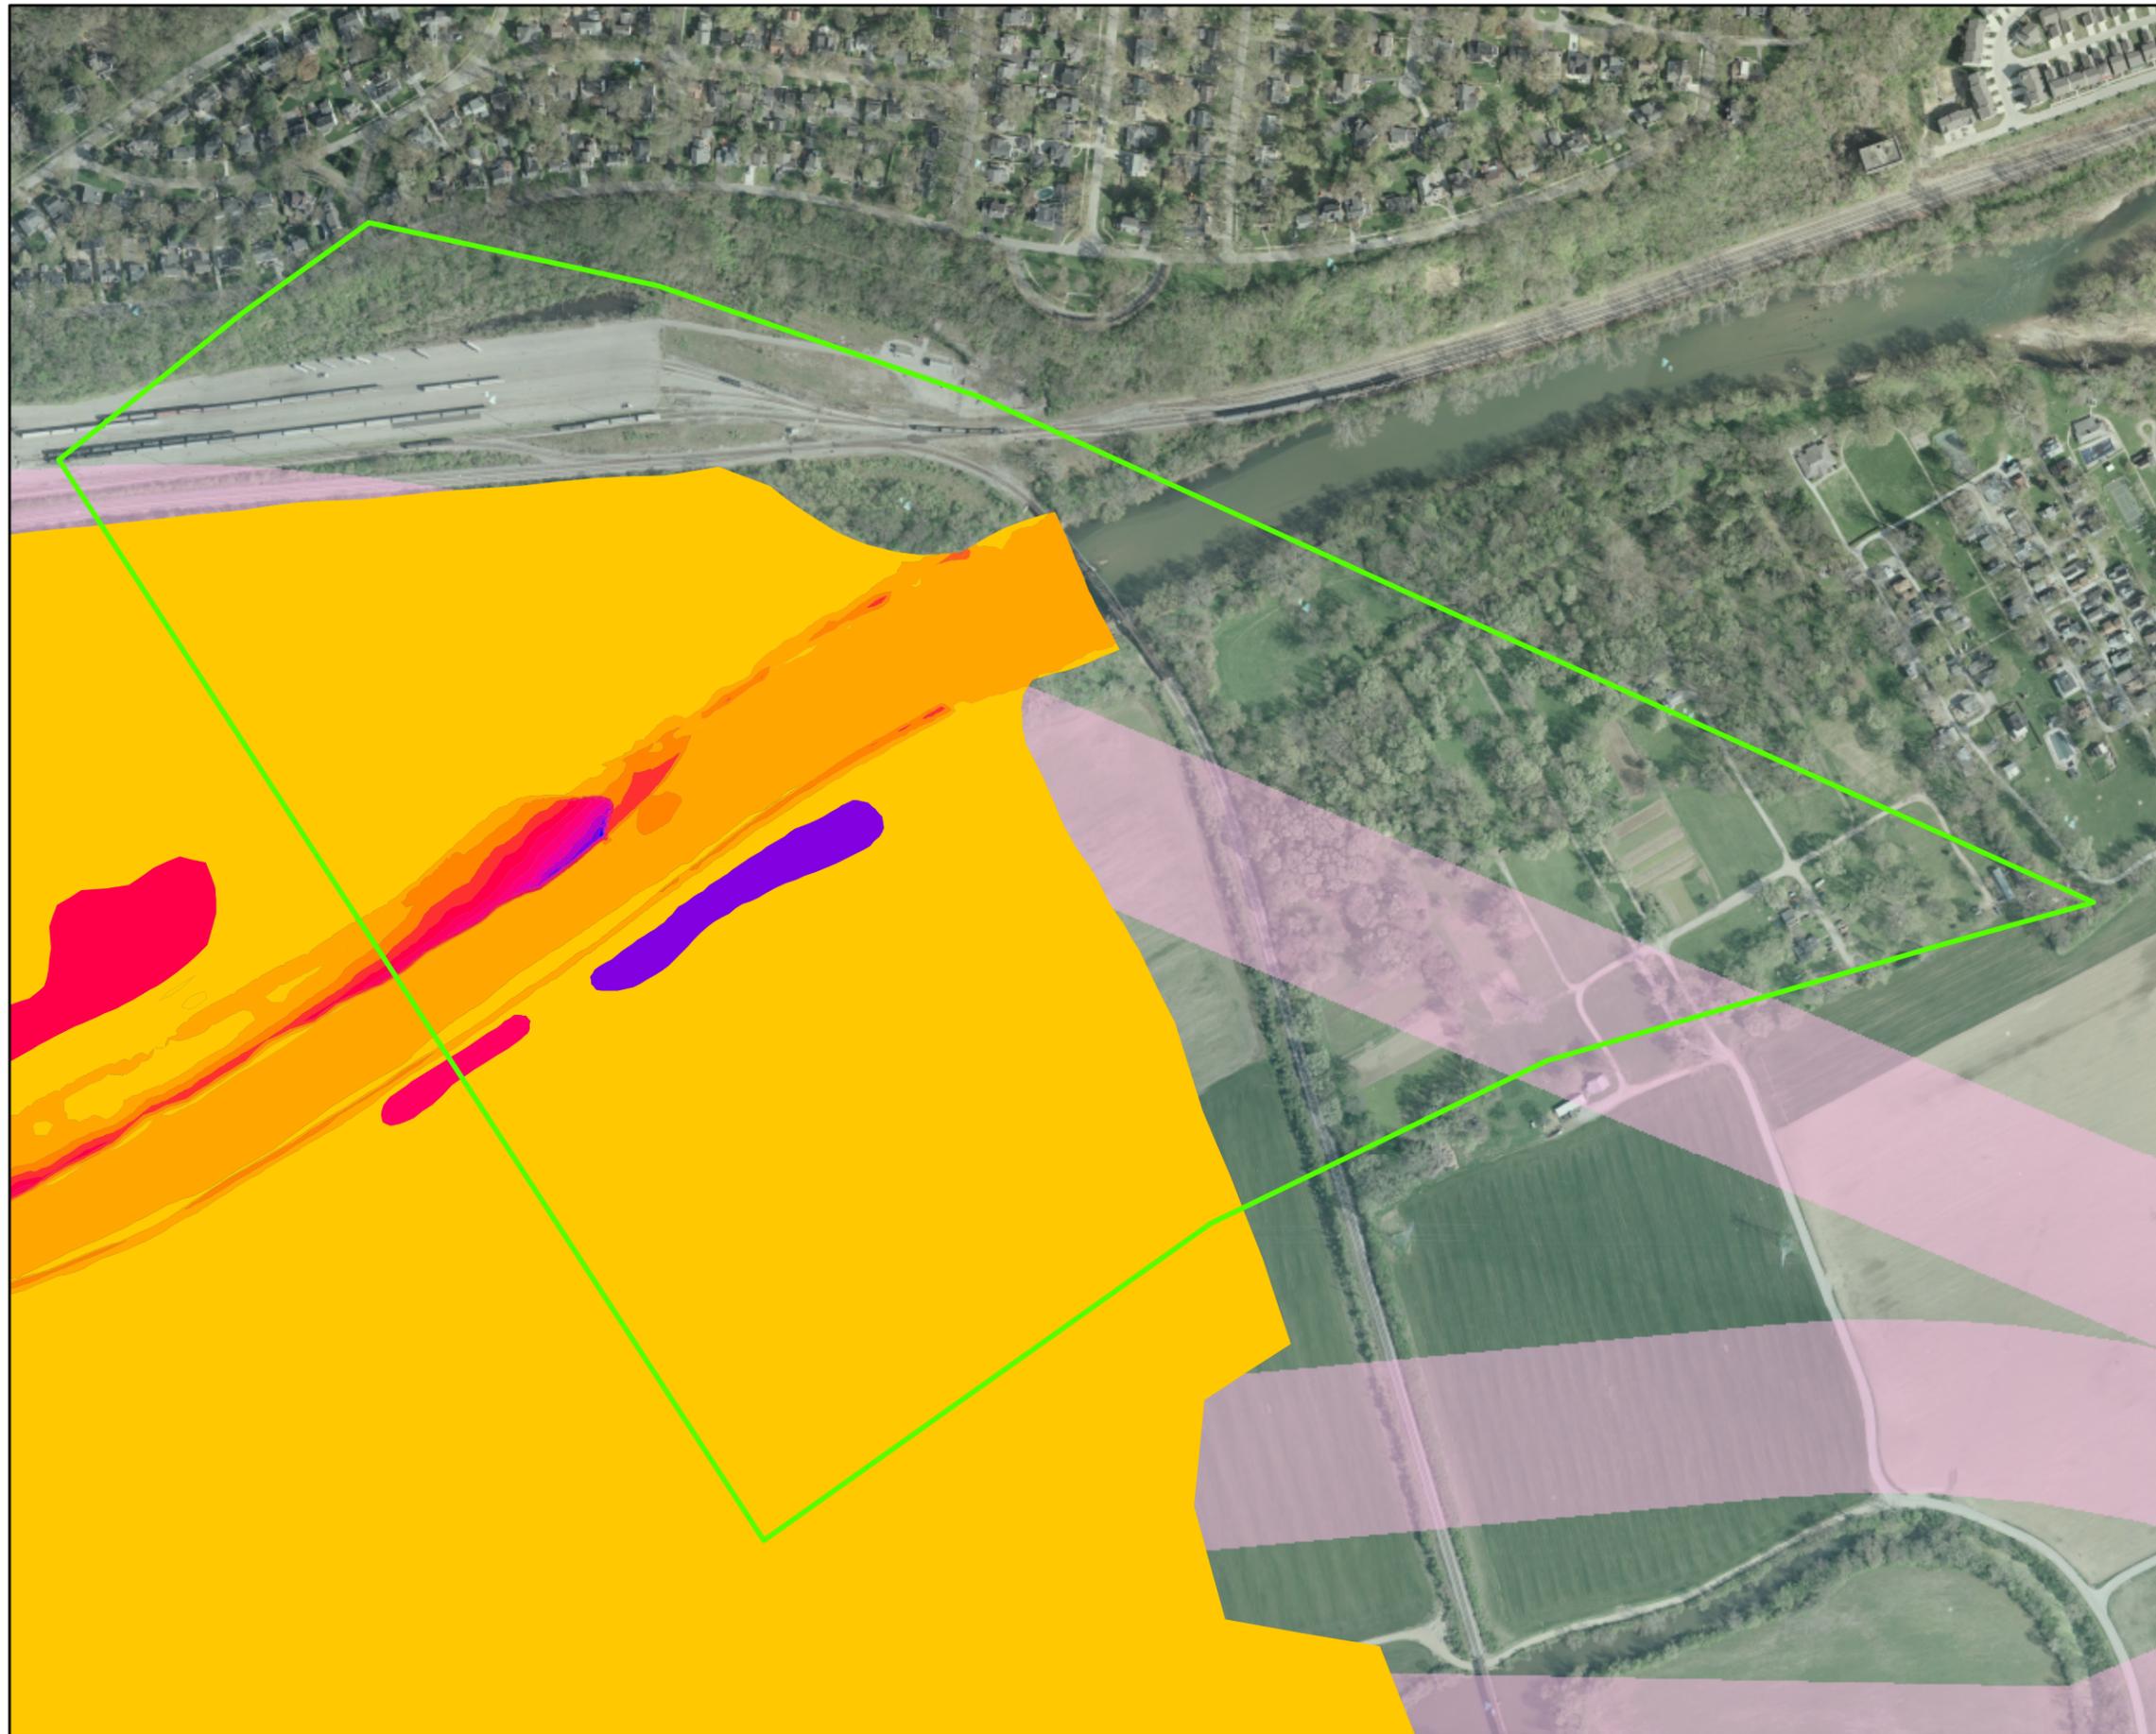
**FIGURE A16**  
**DISTRIBUTION OF BED SHEAR**  
**STRESS AT 65,000 CFS**  
**GEOMORPHIC REACH 4**  
 Little Miami River Geomorphic and  
 Hydraulic Modeling Evaluation, Phase II
