Excerpts from *Transportation Needs Analysis*

**EASTERN CORRIDOR SEGMENTS II AND III
(PID 86462)
TRANSPORTATION NEEDS ANALYSIS**

2.3 SR 125/SR 32 AREA FOCUS AREA

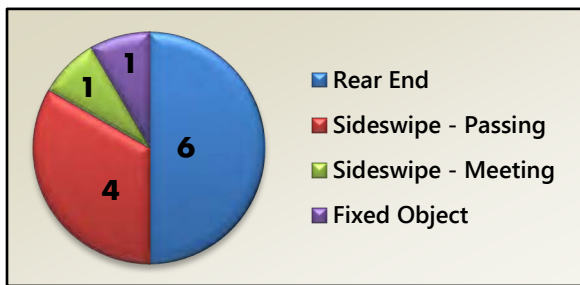
**Figure 25: Frequency of Crashes by Crash Type
SR 125: Beechmont Circle to SR 32**

Crash Data: An ODOT crash screening identified an approximate 0.15-mile stretch of SR 125 adjacent to the Reeves Golf Course Tennis Courts as a high hazard location. As a result, the entire segment of SR 125 from Beechmont Circle to SR 32 was further analyzed. As illustrated in **Figure 25**, there were 12 total crashes on this segment during a three-year period (2013-2015). Rear-end collisions represent 50% of the total crashes. Of the 12 total crashes on the segment, five (40%) occurred in the high hazard segment. Within the

high hazard segment, 60% of the crashes were rear-end crashes. See **Attachment A-2** for a plot of all 12 crashes.

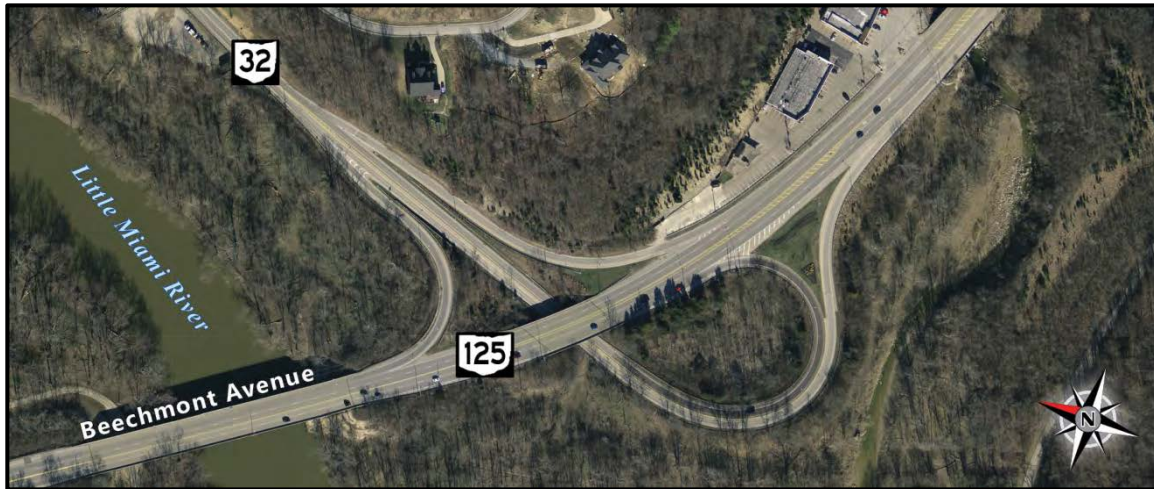
Figure 26. SR 125/SR 32 Interchange

The SR 125/SR 32 interchange is a trumpet interchange which features a loop ramp to serve traffic traveling from eastbound SR 125 to SR 32, and slip ramps for traffic traveling to and from westbound SR 125 and SR 32. A partial loop ramp carries traffic from SR 32 to eastbound SR 32:

Crash Data: Over a three-year period (2013-2015), a total of 27 crashes occurred at this interchange. Fixed object and rear-end crashes represented about 75% of the overall crashes, with a majority (17 crashes) occurring in wet conditions. The frequency of crashes by crash type is shown in [Figure 27](#).

Data indicates that many of the crashes at this interchange occurred in two distinct clusters. One cluster of nine (9) crashes occurred at the curve/merge on the ramp from southbound SR 32 to westbound SR 125. A majority of these crashes (6) occurred in wet conditions between the hours of 11:00 a.m. and 2:00 p.m. Fixed object crash type was the most prevalent at this cluster (4 crashes), all in wet conditions.

Another cluster of eleven (11) crashes occurred along the curve on the ramp from eastbound SR 125 to northbound SR 32. Ten (10) of these crashes occurred in the daylight, and eight (8) occurred in wet conditions. Fixed-object crash type was the most prevalent (6 crashes), all in wet conditions.

Potential causal factors for crashes at this interchange include excessive speed, slippery pavement, inadequate geometry, and inadequate delineation. See [Attachment A-2](#) for a plot of all 27 crashes.

Geometric Data: One sag vertical curve is deficient at this interchange and the superelevation rate on all ramps does not meet current standards. The deficient sag vertical curve has a k-value of 43 and the minimum value for a design speed of 35 mph is 49. The superelevation on all four interchange ramps is based on an 0.083 ft/ft maximum superelevation. The current standard for maximum superelevation on urban ramps is 0.06 ft/ft.

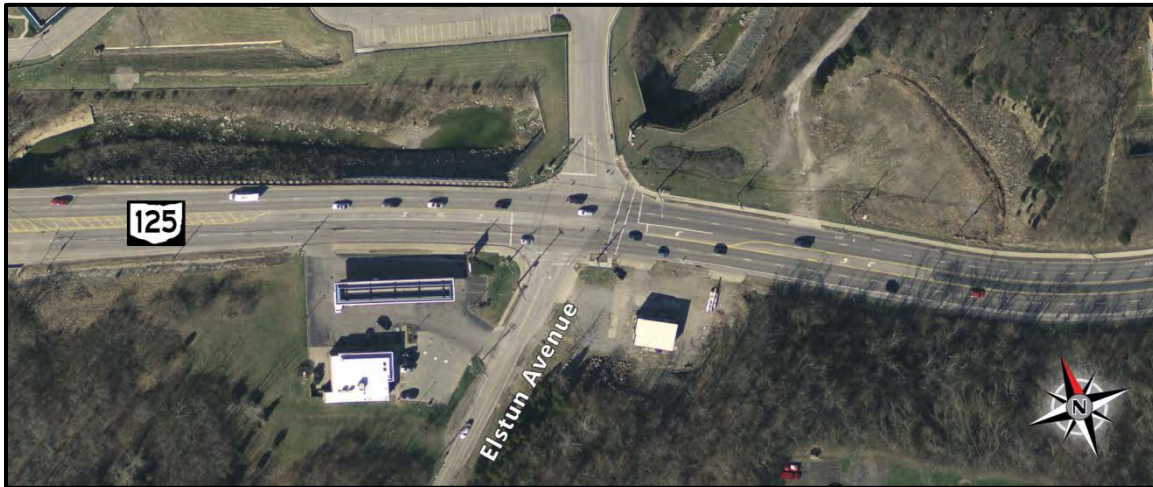
Figure 28. SR 125/Elstun Road Intersection

The SR 125/Elstun Road intersection is a signalized four-leg intersection:

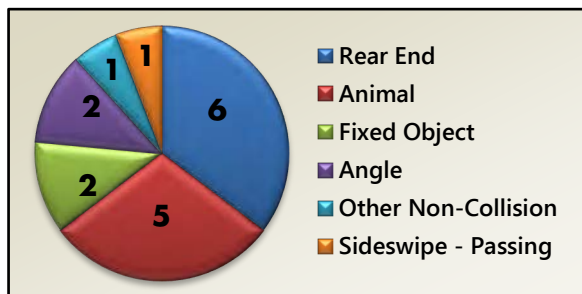
**Figure 29. Frequency of Crashes by Crash Type
SR 32: SR 125 to Clough Pike**

Crash Data: An ODOT crash screening identified an approximate 0.15-mile sub-segment east of the Beechmont Avenue interchange as a high-hazard location. Therefore, a detailed crash analysis of the entire segment was completed.

occurred in the high-hazard section. Within the high hazard segment, half of the crashes were rear-end crashes. All six of the rear-end crashes occurred in dry conditions. Five of the rear-end crashes occurred in clear daylight conditions, five occurred from 4:00 PM to 6:00 PM, and four occurred in the northbound direction. See **Attachment A-2** for a plot of all 17 crashes.

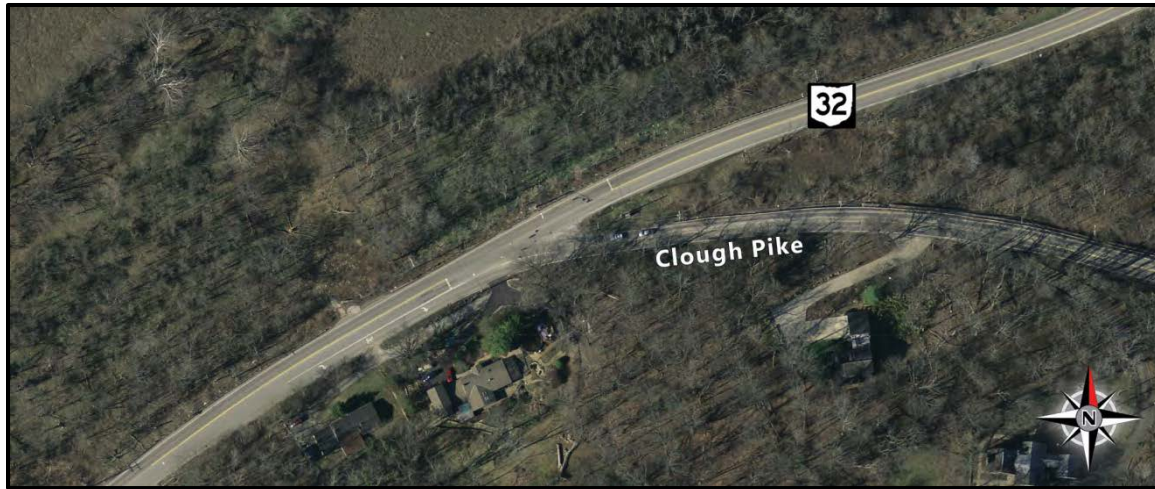
Figure 30. SR 32/Clough Pike Intersection

The SR 32/Clough Pike intersection is a three-leg, signalized intersection:

LOS Analysis: The HCS analysis indicates that the westbound movement will fail during the AM peak-hour and have a v/c ratio greater than one during the No Build opening year (2022) and No Build design year (2042) conditions. No intersection improvements are required for the exiting

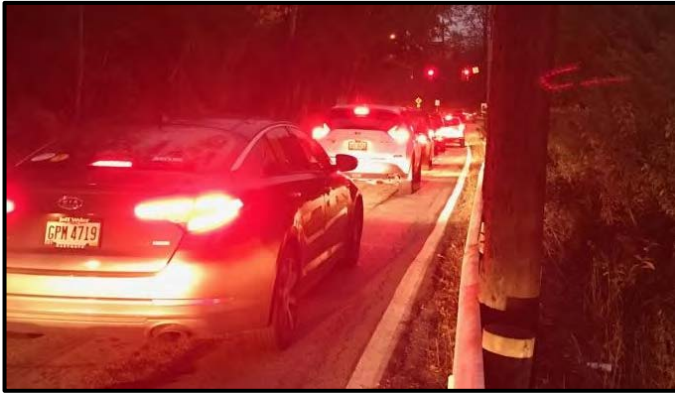
translated to a length by assuming a queue length of 25 feet per vehicle. During the AM peak period the maximum westbound queue extended 1,025 feet. The recorded queues during the AM peak period are shown in **Figure 31**:

Figure 31. Westbound Clough Pike AM Peak Period Queue at SR 32

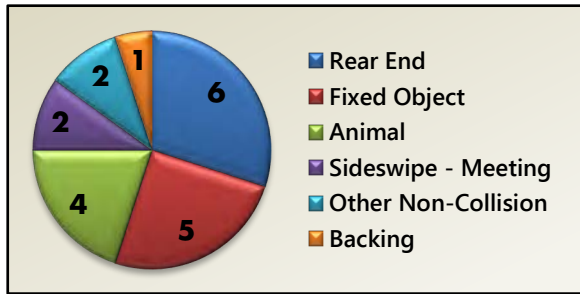
**Figure 32: Frequency of Crashes by Crash Type
SR 32: Clough Pike to Newtown Corp. Limit**

As illustrated in [Figure 32](#), there were 20 total crashes in this roadway section during a three-year period (2013-2015). Rear-end and fixed object crashes represent 55% of the total crashes. Of the 20 total crashes on the segment, four (20%) occurred in the high hazard section west of McCullough Run and two (10%) occurred in the high hazard segment at Clear Creek Park.

There were two clusters of crashes along the segment; the four that occurred in the high hazard section west of McCullough Run and four that occurred at Turpin Lake Place. Excluding the animal crash at both clusters, there is no correlation between the crash data and a specific contributing cause for the crashes at either location. See [Attachment A-2](#) for a plot of all 20 crashes.

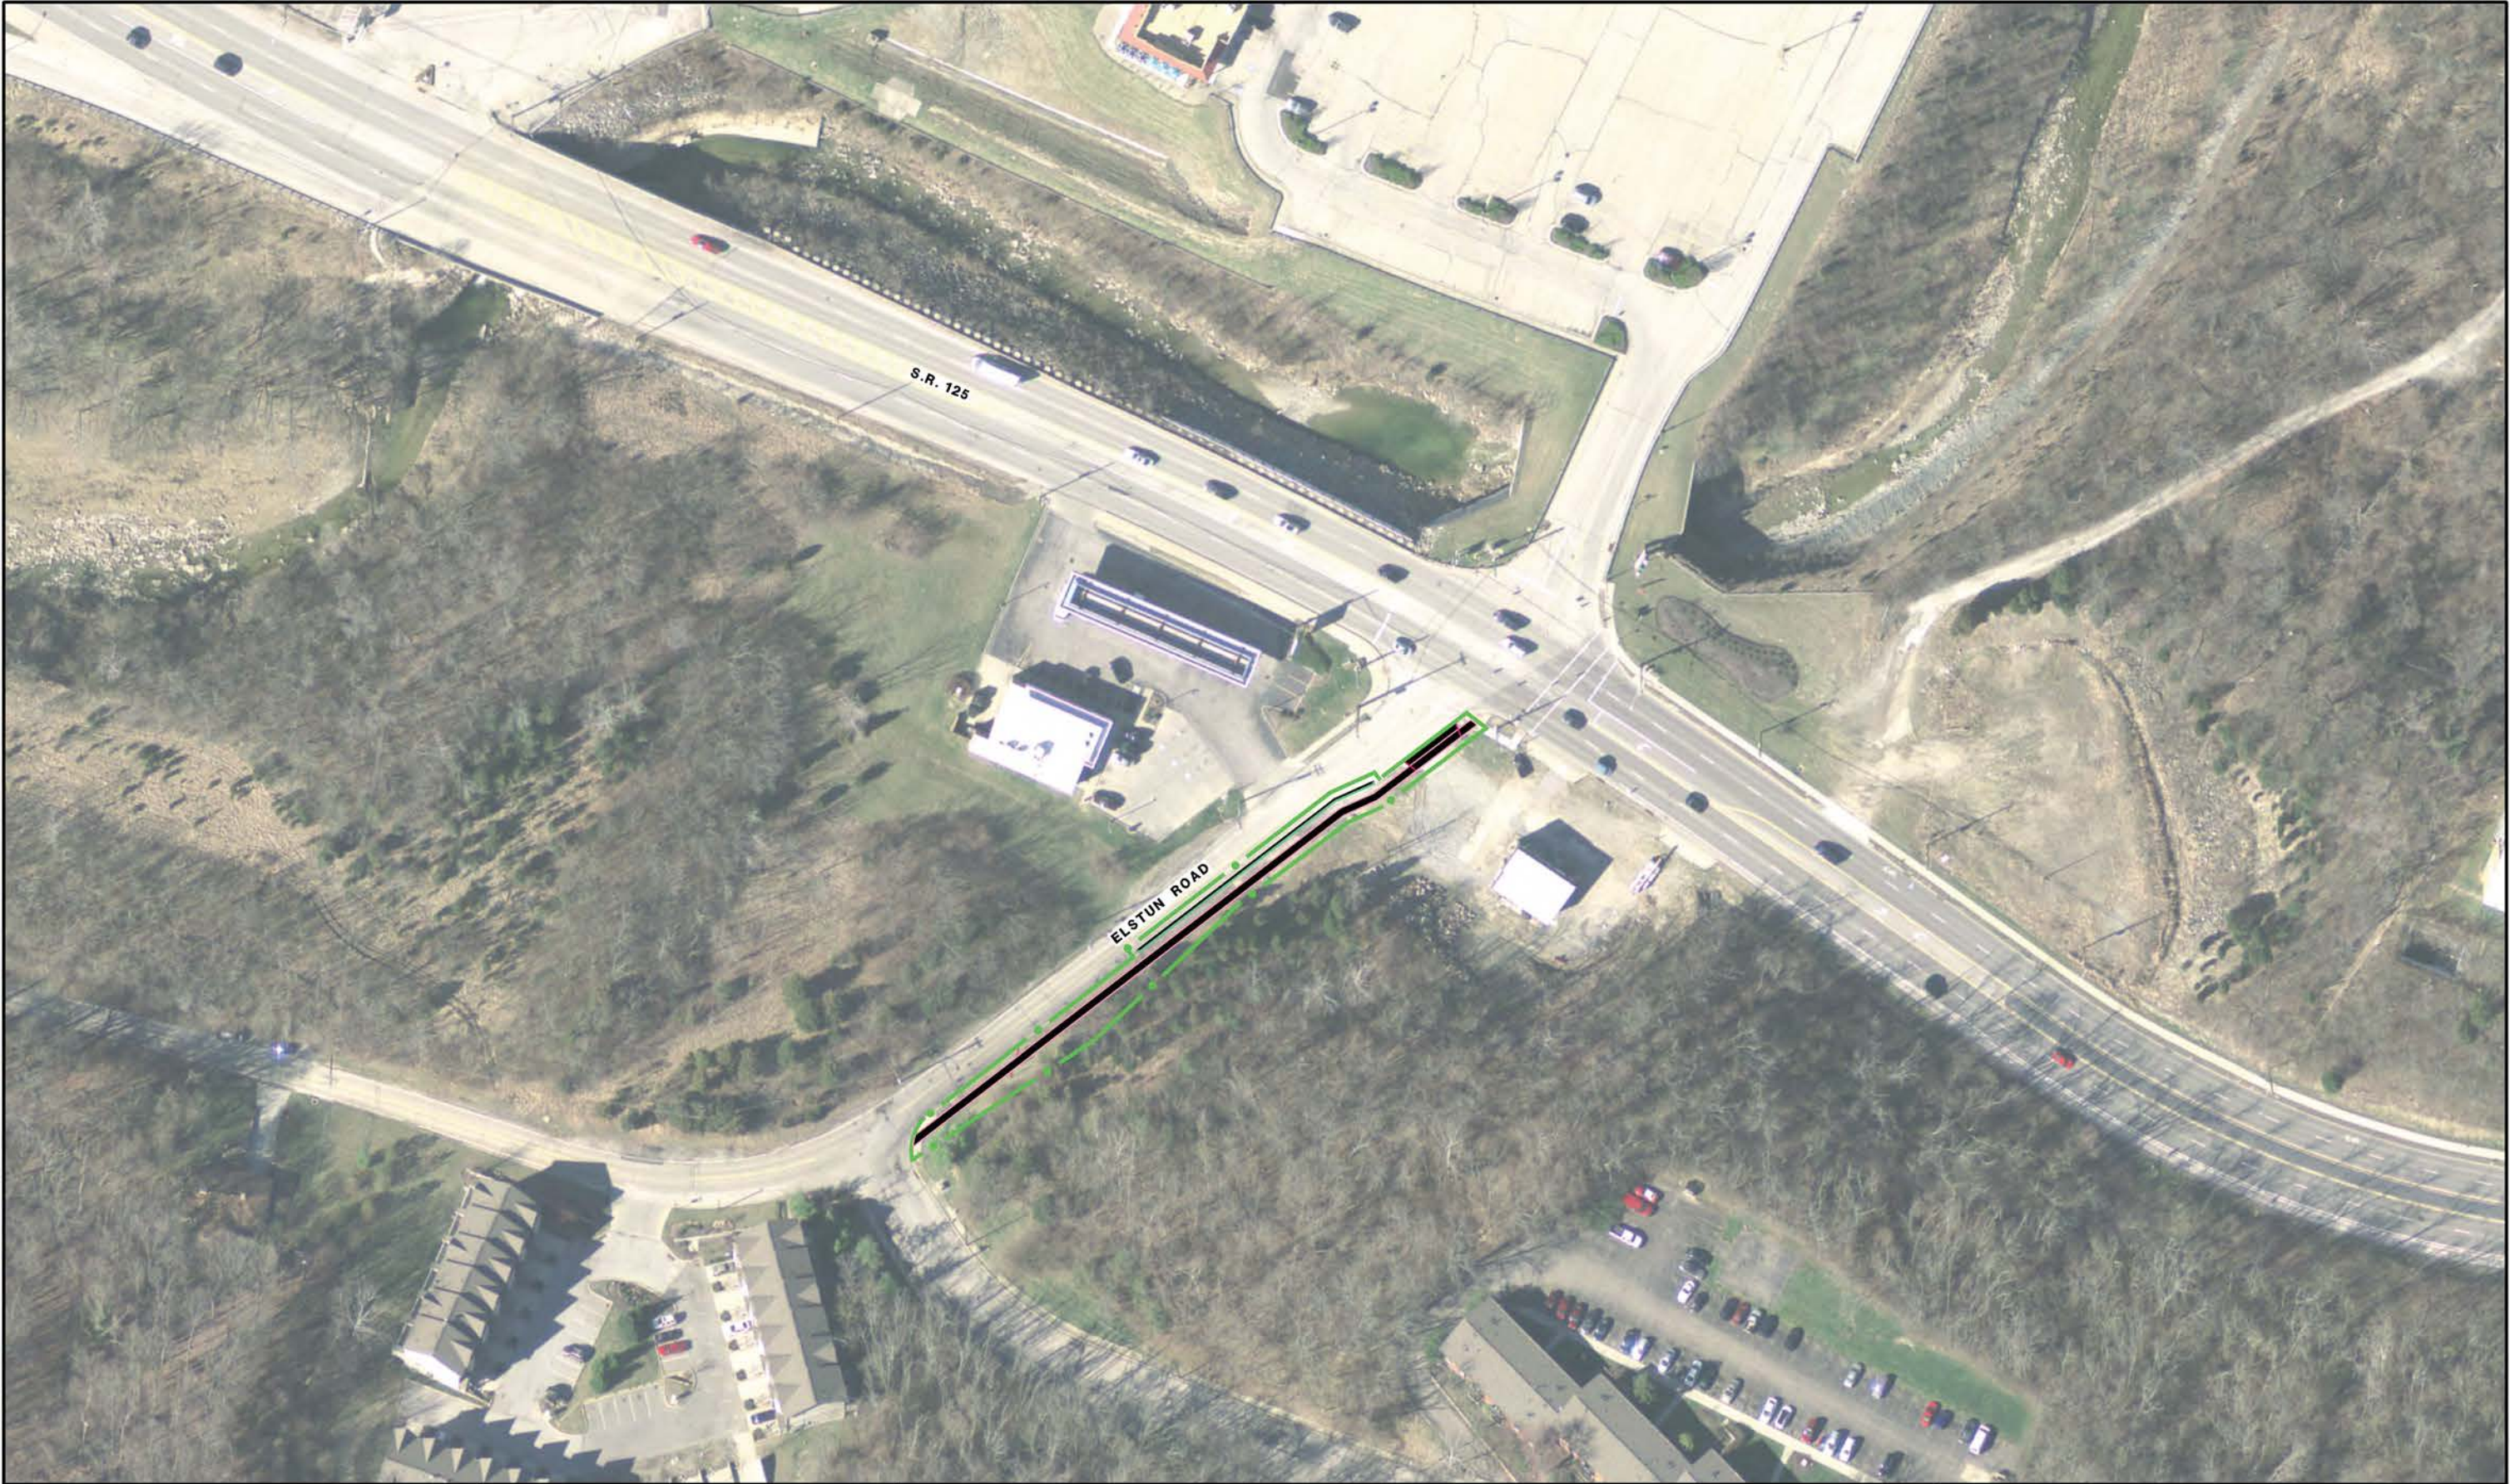
Figure Elstun-1
SIDEWALK CONNECTION FROM S.R. 125 TO RENTAL PROPERTIES

Concept Drawing
Eastern Corridor Projects
Segment II-III (SR 32 Corridor)
HAM-32F-0.00; PID 86462

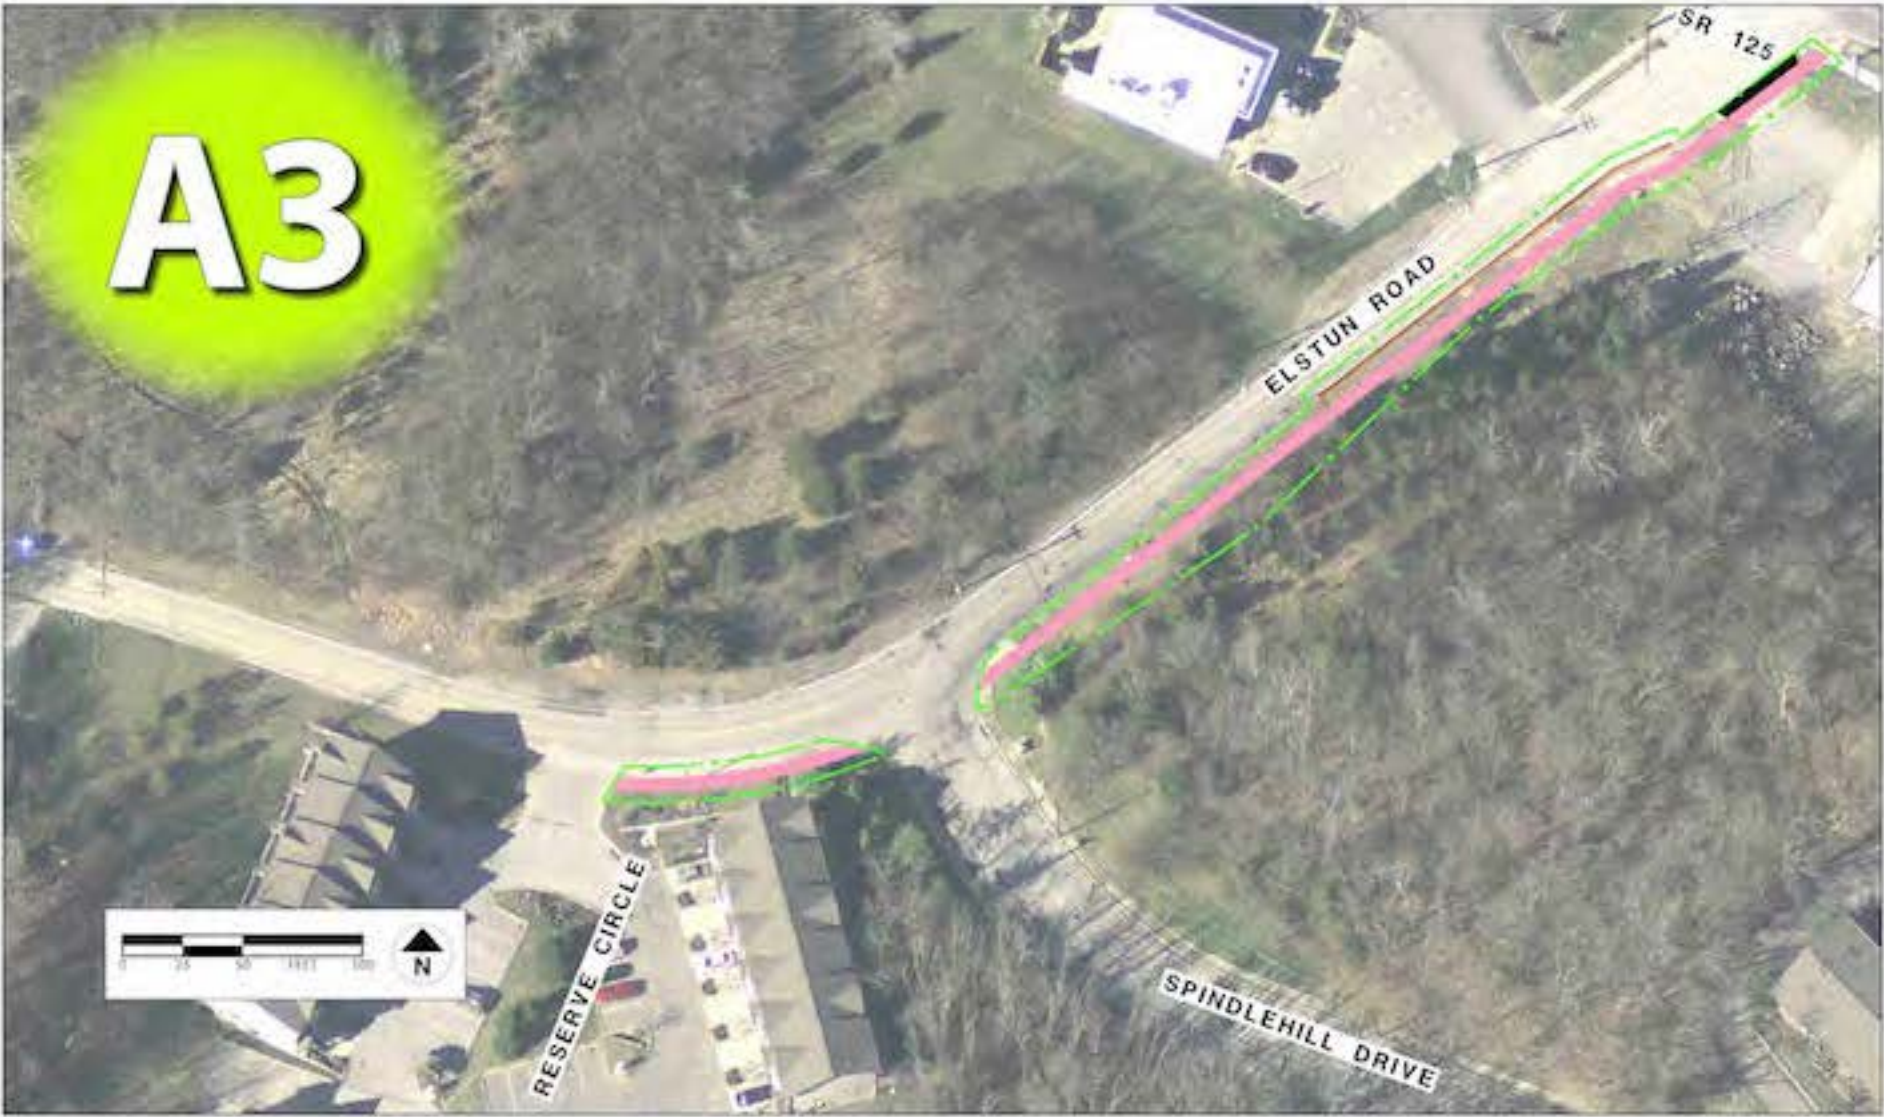
**New Sidewalk from
SR 125 to Reserve Circle**

- \$50,000 construction cost
- New R/W needed from 2 parcels; no buildings impacted
- Sidewalk to connect residential properties to Metro bus stop

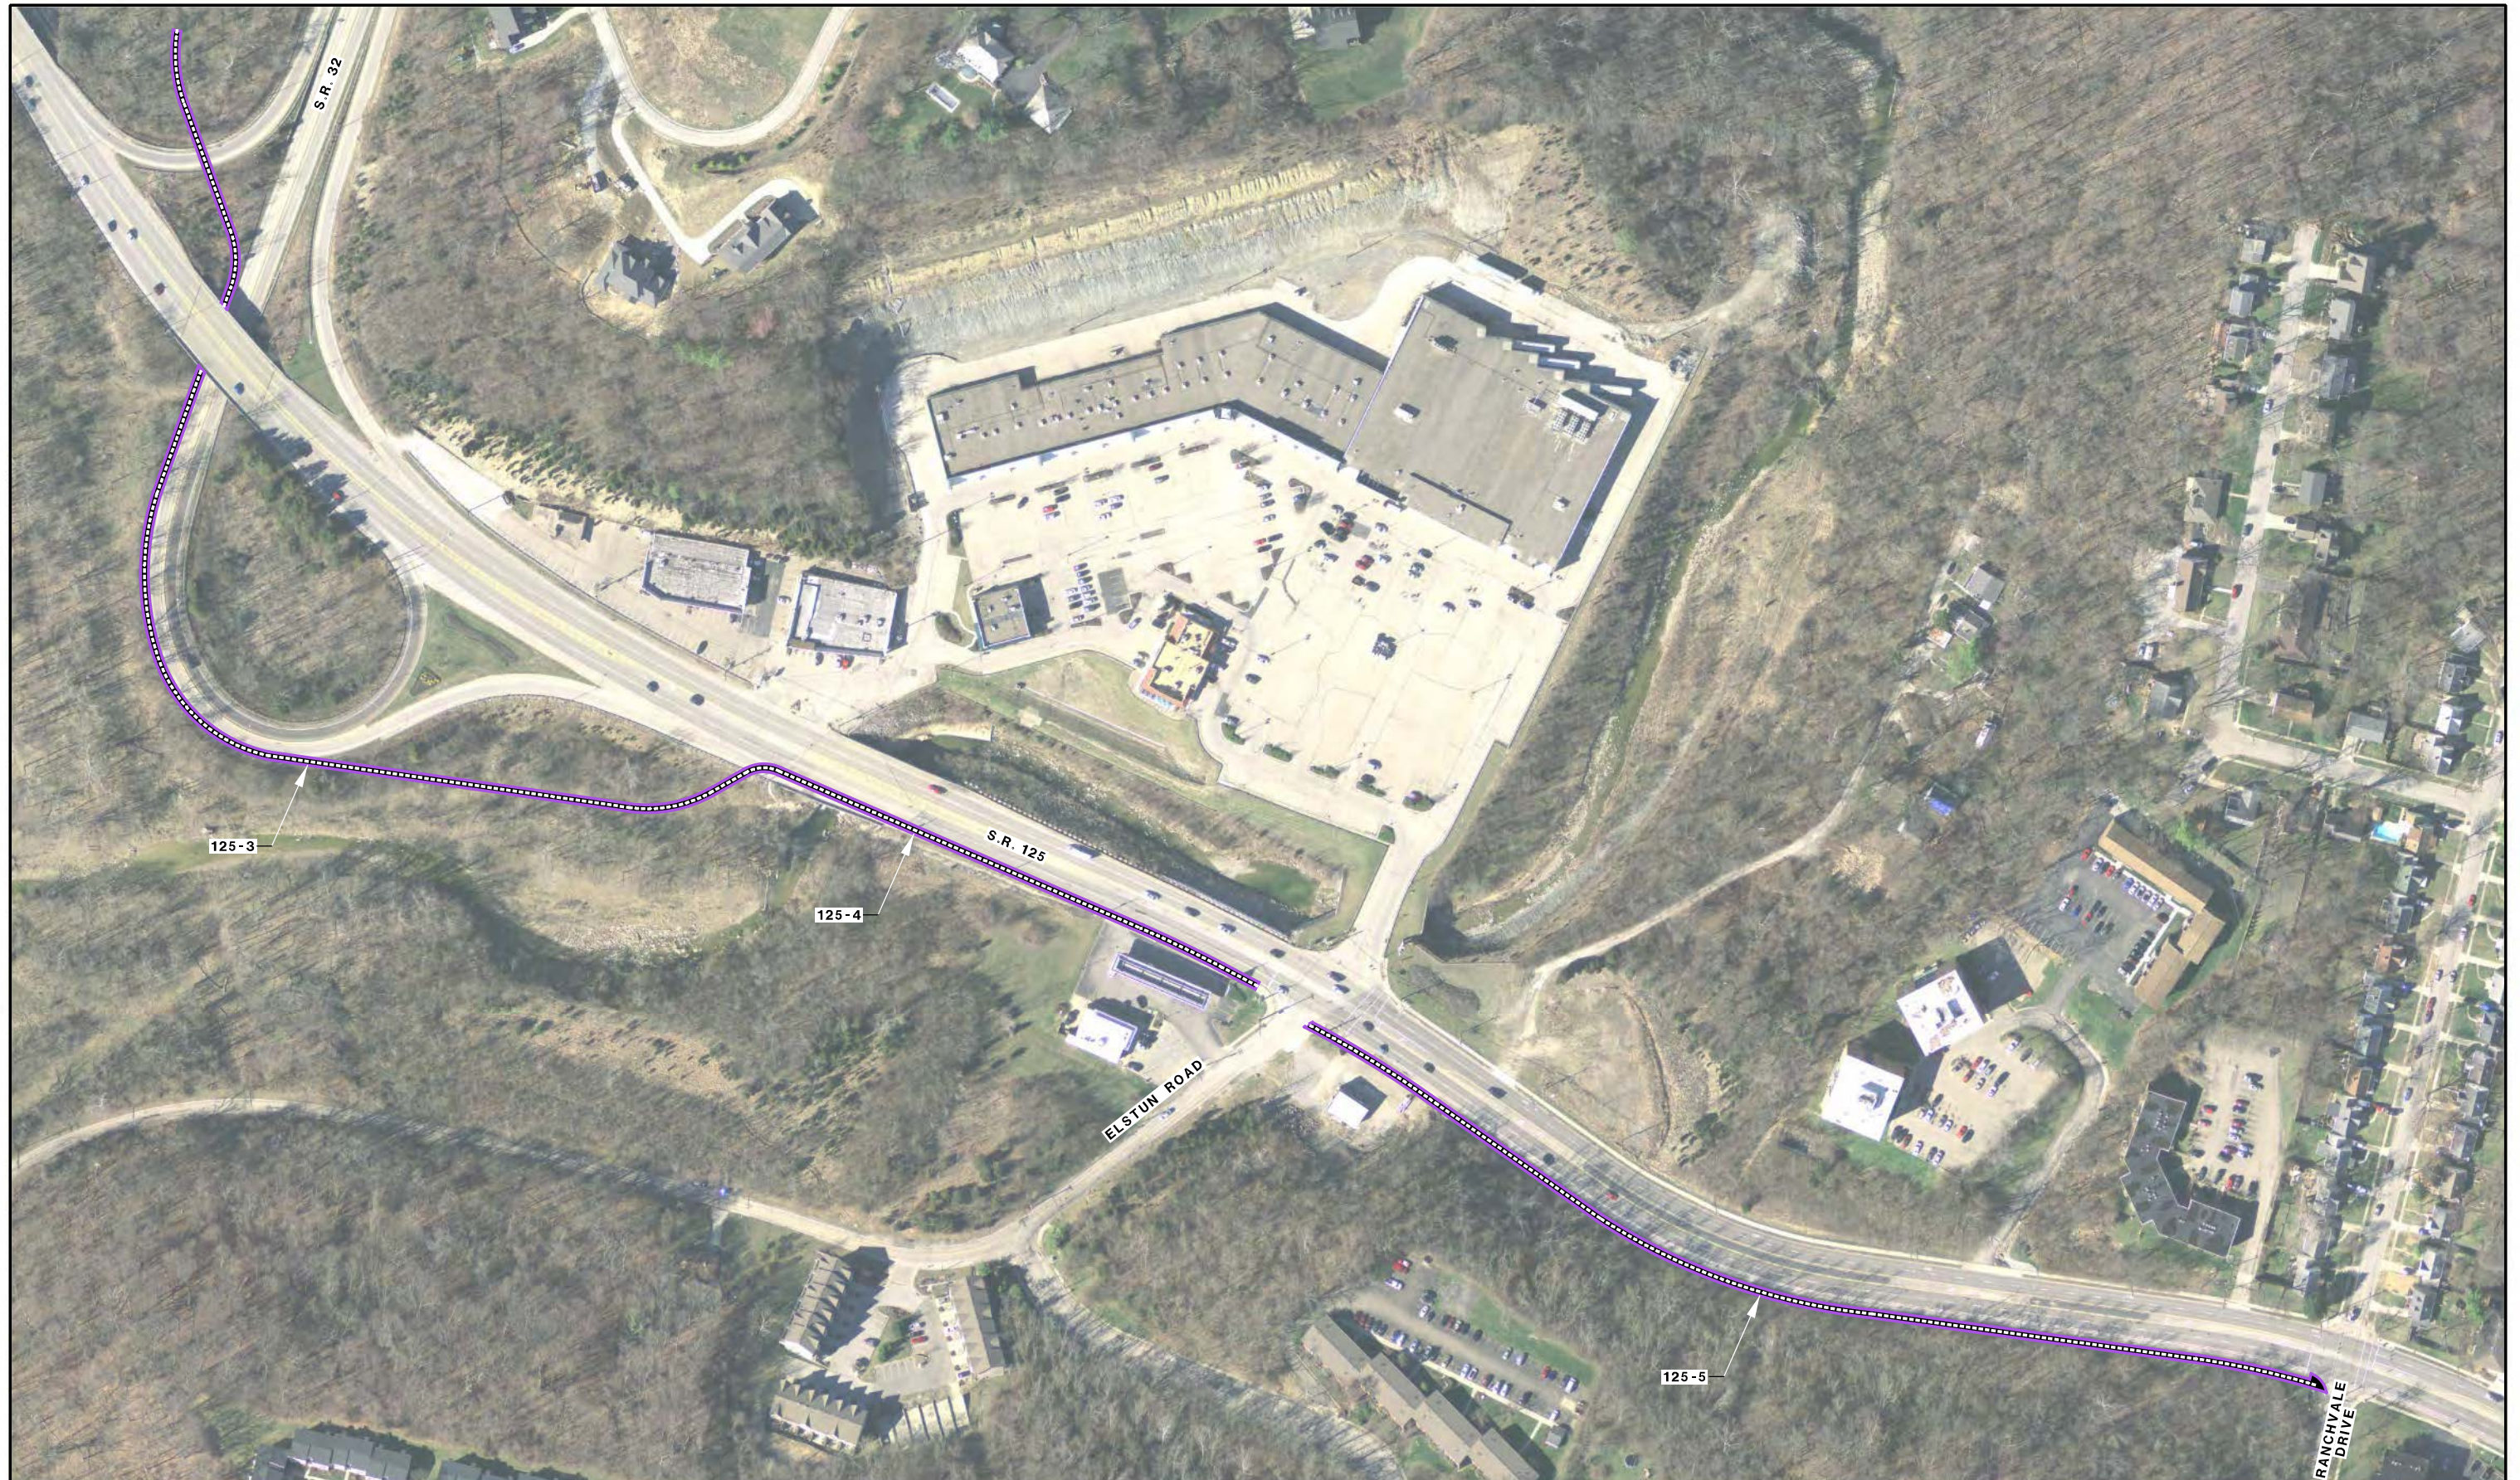
Figure 125-3, 125-4 and 125-5

Concept Drawing
Eastern Corridor Projects
Segment II-III (SR 32 Corridor)
HAM-32F-0.00; PID 86462

Figure 125-3
SHARED US PATH BETWEEN
SR 125 AND LITTLE MIAMI TRAIL

- Include in the Implementation Plan as a medium priority, but do not implement until either 125-3 (A5) or 125-3b (A6) has been completed.
- Consider locating the shared-use path adjacent to the street.

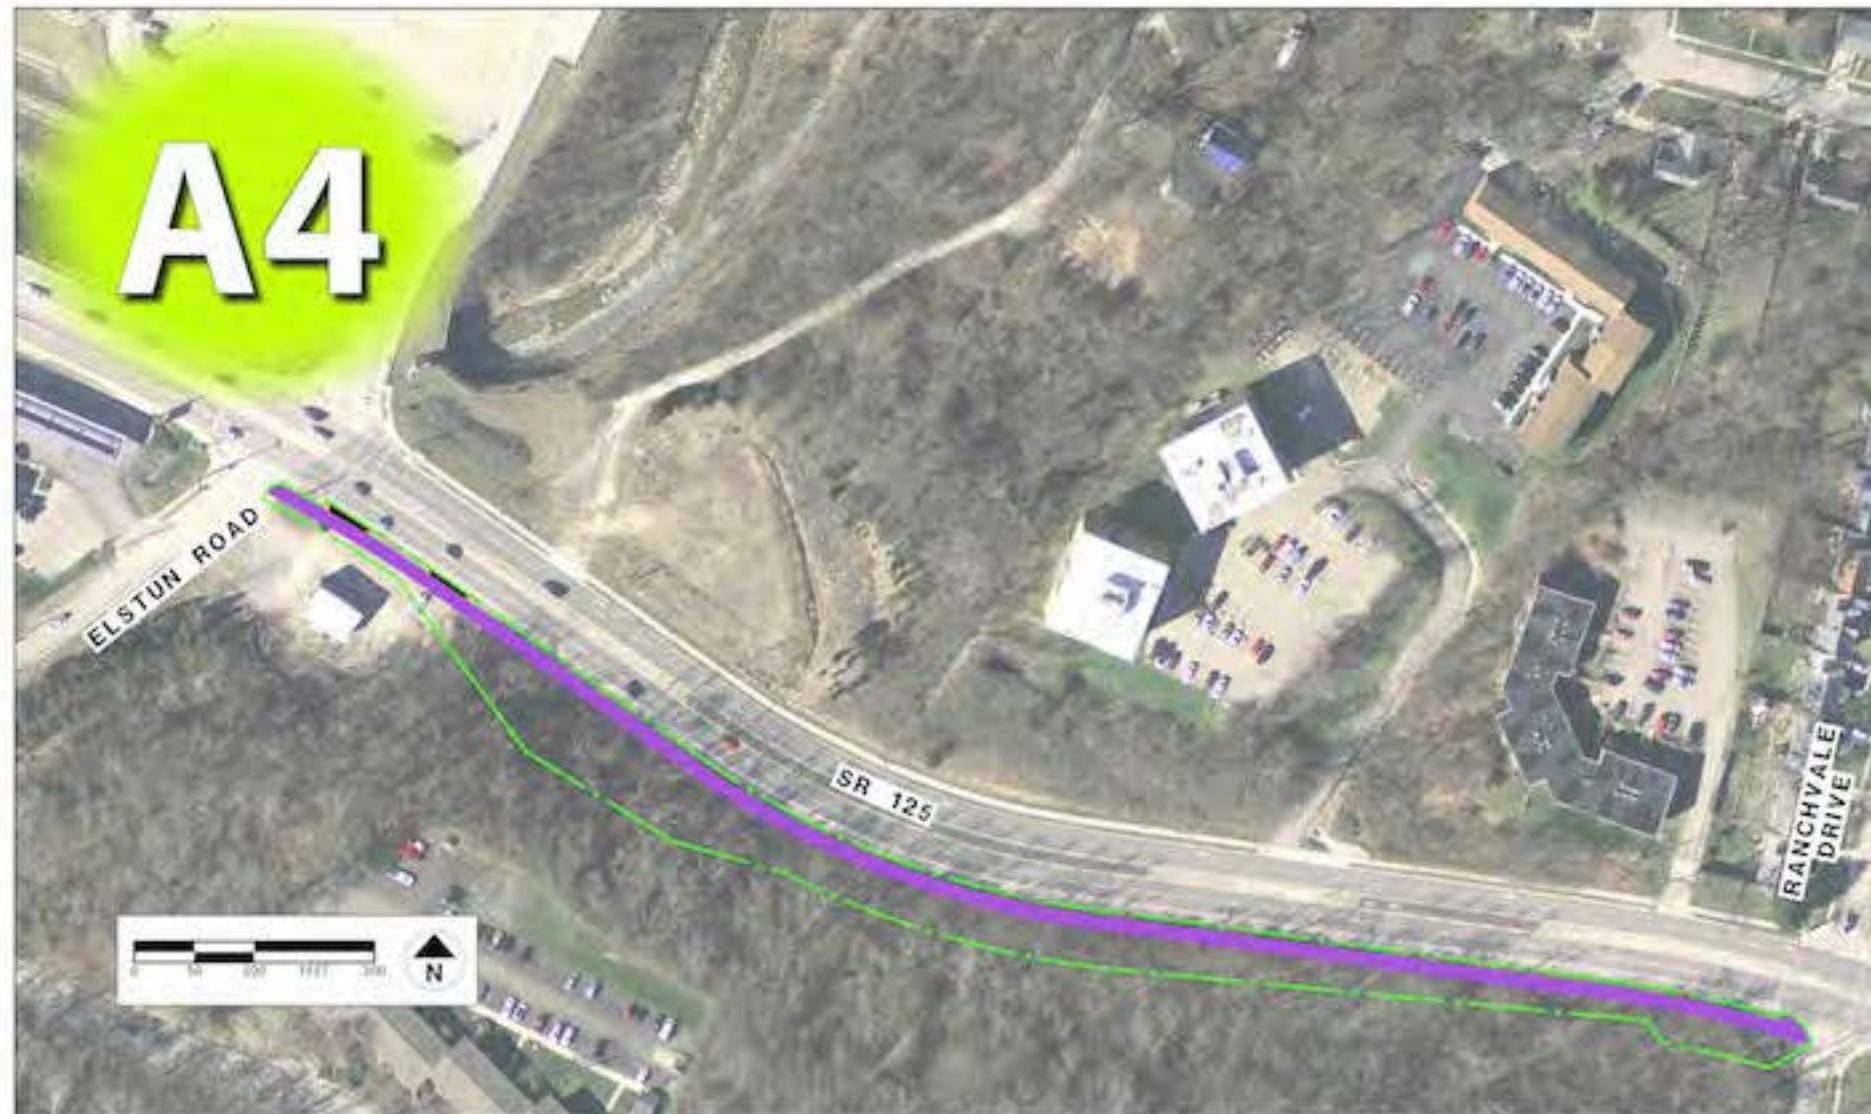
Shared-Use Path Along SR 125 Between Elstun and Ranchvale

- \$140,000 to \$200,000 construction cost
- New R/W needed from 15 parcels; no buildings impacted
- Improve safety for bicyclists riding up the SR 125 hill

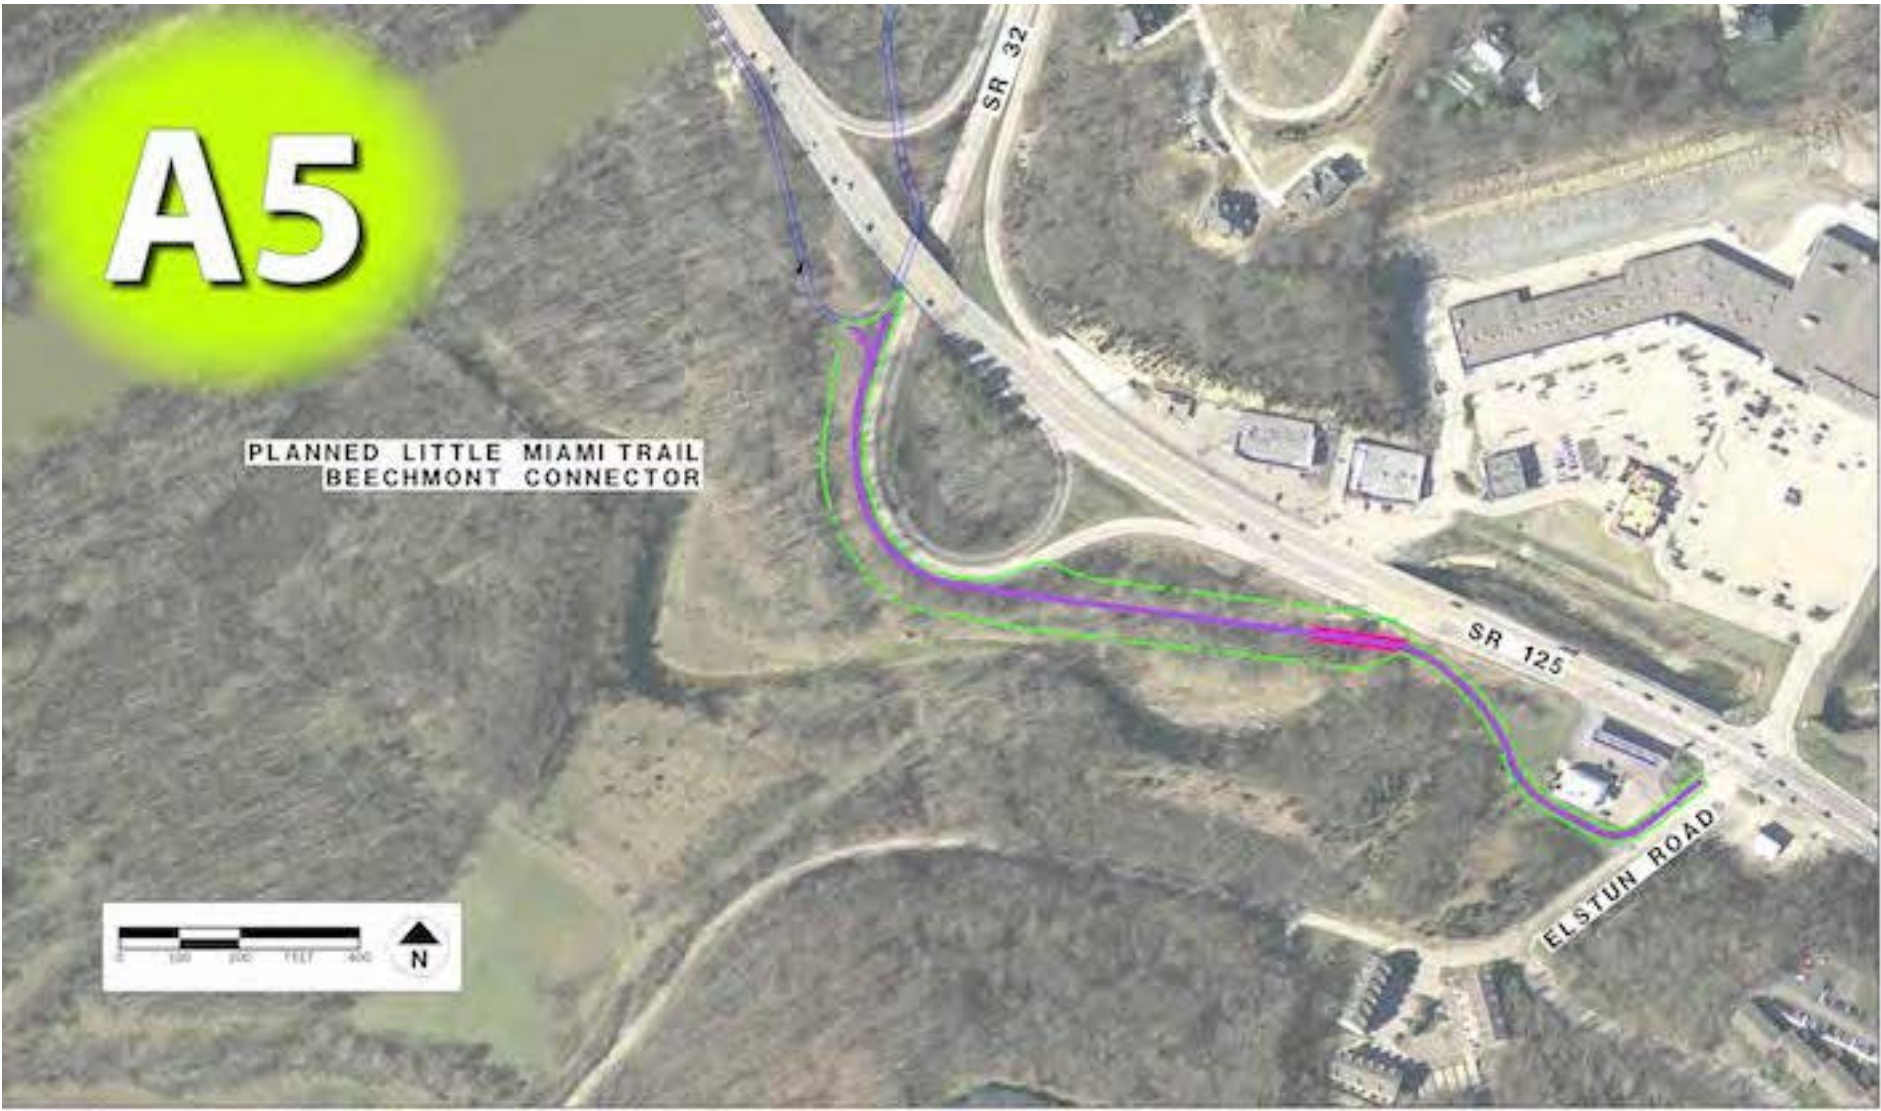
**Shared-Use Path Along
SR 125**

- \$770,000 to \$1.2M construction cost
- New R/W needed from 3 parcels; no buildings impacted
- New bridge over Clough Creek

- The committee noted that the following additional information is needed:
 - Concepts 125-3 (A5): evaluate slope stability
 - Concept 125-3b (A6): evaluate space and hillside issues; update the cost for constructing a shared-use path.

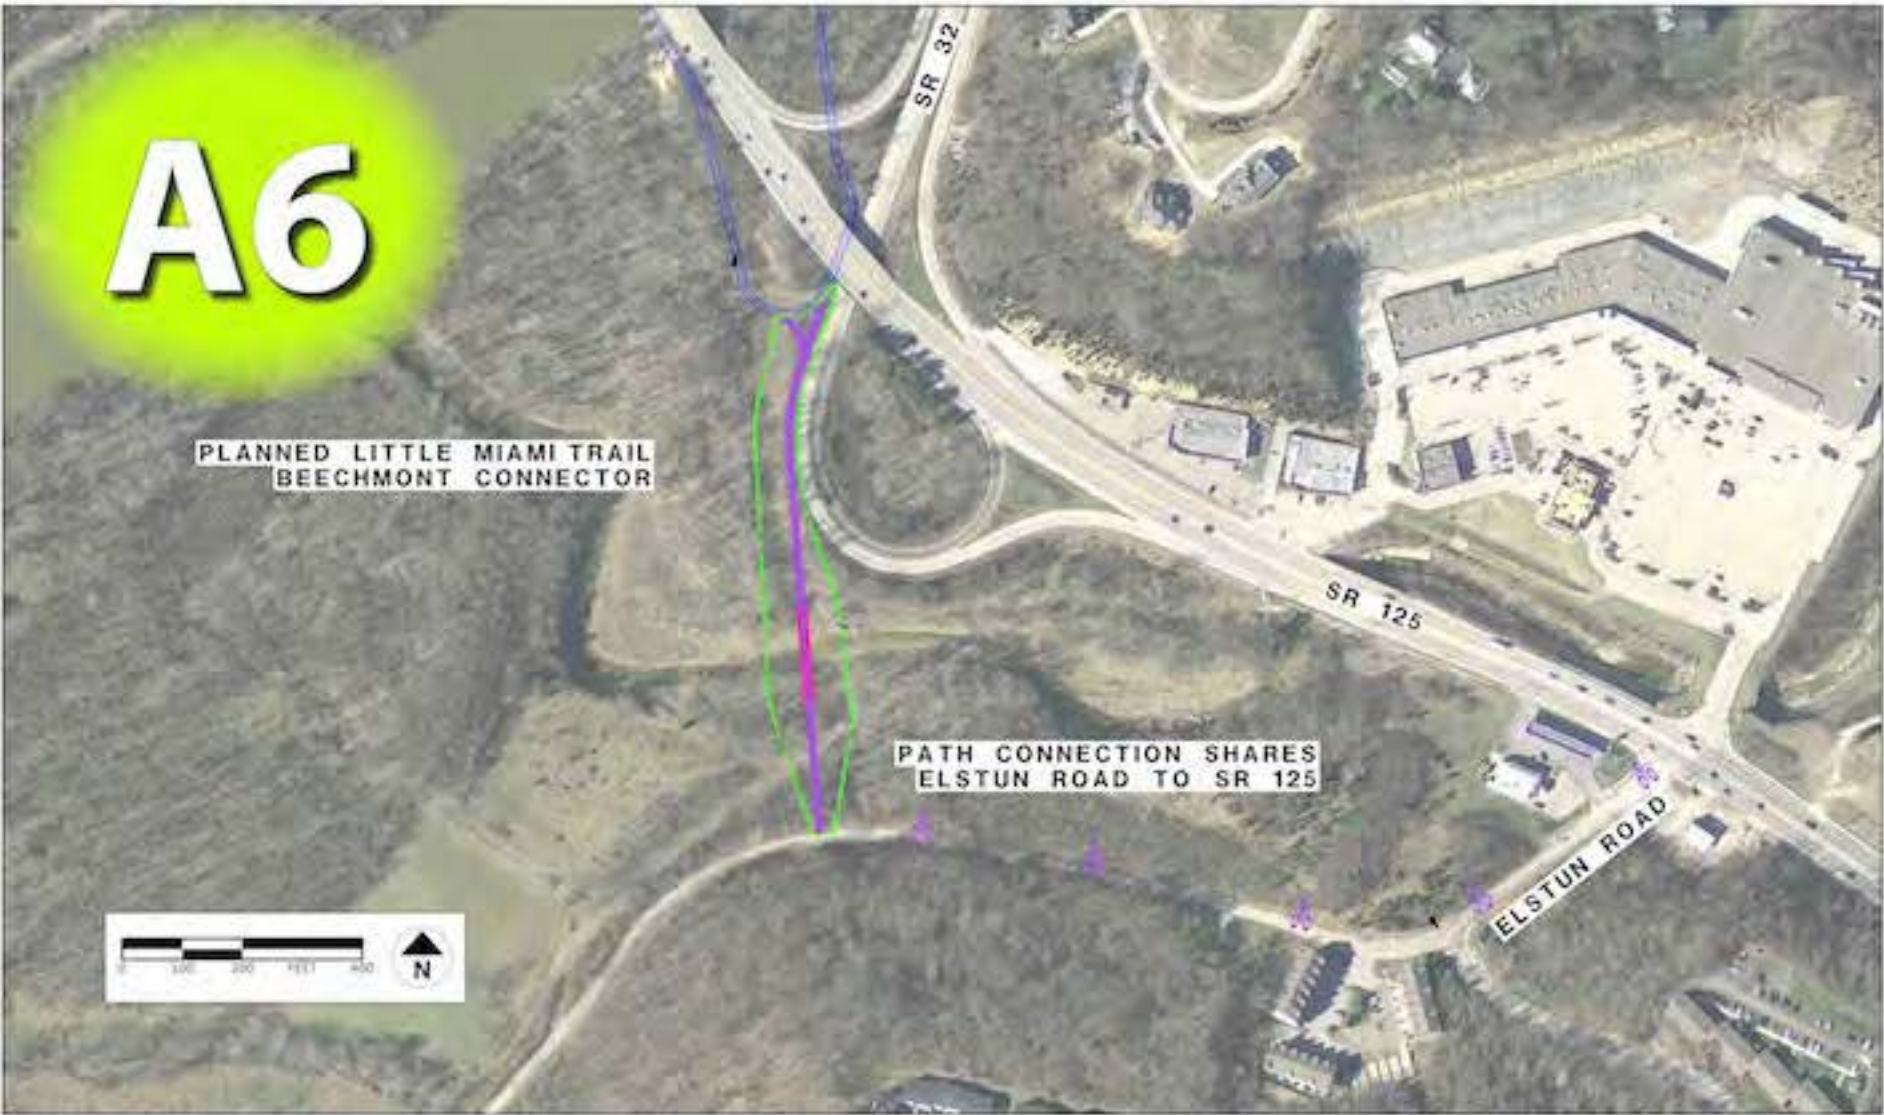
Shared-Use Path Using Elstun

- \$360,000 to \$550,000 construction cost
- New R/W needed from 2 parcels; no buildings impacted
- Sensitive archaeological area
- New bridge over Clough Creek
- Path shares existing Elstun Road pavement with traffic
