Excerpts from *Transportation Needs Analysis*

**EASTERN CORRIDOR SEGMENTS II AND III
(PID 86462)
TRANSPORTATION NEEDS ANALYSIS**

2.3 SR 125/SR 32 AREA FOCUS AREA

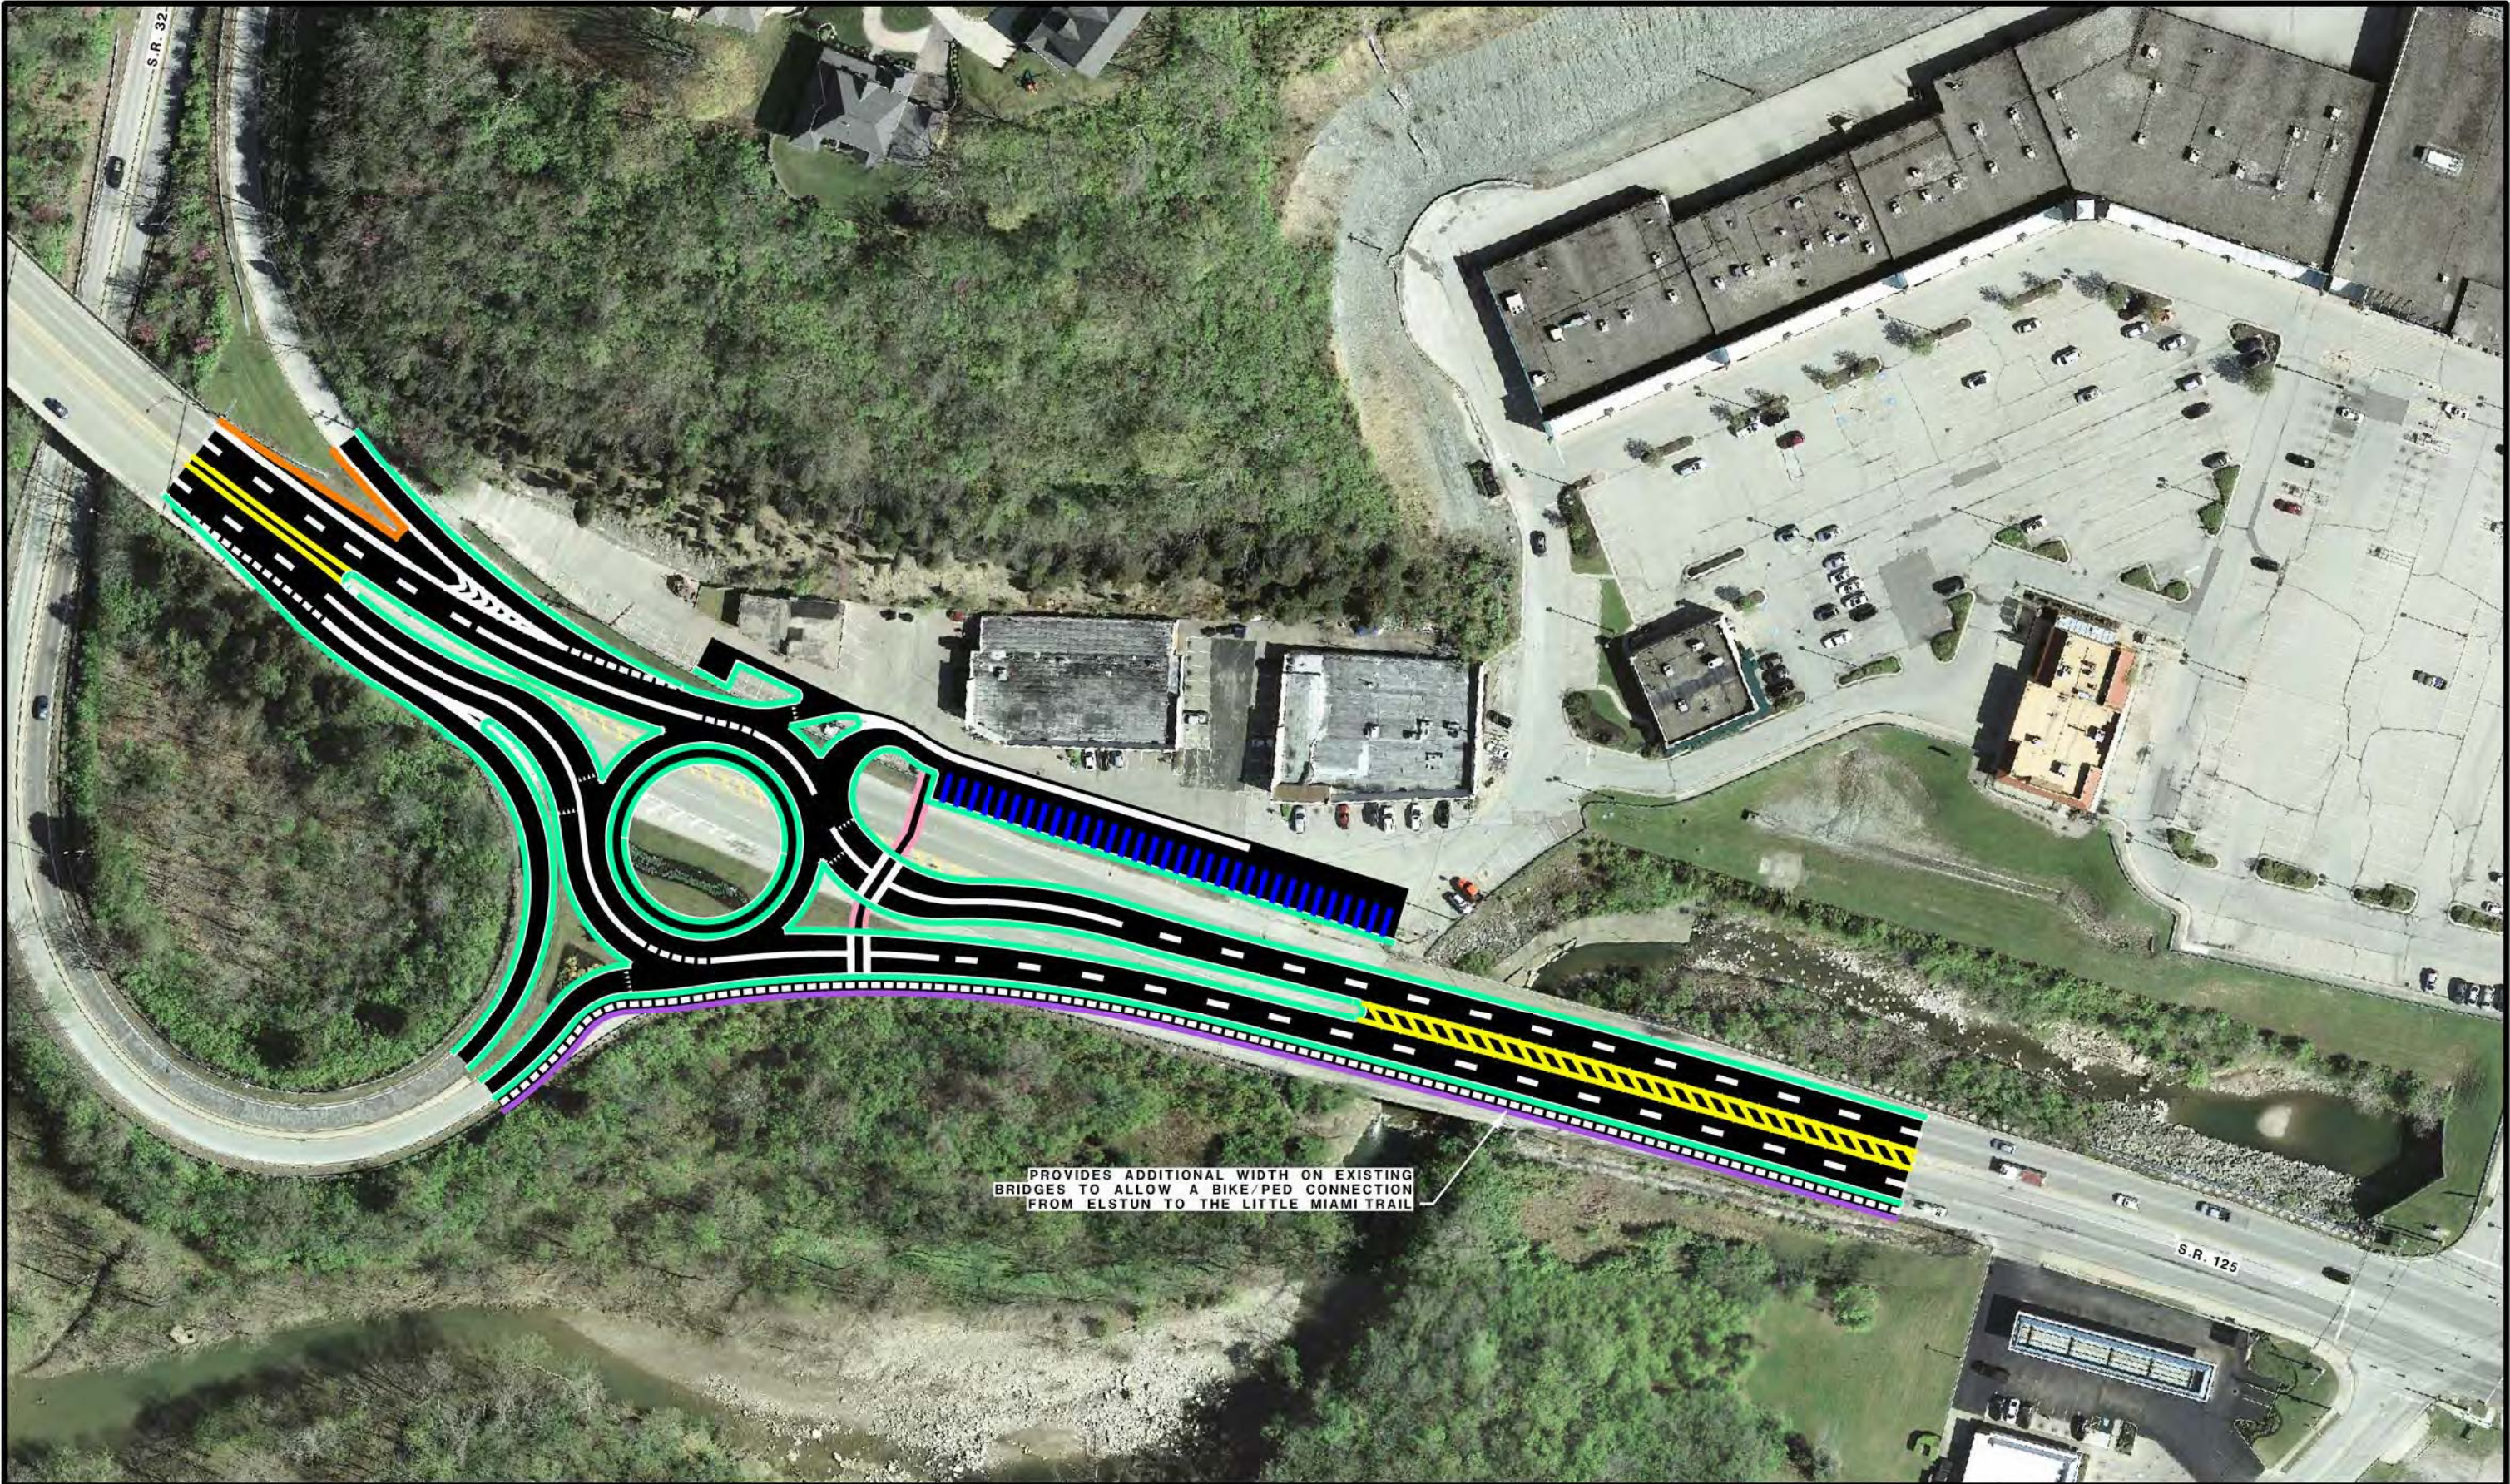
Figure X-1G and 125-4
MODIFY RAMP CONNECTION FROM S.R. 32 TO S.R. 125
TO ROUNDABOUT

PROVIDES ADDITIONAL WIDTH ON EXISTING
BRIDGES TO ALLOW A BIKE/PED CONNECTION
FROM ELSTUN TO THE LITTLE MIAMI TRAIL

- 5/24:
- Adjust lane widths on SR 125 to obtain the space needed to establish a shared-use path across the existing bridge over Clough Creek.
 - Work would be done in conjunction with creating the signalized intersection noted in concepts X-1f.
- 8/20:
- Connect SR 125 sidewalk at Elstun Rd to the Little Miami Trail with a shared-use path utilizing the existing bridges over Clough Creek by modifying the ramp from SR 32 to eastbound SR 125.

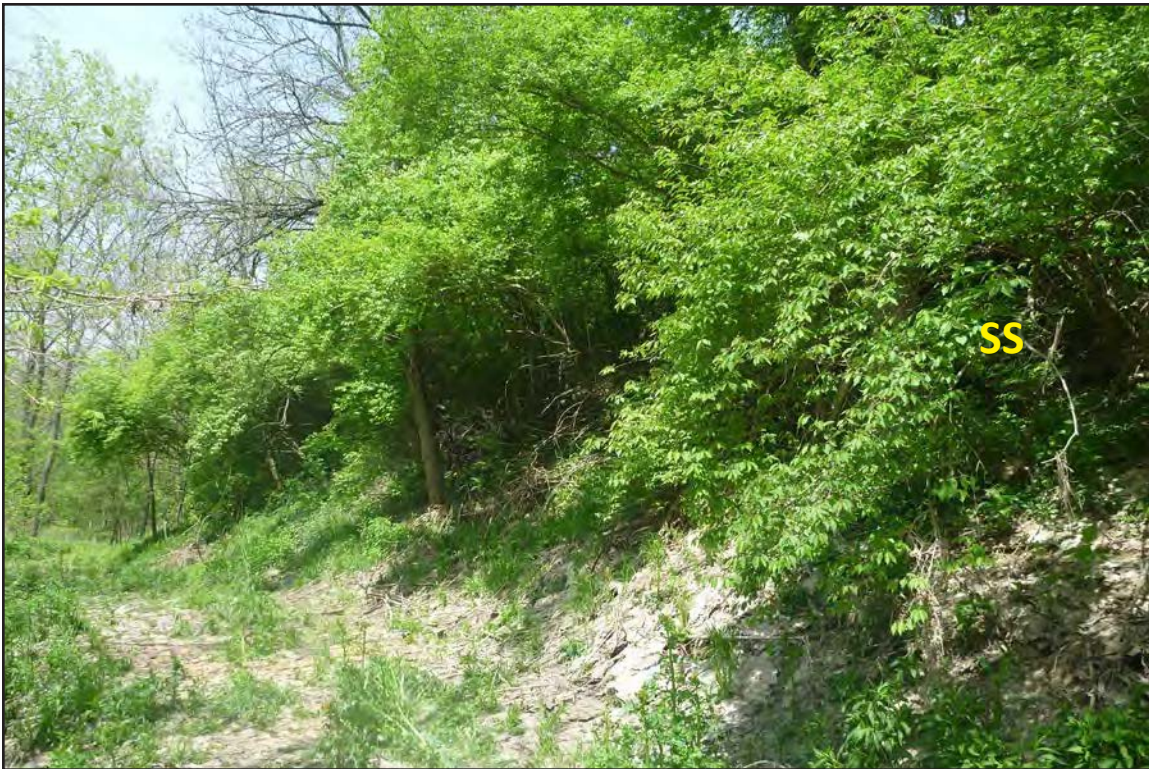
Photo 33: Combined sewer outflow (CSO) pollution; Scrub/Shrub (SS), facing north.

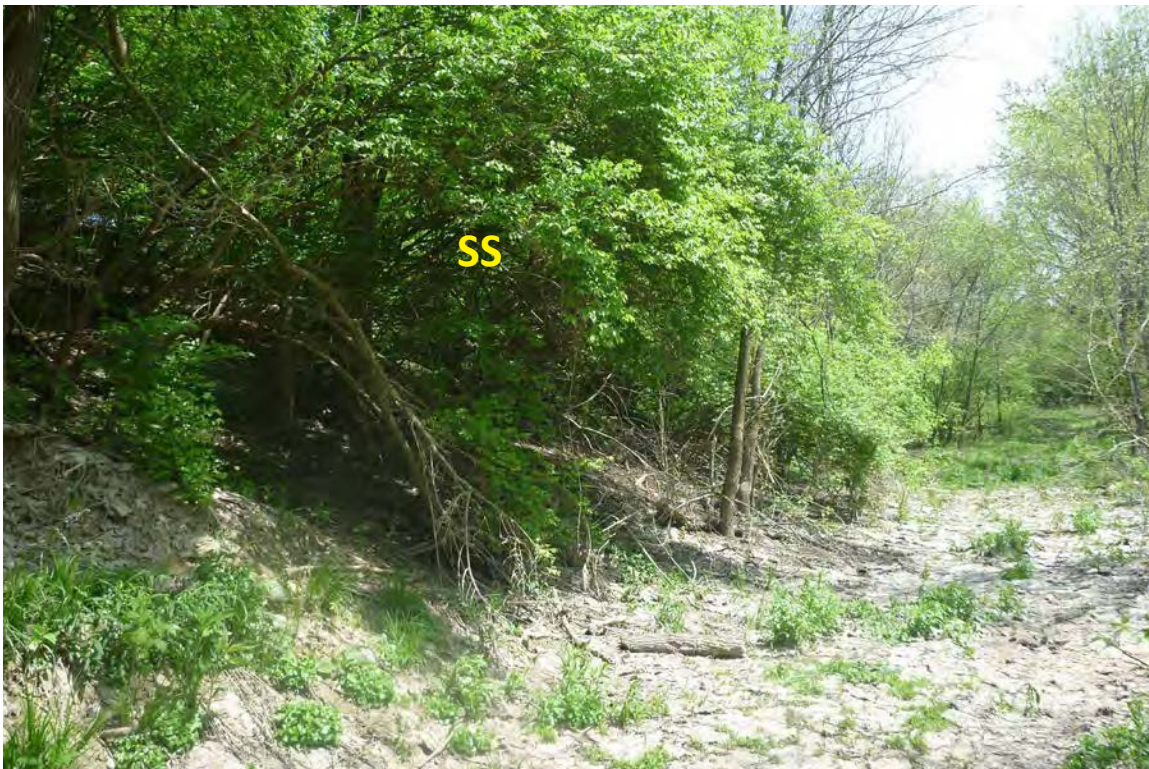
Photo 34: Combined sewer outflow (CSO) pollution; Scrub/Shrub (SS), facing east.
