Phase I Feasibility Analysis Report

Eastern Corridor Multi-Modal Projects
Segment II/III - Priority Part B Work
Little Miami River Geomorphic
Assessment

February 17, 2009

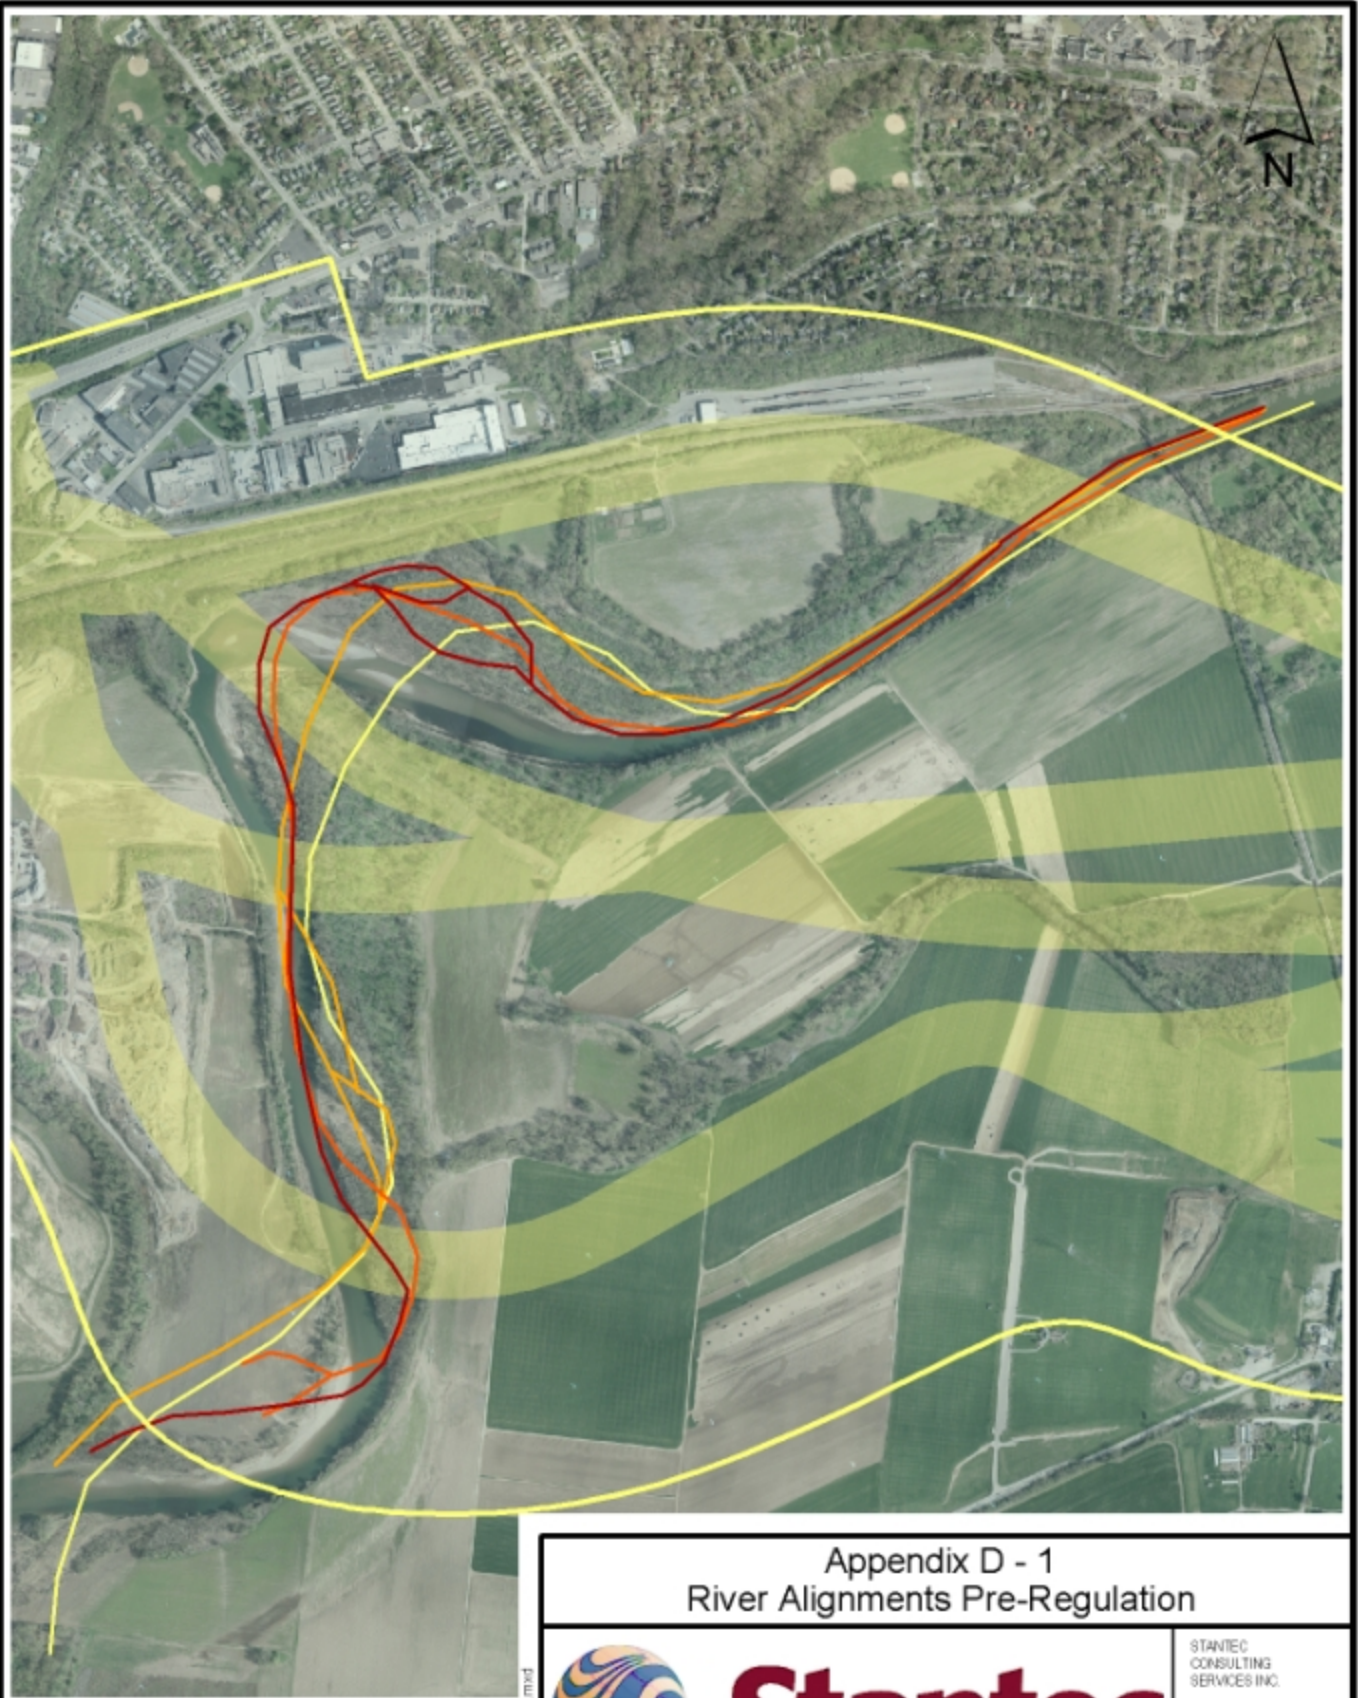
Appendix D - 1 River Alignments Pre-Regulation

Significant pattern changes and depositional feature changes in Reach 2 are first observed in 1950. At this time, flow at the entrance to the bend began shifting south and widening the active channel. This created mid-channel bars near the confluence with the unnamed tributary and slough / distributary. By 1968 the island is nearly 1,500 feet in length with transverse, high-flow channels. The island continued to build with the majority of flow shifting to the southern channel in the 1970's. By 1981 the northern channel was abandoned and vegetated between the river and the slough / distributary. The point bar at the Horseshoe Bend has consistently been a prominent feature extending into the active channel and has progressively moved downstream. The progression may be viewed in Appendix D.
