Stream Stability Analysis Report

Eastern Corridor Multi-modal Projects Segment II/III - Priority Part B Work Little Miami River Geomorphic Assessment

December 18, 2009

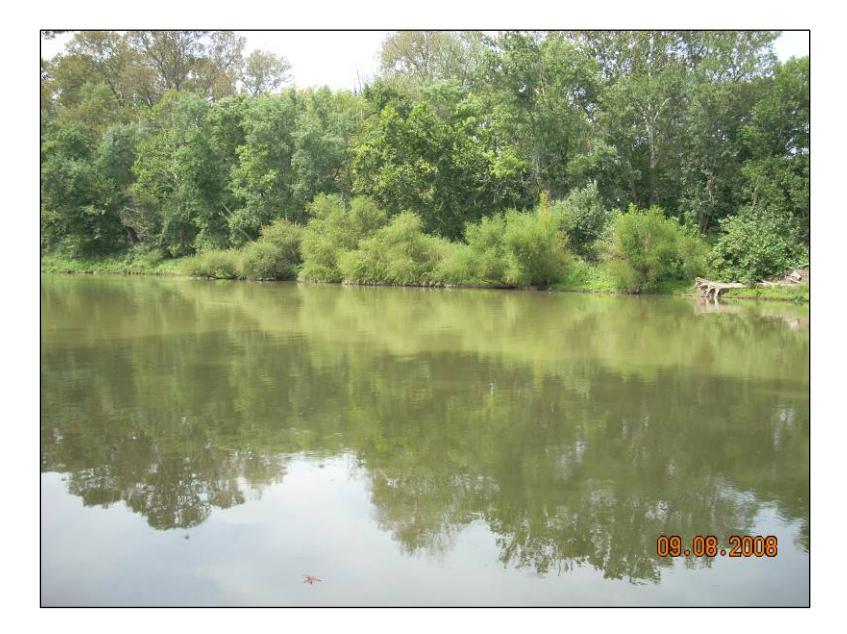
Figure 2. Typical Vegetation of Lower Riparian Zone in Reach 1

On the right bank, the width of the woody riparian vegetation is approximately 300 feet. Downstream of the railroad bridge, open grass fields with scattered trees extend 400 to 1,200 ft from the river bank before ending near a railroad yard and industrial land use area. A portion of the riparian zone has developed on depositional material, which is primarily located at a lower elevation, while the remainder of the wooded riparian vegetation is at the top of the bank. The depositional area and top of bank are separated by a slough/distributary, beginning approximately 1,100 ft downstream from the railroad bridge and reconnecting to the main channel at Horseshoe Bend. The wooded area on top of the bank has a similar composition of over- and understory as the left bank. The younger/lower riparian zone located on the depositional material extends the entire length of the slough/distributary. The younger/lower riparian zone has a well established population of mixed, deciduous trees (Figure 2) which are evident in historical aerial photographs dating back to 1938.

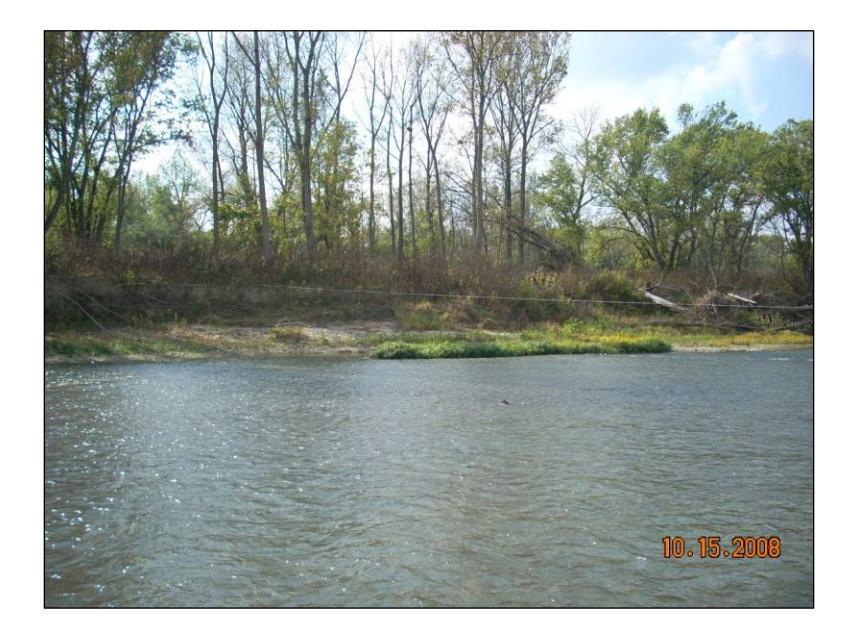
Figure 3. Typical Vegetation on Left Bank, Upstream of Horseshoe Bend

Reach 2 The woody riparian vegetation along the left bank of Reach 2 has a similar composition to that of Reach 1. This zone maintains a width of approximately 150 ft for another 600 ft downstream from the end of Reach 1. Beyond the 600 ft on the left bank of Reach 2, the riparian zone is approximately 500 ft wide. The canopy trees have been selectively cleared and the understory thinned (Figure 3). Remaining understory vegetation is primarily giant ragweed with a low percentage of grass cover. The giant ragweed has a shallow rooting depth as well as low root density. The composition of this zone continues downstream to the confluence of the Little Miami River and Clear Creek in Reach 4, but it varies in width. A number of large cottonwood trees along the left bank of Reach 2 have recently fallen into the river due to bank erosion.

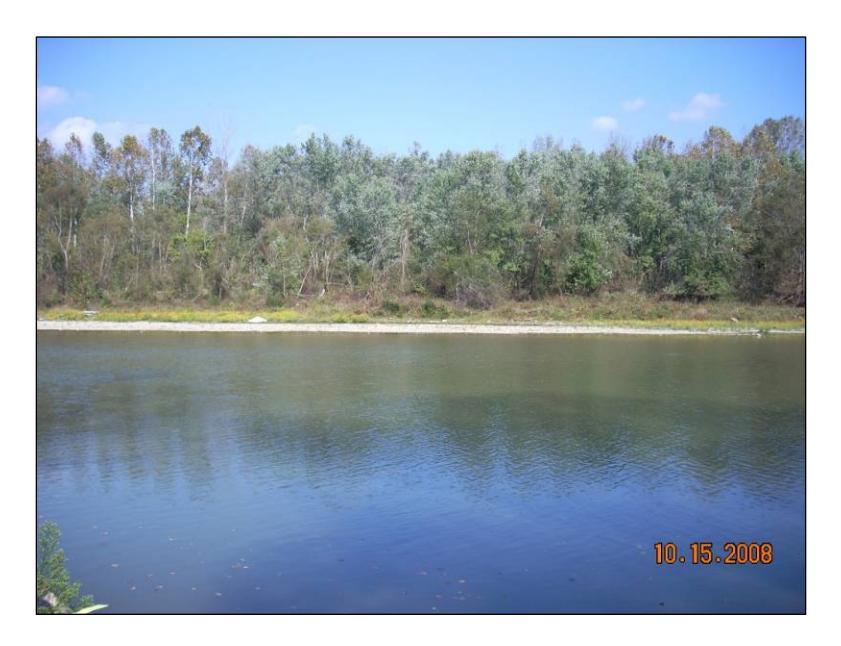
Figure 4. Typical Island Vegetation in Reach 2

The right bank of Reach 2, upstream of the slough/distributary confluence with the river, is similar in density and composition to the lower riparian zone located on the depositional area of Reach 1 (Figure 4). It ranges in width from approximately 500 to 900 ft. The right bank of Reach 2 is a depositional zone at the inside of a meander bend (i.e. point bar). The vegetation community is a good indicator of this fluvial process as the woody vegetation community close to the river bank consists of younger willow species.

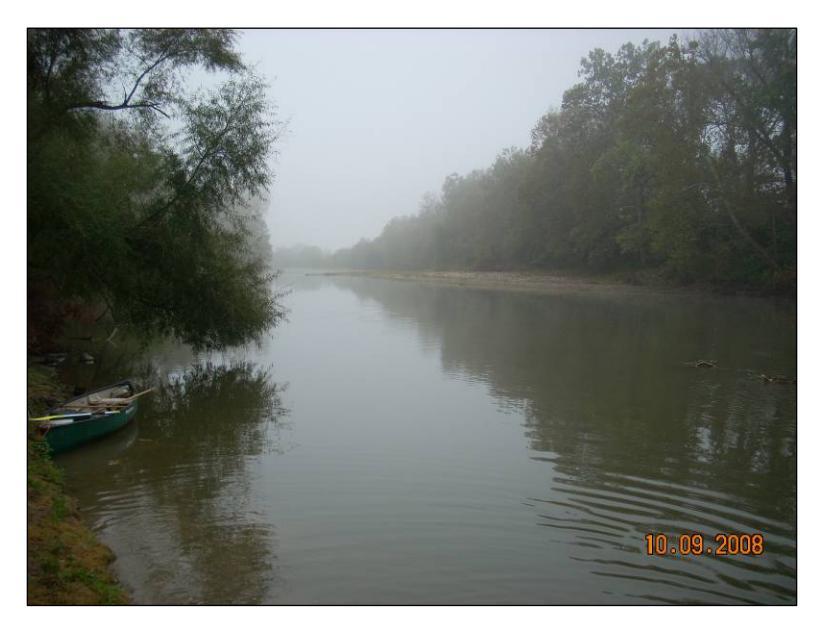
Figure 5. Riparian Vegetation through Reach 3

Reach 3 The left bank woody riparian vegetation is dominated by mature willows close to the river and mature silver maple, eastern cottonwood, and sycamores along adjacent terraces (Figure 5). The average width is over 500 ft, bordered by thousands of feet of various grass and sod fields.

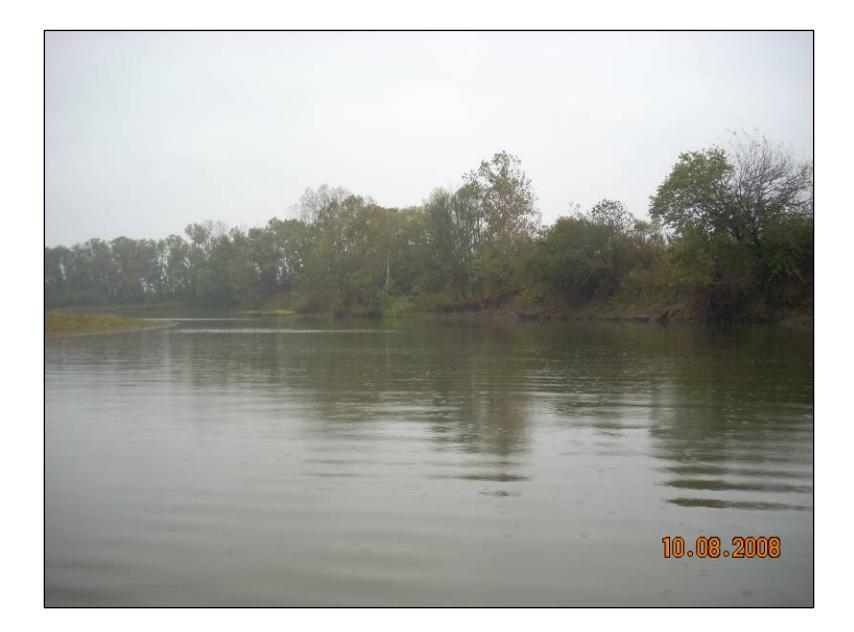
Figure 6. Thinning Riparian Vegetation on Left Bank of Reach 4

Reach 4 The left bank riparian zone narrows significantly (Figure 6), with the lower half having little to no woody vegetation in the riparian buffer. A short segment at the end of the reach has a 200 ft wide stand of trees atop the bank. Only a few trees are growing below the top of bank. Several large trees have fallen into the river due to bank erosion. Sycamores are common in this segment. Beyond the tree line, flat sod fields extend thousands of feet.

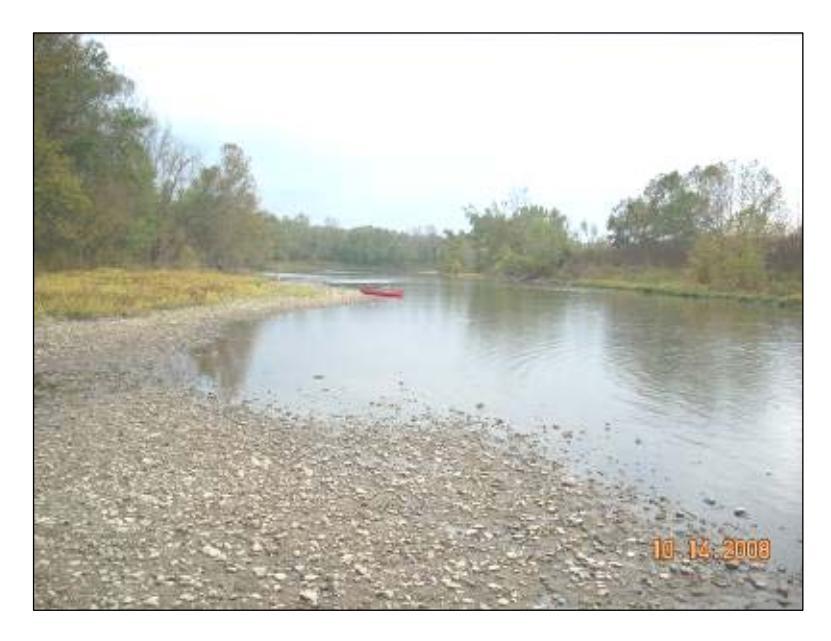
Figure 9. South/Downstream View from Gravel Bar in Reach 4

Reach 4 A submerged, transverse gravel bar connects the end of the large bar in Reach 3 to the head of the next side bar on the opposite bank in Reach 4. The thalweg switches from the left third of the channel to the right third at this transition. The side bar on the left bank (Figure 9) is predominantly composed of gravel, and it is adjacent to the island between the slough and Little Miami River. The slough receives inflows from Clear Creek and connects to the Little Miami River on the downstream end. This sidebar is low and is frequently submerged.

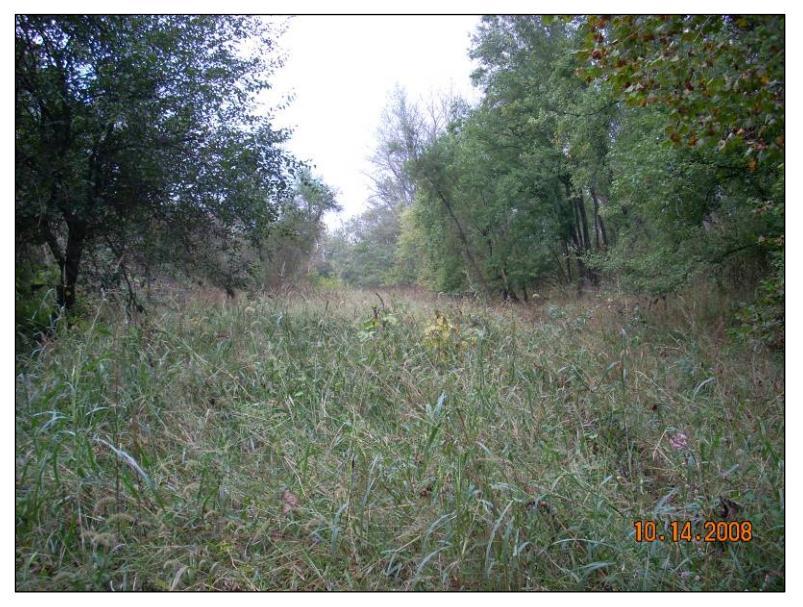
Figure 11. View North/Upstream toward Entrance to Clear Creek Slough

Historical aerial photographs show various other sloughs which have developed and faded through the study area in past years. The slough at the Clear Creek confluence, within Reach 4, appears to be a result of past channel migration westward. Historical aerial photography shows that this slough is now less frequently accessed by the Little Miami River and is presently filling with sediment and becoming more vegetated; field observations confirm this trend (Figure 11).

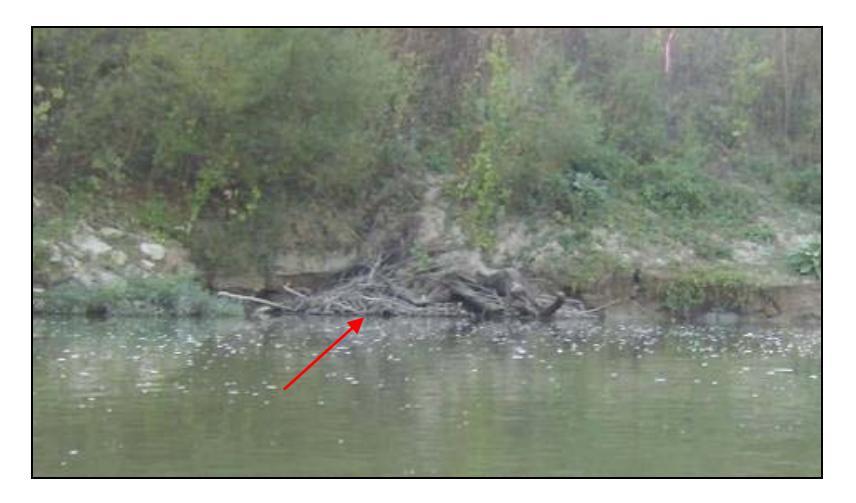
b. Beaver activity

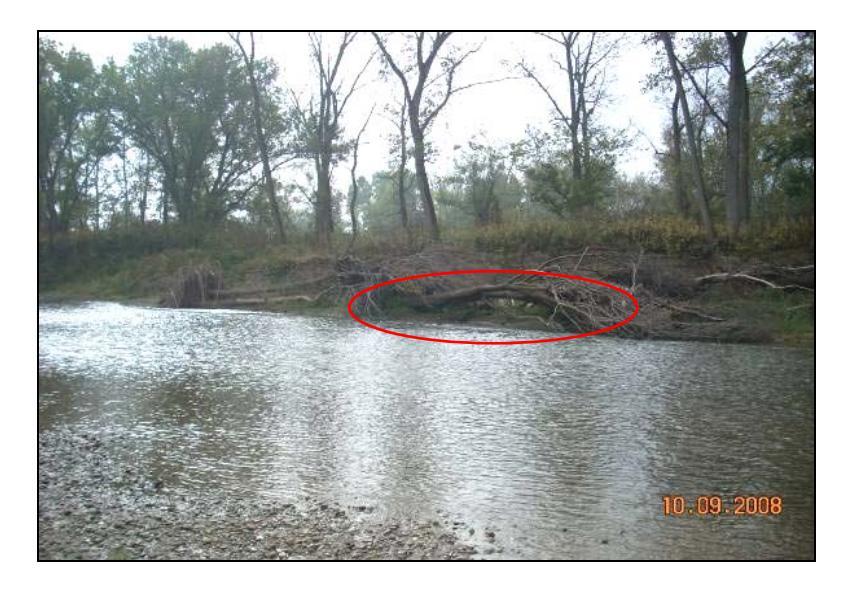
channel. In each reach, large, fallen trees are seen frequently along the banks (Figure 12c) and infrequently within the middle one-third of the channel. In general, these fallen trees often cause scour or some bank erosion, but have not had significant impacts to flow patterns. Two tree trunks extending from the outer bank in the Horseshoe Bend (Figure 12d) are affecting flow, as evidenced by local scour of the bank toe.

c. Fallen Trees along Left Bank in Reach 2

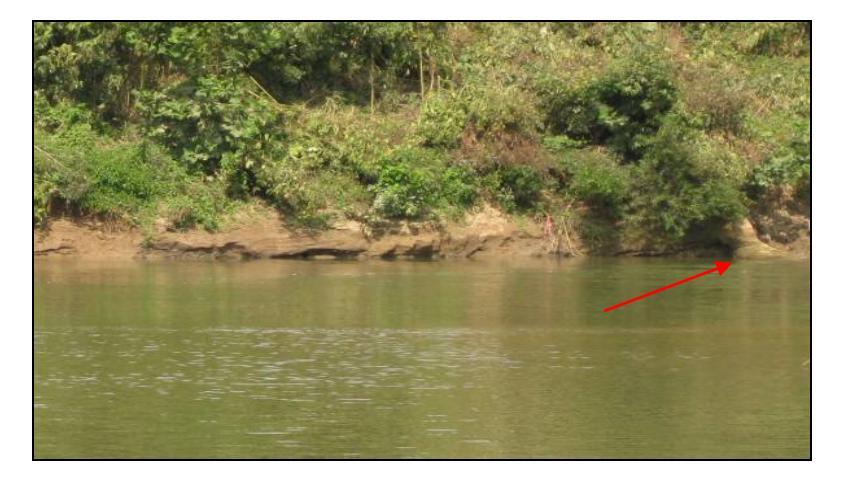
d. Buried Trees extending from Bank

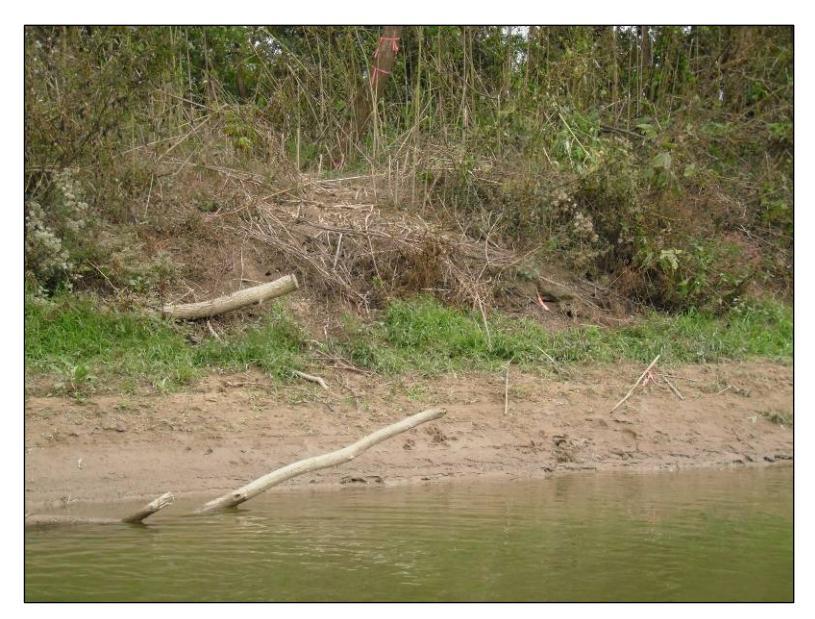
Figure 14. High Sand Content in Left Banks of Reach 3

Reach 3 The banks in Reach 3 have a high percentage of sand (Figure 14) as well as material stratification. Bank height, rooting depth and rooting density vary throughout the reach. The thalweg of the river is located on the left one-third of the channel, causing the near bank stress on the left banks to be moderate to high. SB 5 had several mature trees nearby with greater than 50 percent of their rootwads hanging over the bank, indicating past erosion along this reach. Overall, this reach exhibits high erosion potential.

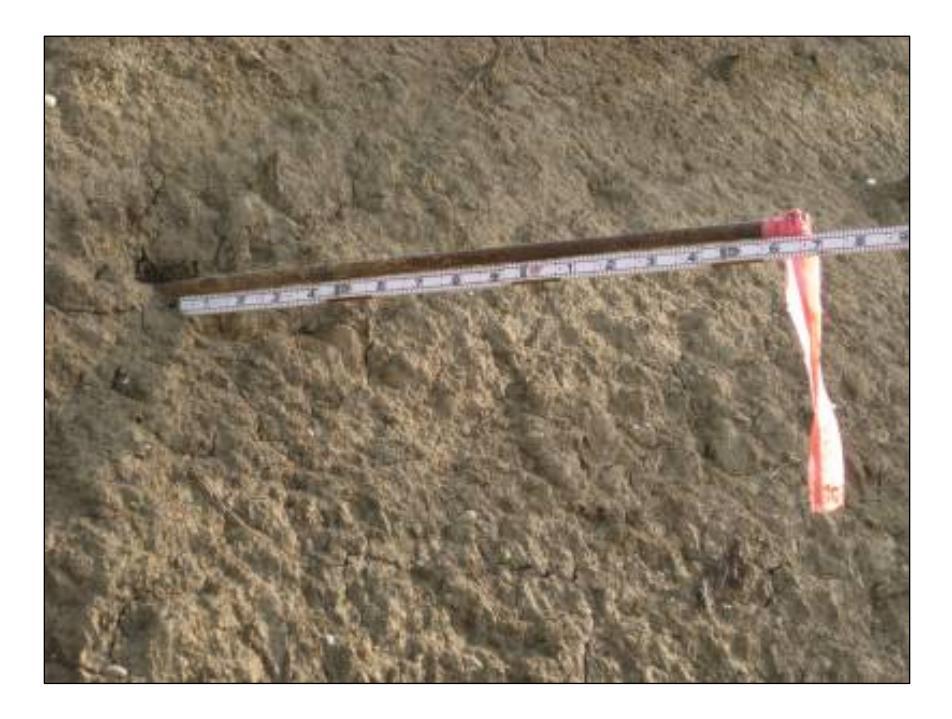
Figure 18. Study Bank 2 Upper Bankpin Exposure

Reach 4 Reach 4 had the highest erosion rates with a minimum average lateral erosion rate of 0.5 ft/yr (SB 4) and a maximum of 2.26 ft/yr (SB 1). SBs 1, 2 and 3 each had a bank pin exposed greater than 1.5 feet (Figure 18), with the upper pin at SB 1 exposed 3.2 feet.

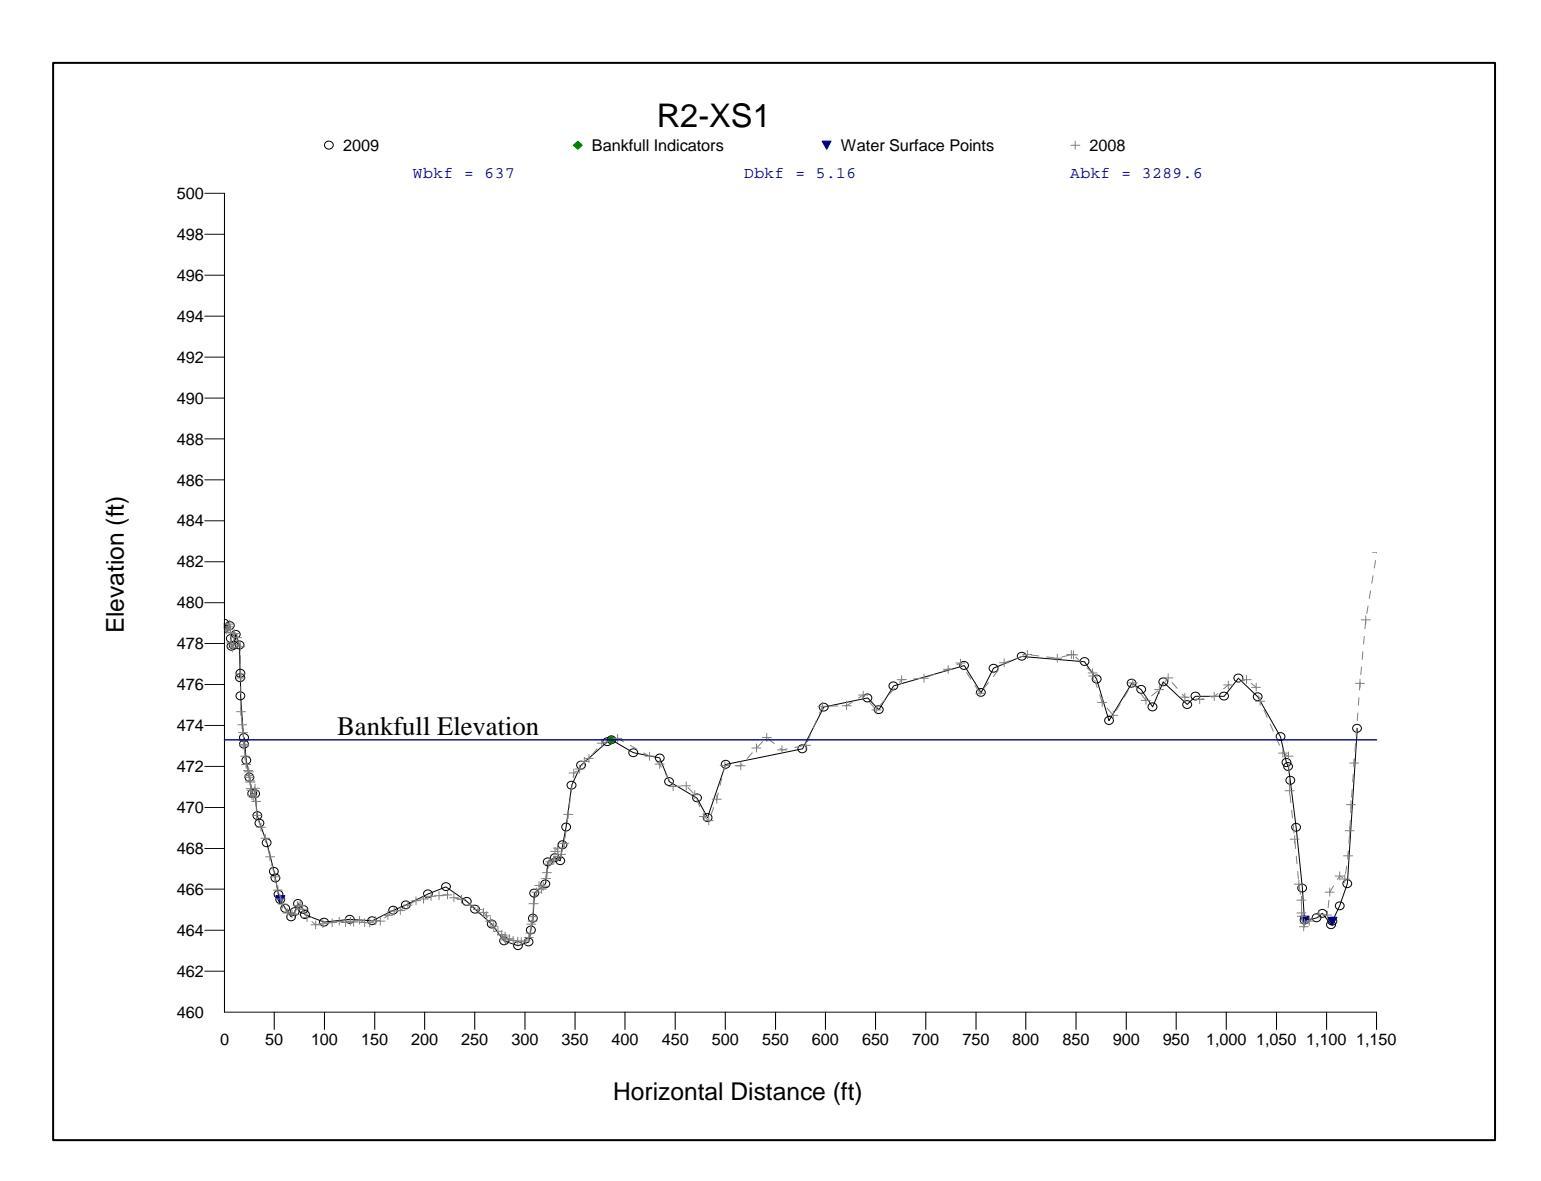
River Name:	Little Miami River
Reach Name:	RM 4.5 to RM 7.0
Cross Section:	R2-XS1
Survey Dates:	10/15/2008 & 9/10/2009

Reach 2 The riffle section (R2 XS1) in this reach has a very high width to depth (W/D) This high W/D ratio caused a reduction in stream power, hence causing ratio of 124. sediment to fall out in this reach by a process known as deposition. The deposition and instability was apparent by 1) an observed gravel island and 2) active deposition in the middle of the bankfull channel before Horseshoe Bend. The low flow channel and thalweg in that specific section of the study reach are in a state of flux. A submerged transverse bar connects the head of the island to a gravel bar feature along the right bank, visible only during lower flows. A long, wide, shallow riffle is present along the left low-flow path. The right side loops around the island and is near half the width of the left and slightly deeper than the left low-flow path. As the right alignment loops around the island, it abruptly bends left along a large side bar to rejoin the left alignment before continuing along the left side heading into the bend. The island is not discernible in 2004 aerial photography, although depositional processes are evident in this area. In 1990, one channel followed along the existing right alignment in a northwest direction. The channel appears to have widened and now flows in a more westerly direction with visible deposition in the island area in 2004. By 2005, the island and dual low flow alignments had become established with the majority of flow remaining in the left alignment. Flow to the right alignment has increased each year since and has pushed the alignment further downstream.

Several changes occurred in Reach 2. Cross section R2 XS1, located in the Reach 2 riffle and through the head of the gravel island above Horseshoe Bend, indicates slight deposition of the left alignment and slight scour of the right alignment. Scour chains reevaluated in Phase II indicated the same results. Scour chain results may be viewed in Appendix F. Further analysis of the reach profile revealed no overall aggradation or degradation of the river profile at the riffle. Pebble counts collected through the section were very similar between study phases, with only a very slight shift to coarser material in 2009. During the study period, significant depositional processes have been observed at the downstream end of the riffle/island complex. Additional mid-channel bar features were created in the northern/downstream path of the river. These features formed as a result of the river eroding away and cutting through the right bank and lower end of the existing gravel island and then depositing the material downstream (Figure 16). Depositional features/patterns were observed during the study period and documented on Worksheet 5-10 in Appendix F. The new channel configuration directs flow towards the left bank and inside of the point bar at Horseshoe Bend. This flow pattern increases local near-bank stress and susceptibility to erosion, which corresponds with field observations of erosion along the inside of Horseshoe Bend and data from cross section R2_XS2.

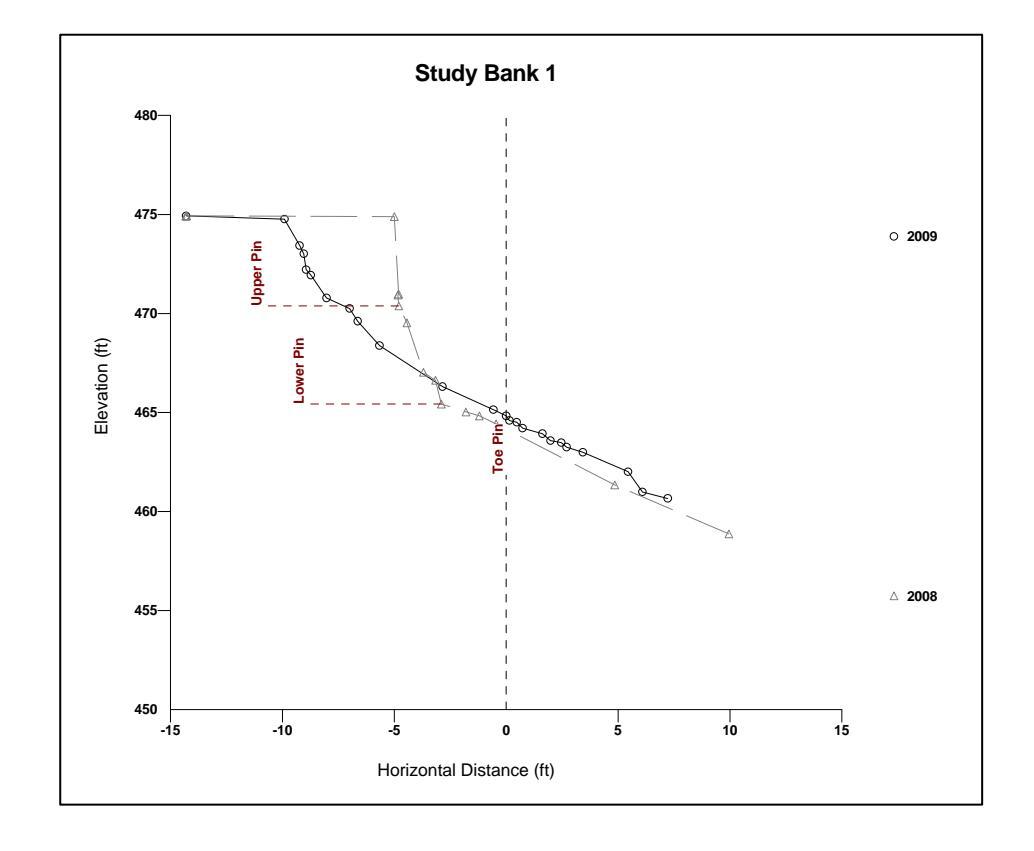
Stream:	Little Mia	le Miami River Location: RM 4.5 - 7.0							
Station:	Study Ba	ink 1	Observers: SDP, TJT						
Date:	12/10/08	Str	ream Type:	C 4c-	Valley Type	e: VIII			
				Study	/ Bank Heig	ht / Bankfull He	eight(C)	BEHI Score (Fig. 5-19)	
		Study Bank Height (ff) =	13.9 (A)	Bankfull Height (ft) =	8.06 (B	(A)/(B) =	1.7246 (C)	6.57	
		noight (ii) -	,	R	oot Depth /	Study Bank H	eight (E)		
		Root Depth (ft) =	5 (D)	Study Bank Height (ft) =	13.9 (A	(D)/(A) =	0.35971 (E)	5.3	
					Weig	ghted Root Dei	nsity(G)		
				Root Density as % =	1 (F	(F)×(E) =	0.35971 (G)	10	
						Bank A	Angle (H)		
						Bank Angle as Degrees =	79.3 (H)	5.7	
						Surface Prote	ection (I)		
						Surface Protection as % =	5 (1)	10	
	De des els "	Bank Materi	al Adjustmen	it:			wk Meterial		
	Boulders (Cobble (S)	Overall Very Low (Overall Low BE ubtract 10 points	HI) ∺if uniform medi	ium to large cobl	>		Adjustment	1	
	Gravel or	Composite Ma of bank material	atrix (Add 5–10 that is compose) points dependir ed of sand)	ng on	Stratification A Add 5–10 points, de	Adjustment epending on

Sand (Add 10 points) position of unstable layers in relation to bankfull stage							2	
Verv Low	Low	Moderate	High	Verv Hiah	Extreme	Adiect	tive Rating	High	
							and		
5 – 9.5	10 – 19.5	20 – 29.5	30 – 39.5	40 – 45	<u>46 – 50</u>	Tot	tal Score	40.7

(5)	d _{nb} (ft)	d _{bkf} (ft)	d _{bkf}	(NBS)				
≣		14.6	8.3	1.76	Moderate				
eve				Near-Bank			Bankfull		
Ľ	(6)	Near-Bank Max Depth	Near-Bank	Stress T _{ab} (Mean Denth	Average	Stress The (Ratio τ _{nb} /	Near-Bank

(0)	d _{nb} (ft)	Slope S _{nb}	lb/ft ²)	d _{bkf} (ft)	Slope S	lb/ft ²)	τ _{bkf}	(NBS)
>				Near-Bank					
/el l	(7)	Velocity Grad	dient (ft/sec	Stress					
Lev		/ 1	()						
			_]				
Noar-F	Sank Str		nverting va	alues to a l	Near-Bank	Stress (NE	BS) rating		
near-L	rating	S (NDO)	(1)	(2)	(3)	(4)	(5)	(6)	(7)
	Very Lo	w	N / A	> 3.00	< 0.20	< 0.40	< 1.00	< 0.80	< 0.50
	Low		N/A	2.21 – 3.00	0.20 - 0.40	0.41 – 0.60	1.00 – 1.50	0.80 – 1.05	0.50 – 1.00
	Modera	ate	N / A	2.01 – 2.20	0.41 – 0.60	0.61 – 0.80	1.51 – 1.80	1.06 – 1.14	1.01 – 1.60
	High	1	See	1.81 – 2.00	0.61 – 0.80	0.81 – 1.00	1.81 – 2.50	1.15 – 1.19	1.61 – 2.00
	Very Hi	gh	(1)	1.50 – 1.80	0.81 – 1.00	1.01 – 1.20	2.51 – 3.00	1.20 - 1.60	2.01 – 2.40
	Extren	ne	ADOVE	< 1.50	> 1.00	> 1.20	> 3.00	> 1.60	> 2.40
				Overall N	ear-Bank S	Stress (NB	S) rating	Mod	erate

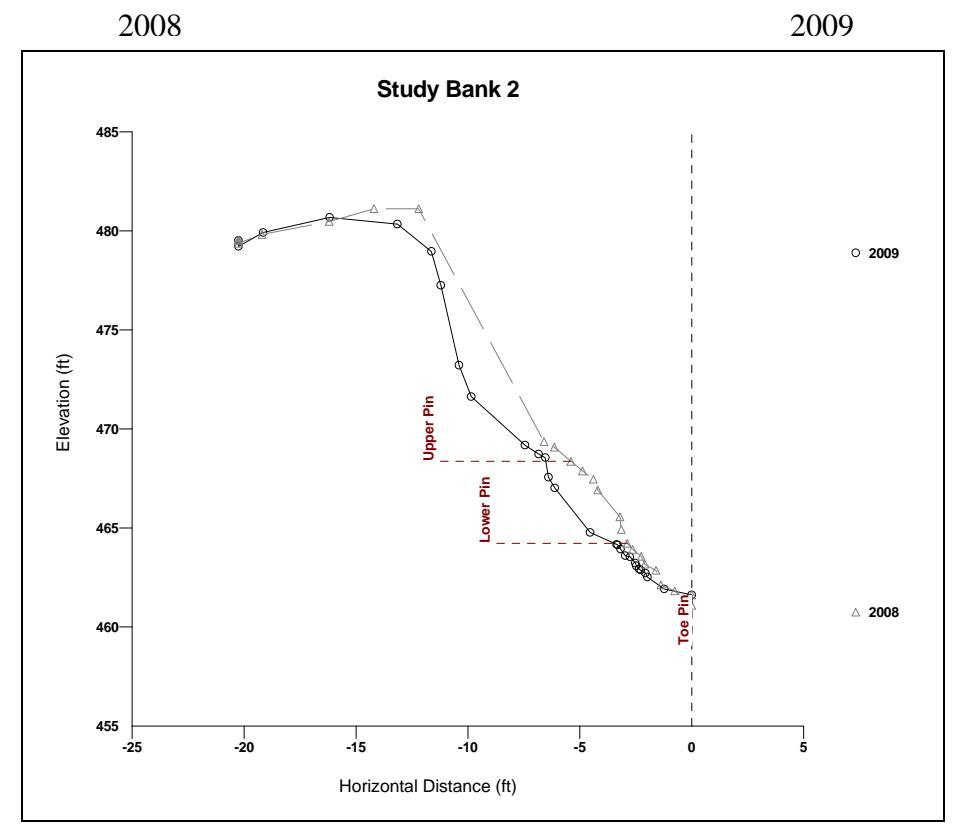
Stream:	Little Mia	iami River Location: RM 4.5 - 7.0							
Station:	Study Ba	ink 2	Observers: SDP, TJT						
Date:	12/10/08	Sti	ream Type:	C 4c-	Valley Type	e: VIII			
								BEHI Score	
				Study	/ Bank Heig	ht / Bankfull He	eight (C)	(Fig. 5-19)	
		Study	19.48	Bankfull	8.08		2.41089	0.44	
		Bank	(Δ)	Height	(P	(A)/(B) =	(C)	8.44	
		Height (ft) =	(~)	(n) =	 2oot Denth /	<u>Study Bank H</u>	eight (E)		
		Root		Study					
		Depth	0.5	Bank	19.48	(D)/(A)=	0.02567	10	
		(ft) =	(D)	Height (ft) =	(A		(E)		
					Weig	ghted Root De	nsity(G)		
				Root	10		0.25667	10	
				Density	/F	$(F) \times (E) =$	(G)	10	
				as /0 =	,	Bank A	Angle (H)		
						Bank			
						Angle	61.5	4.05	
						as Degrees =	(H)		
						Surface Prote	ection (I)		
						Surface	1	10	
						as % -	(1)	10	
		Bank Materi	al Adjustmen	t:		us / u	,		
	Bedrock (Overall Very Lov	v BEHI)	<u> </u>	>	Ba	ank Material	_	
	Boulders	(Overall Low BE	HI) 				Adjustment	5

Gravel or	Composite M	atrix (Add 5-10	um to large cool		Stratification	Adjustment		
	percentage	of bank material	that is compose	ed of sand)	ig on	Add 5–10 points, de	epending on		
	Sand (Add	10 points)				position of unstable	layers in	4	
	Silt/Clay (r	no adjustment)					Jugo		
VeryLow		Moderato	High	Vory High	Extromo		ive Rating	Extreme	
	LOW	Moderale	riigii				and	LAUGING	
5 – 9.5	10 – 19.5	20 - 29.5	30 - 39.5	40 – 45	46 – 50	To	tal Score	51.5

-				Overall N	ear-Bank S	Stress (NB	S) rating	Lo	w

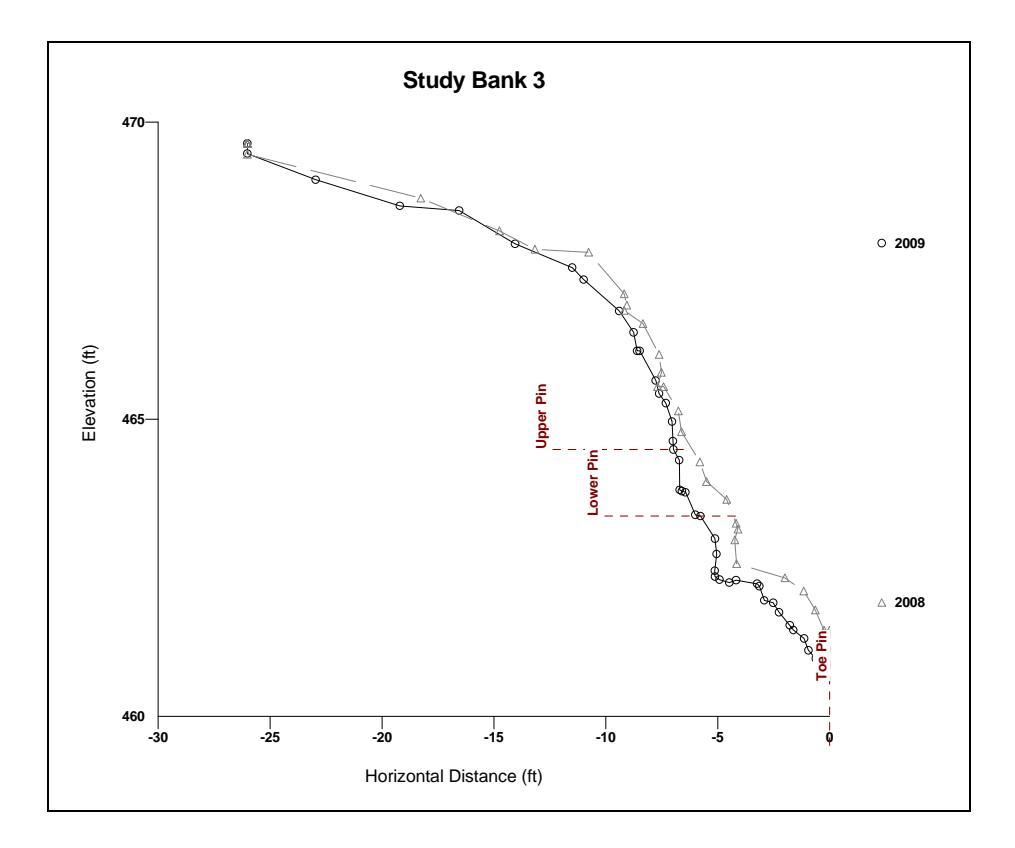
Stream:	Little Mia	mi River			Locati	on: RM 4.5 - 1	7.0	
Station:	Study Ba	nk 3			Observe	ers: SDP, TJ1	F	
Date:	12/10/08	Sti	ream Type:	C 4c-	Valley Ty	pe: VIII

•		BEHI Score
				Study	/ Bank Hei	ight / Bankfu	Ill Height (C)	(Fig. 5-19)
		Study Bank	7.96	Bankfull	8.85		B) _ 0.89944	0.1
		Height (ft) =	(A)	(ft) =		(B)	(C)	0.1
				R	oot Depth	/ Study Bar	nk Height (E)	
		Root	1	Study	7 96		0 12563	
		Depth	י . (ח)	Bank	1.00	(D)/($\mathbf{A}) = \mathbf{(F)}$	8.11

(4)	Pool Slope	Riffle Slope	S _{ef}	Stress (NBS)							
		- p	- 111	- 111	(1						
		Near-Bank			Near-Bank	1						
	(5)	Max Depth	Mean Depth	Ratio d _{nb} /	Stress							
_		d _{nb} (ft)	d _{bkf} (ft)	d _{bkf}	(NBS)							
el II	<u> </u>	12.27	0.3	I.40 Near-Bank	LOW	ļ	Bankfull					
Lev		Near-Bank		Shear			Shear		Near-Bank

(6)	Max Depth	Near-Bank	Stress τ_{nb} (Mean Depth	Average	Stress τ_{bkf} (Ratio τ_{nb} /	Stress			
		d _{nb} (ft)	Slope S _{nb}	lb/ft ²)	d _{bkf} (ft)	Slope S	lb/ft ²)	τ _{bkf}	(NBS)			
≥ 1		Velocity Grad	dient (ft / sec	Near-Bank Stress								
eve	(7)	/ f	t)	(NBS)								
		Со	nverting va	alues to a l	Near-Bank	Stress (NE	3S) rating					
Near-	Bank Str	ess (NBS)			Me	ethod numb	per C					
ratings (1) (2)				(3)	(4)	(5)	(6)	(7)				
	Very Lo	W	N / A	> 3.00	< 0.20	< 0.40	< 1.00 < 0.80 < 0.50					
	LOW	ato	N/A	2.21 - 3.00	0.20 - 0.40	0.41 - 0.60	1.00 - 1.50	0.80 - 1.05	0.50 - 1.00			
	High	415	See	1.81 - 2.20	0.61 - 0.80	0.81 - 1.00	1.81 - 2.50	1.15 - 1.14	1.61 - 2.00			
	Very Hi	gh	(1)	1.50 - 1.80	0.81 - 1.00	1.01 - 1.20	2.51 - 3.00	1.20 - 1.60	2.01 - 2.40			
	Extren	ne	Above	< 1.50	> 1.00	> 1.20	> 3.00	> 1.60	> 2.40			
				Overall N	ear-Bank S	Stress (NB	S) rating	Lo	w

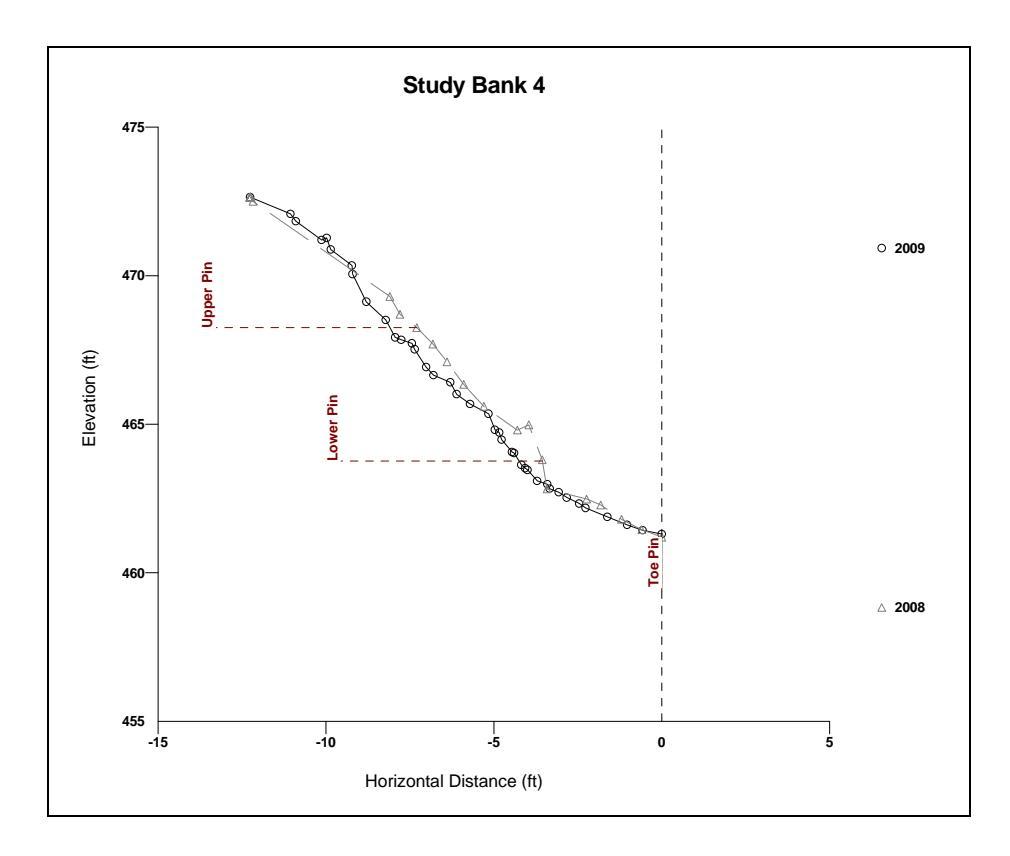
Stream:	Little Mia	mi River			Locatio	n: RM 4.5 - 7. 0		
Station:	Study Ba	ink 4			Observer	s: SDP, TJT		
Date:	12/10/08	Str	eam Type:	C 4c-	Valley Typ	e: VIII		
				Study	/ Bank Heid	aht / Bankfull He	eiaht (C)	BEHI Score (Fig. 5-19)
		Study Bank Height (ft) =	11.5 (A)	Bankfull Height (ft) =	9.4	(A)/(B)=	1.2234 (C)	4.13
				R	oot Depth	/ Study Bank He	eight (E)	
		Root Depth (ft) =	8.5 (D)	Study Bank Height (ft) =	11.5 (/	(D)/(A)=	0.7391 (E)	2.73
					Wei	ighted Root Dei	nsity(G)	
				Root Density as % =	10% ((F) x (E) =	7.3913 (G)	8.73
						Bank A	Angle (H)	
						Bank Angle as Degrees =	48 (H)	3.32
						Surface Prote	ection (I)	
						Surface Protection as % =	30% (1)	5.9
	Dedreek (Bank Materi	al Adjustmen	t:			nk Motorial	
	Bedrock (Boulders (Cobble (S)	Overall Very Low (Overall Low BE ubtract 10 points	/ BEHI) HI) . if uniform medi	um to large cob	>		Adjustment	0
	Gravel or	Composite Ma	atrix (Add 5–10) points dependir	ng on	Stratification A	Adjustment

Sand (Add Silt/Clay (r	10 points) no adjustment)				position of unstable relation to bankfull s	layers in stage	6
Very Low	Low	Moderate	High	Very High	Extreme	Adject	ive Rating	High

-		\geq			and	<u> </u>
5 – 9.5	10 – 19.5	20 – 29.5	30 – 39.5	40 – 45	46 – 50	Tot	tal Score	30.8

(6)	Max Depth	Near-Bank	Stress τ_{nb} (Mean Depth	Average	Stress τ_{bkf} (Ratio τ_{nb} /	Stress			
		d _{nb} (ft)	Slope S _{nb}	lb/ft ²)	d _{bkf} (ft)	Slope S	lb/ft ²)	τ_{bkf}	(NBS)			
2		Velocity Grad	dient (ft / sec	Near-Bank Stress								
eve	(7)	/ f	t)	(NBS)								
Ľ												
		Со	nvertina v	alues to a l	Near-Bank	Stress (NE	3S) rating					
Near-	Bank Str	ess (NBS)	j		M	ethod numb	ber					
	rating	S	(1)	(2)	(3)	(4)	(5)	(6)	(7)			
	Very Lo	ow	N / A	> 3.00	< 0.20	< 0.40	0.40 < 1.00 < 0.80 < 0.50					
	Low	-1-	N/A	2.21 - 3.00	0.20 - 0.40	0.41 - 0.60	1.00 - 1.50	0.80 - 1.05	0.50 - 1.00			
	Wodera	ate	N / A	2.01 - 2.20	0.41 - 0.60	0.61 - 0.80	1.51 - 1.80	1.06 - 1.14	1.01 - 1.60			
	Verv Hi	iah	(1)	1.81 - 2.00 1.50 - 1.80	0.81 - 1.00	0.81 - 1.00 1.01 - 1.20	1.81 - 2.50 2.51 - 3.00	1.15 - 1.19	2.01 - 2.00			
	Extren	ne	Above	< 1.50	> 1.00	> 1.20	> 3.00	> 1.60	> 2.40			
l					oar-Bank (Strose (NP	S) rating	- 1.00	> 2.TV

Overall N		Suess (INB	Sjrating	LC	V V

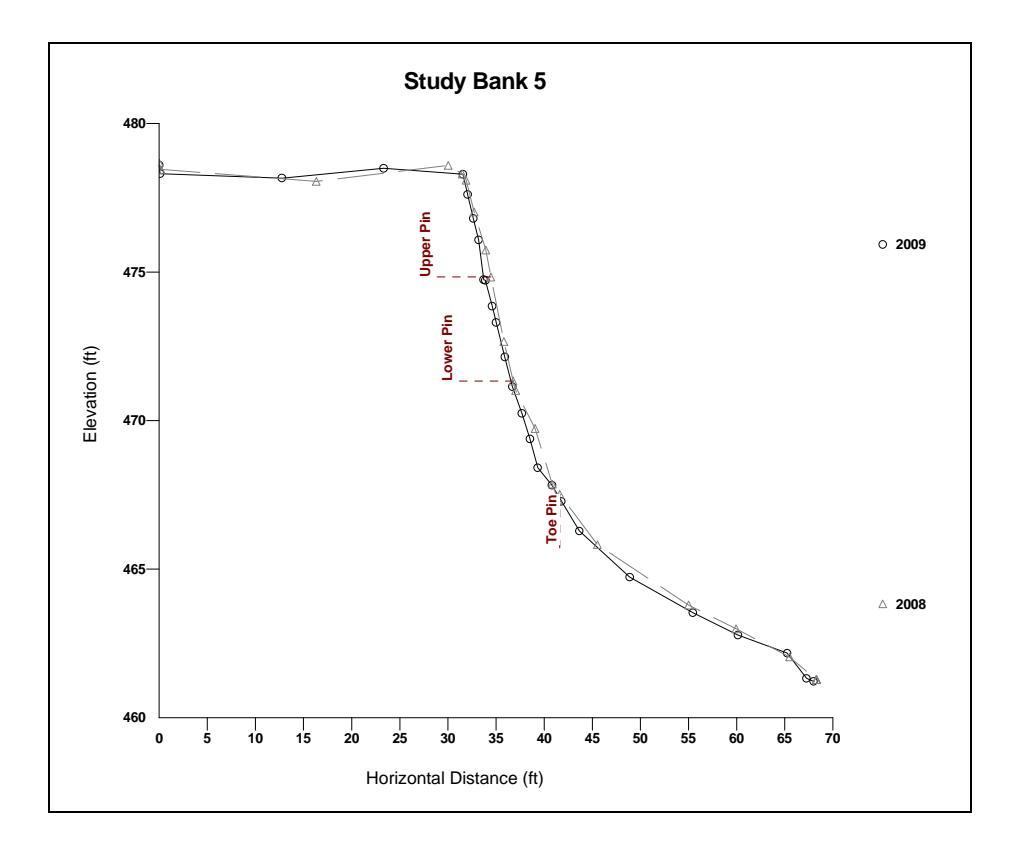
Stream:	Little Mia	imi River			Locatio	on: RM 4.5 - 7.0		
Station:	Study Ba	ink 5			Observe	rs: SDP, TJT		
Date:	12/10/08	St	ream Type:	C 4c-	Valley Typ	be: VIII		
		_		Study	/ Bank Hei	ght / Bankfull He	eight(C)	BEHI Score (Fig. 5-19)
		Study Bank Height (ft) –	10.78 (A)	Bankfull Height (ft) =	4.03	(A)/(B) =	2.6749 (C)	8.81
		neight (ii) –		R	Root Depth	/ Study Bank H	eight (E)	
		Root Depth (ft) =	9.28 (D)	Study Bank Height (ft) =	10.78	(D)/(A) =	0.8609 (E)	2.15
					We	ighted Root De	nsity(G)	
				Root Density as % =	10	(F) × (E) =	8.6085 (G)	8.6
						Bank A	Angle (H)	
						Bank Angle as Degrees =	43 (H)	3.07
						Surface Prote	ection (I)	
						Surface Protection as % =	20 (1)	7.22
	Dedreek (Bank Materi	al Adjustmen	t:			wk Motorial	
	Bedrock (Boulders Cobble (S	Overall Very Lov (Overall Low BE ubtract 10 points	v BEHI) HI) s if uniform medi	um to large cobl	>		Adjustment	2
	Gravel or	Composite Ma	atrix (Add 5–10) points dependi	ng on	Stratification A	Adjustment

percentage Sand (Add Silt/Clay (r	of bank material 10 points) no adjustment)	that is compose	ed of sand)		Add 5–10 points, de position of unstable relation to bankfull s	epending on layers in stage	5
Verv Low	Low	Moderate	High	Verv Hiah	Extreme	► Adiect	ive Rating	High
	1						and	
5 – 9.5	10 – 19.5	20 – 29.5	30 - 39.5	40 – 45	46 – 50	Tot	tal Score	36.9

(5)	d _{nb} (ft)	d _{bkf} (ft)	d _{bkf}	(NBS)							
≣		14.08	8.3	1.7	Moderate							
eve				Near-Bank			Bankfull					
Ľ	(6)	Near-Bank Max Depth	Near-Bank	Stress τ _{nb} (Mean Denth	Average	Stress τ _{bkf} (Ratio τ _{nb} /	Near-Bank

(0)	d _{nb} (ft)	Slope S _{nb}	lb/ft ²)	d _{bkf} (ft)	Slope S	lb/ft ²)	τ_{bkf}	(NBS)			
>				Near-Bank								
vel	(7)	Velocity Grad	dient (ft/sec	Stress								
Le		/ 1	()									
						Otar						
Near-F	Bank Str		nverting va	alues to a l	Near-Bank	Stress (NE	BS) rating					
incui i	rating	s (NDO)	(1)	(2)	(3)	(4)	(5)	(6)	(7)			
	Very Lo	ry Low N/A > 3.00 < 0.20 < 0.40 < 1.00 < 0.80 < 0.50				< 0.50						
	Low		N / A	2.21 – 3.00	0.20 - 0.40	0.41 – 0.60	- 0.60 1.00 - 1.50 0.80 - 1.05 0.50 - 1.					
	Modera	ate	N / A	2.01 – 2.20	0.41 – 0.60	0.61 – 0.80	1.51 – 1.80	1.06 - 1.14	1.01 – 1.60			
	High		See	1.81 – 2.00	0.61 – 0.80	0.81 – 1.00	1.81 – 2.50	1.15 – 1.19	1.61 – 2.00			
	Very Hi	gh	(1) Abovo	1.50 - 1.80	0.81 - 1.00	1.01 – 1.20	2.51 - 3.00	1.20 - 1.60	2.01 – 2.40			
	Extren	le	Above < 1.50					> 1.60	> 2.40			
				Overall N	ear-Bank S	Stress (NB	S) rating	Mod	erate

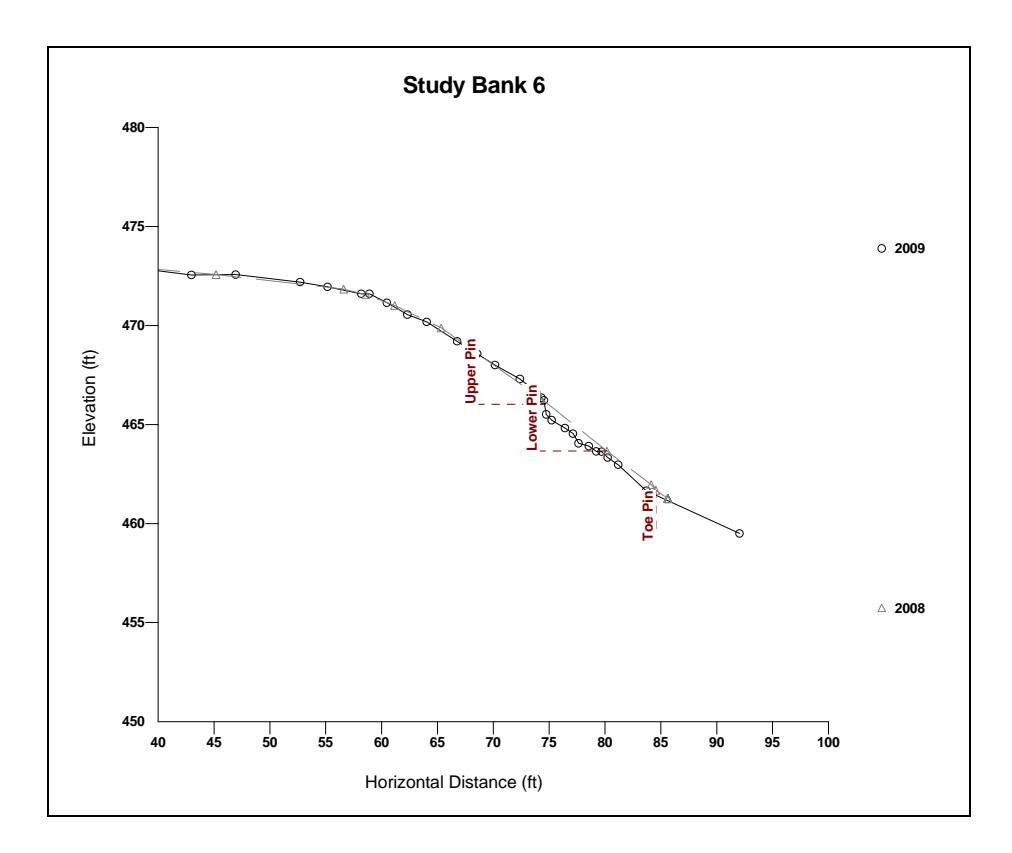
Stream:	Little Mia	ımi River			Locatio	on: RM 4.5 - 7.0		
Station:	Study Ba	ink 6			Observe	rs: SDP, TJT		
Date:	12/10/08	St	ream Type:	C 4c-	Valley Typ	e: VIII		
				Study	/ Bank Heig	ght / Bankfull He	eight(C)	BEHI Score (Fig. 5-19)
		Study Bank Height (ft) –	10.2 (A)	Bankfull Height	10.2	(A)/(B) =	1 (C)	1
		neight (it) =		R	loot Depth	/ Study Bank He	eight (E)	
		Root Depth (ft) =	0.5 (D)	Study Bank Height (ft) =	10.2	(D)/(A) =	0.04902 (E)	9
					We	ighted Root Der	nsity(G)	
				Root Density as % =	20	(F) x (E) =	0.98039 (G)	10
						Bank A	Angle (H)	
						Bank Angle as Degrees =	23 (H)	2.1
						Surface Prote	ection (I)	
						Surface Protection as % =	80 (1)	1.9
	Podrook (Bank Materi	al Adjustmen	it:			nk Motorial	
	Boulders Cobble (S	Overall Very Lov (Overall Low BE ubtract 10 points	י םבחו) HI) if uniform medi	ium to large cobl	>		Adjustment	10
	Gravel or	Composite Ma	atrix (Add 5–10) points dependi	ng on	Stratification A	Adjustment

percentage Sand (Add Silt/Clay (r	of bank material 10 points) no adjustment)	that is compose	ed of sand)		Add 5–10 points, de position of unstable relation to bankfull s	epending on layers in stage	0
Verv Low	Low	Moderate	High	Verv Hiah	Extreme	► Adiect	ive Rating	High
		1					and	
5 – 9.5	10 – 19.5	20 – 29.5	30 - 39.5	40 – 45	46 – 50	Tot	tal Score	34.0

(5)	d _{nb} (ft)	d _{bkf} (ft)	d _{bkf}	(NBS)	1			
		15.85	8.3	1.91	High				
eve		New Deale		Near-Bank Shear			Bankfull Shear		
	(6)	Max Depth	Near-Bank	Stress τ _{nb} (Mean Depth	Average	Stress τ _{bkf} (Ratio τ _{nb} /	Near-Bank
		d _{nb} (ft)	Slope S _{nb}	lb/ft ²)	d _{bkf} (ft)	Slope S	lb/ft ²)	τ_{bkf}	(NBS)
>				Near-Bank					
/el l	(7)	Velocity Grad	dient (ft/sec	Stress					
Lev		/ 1	τ)	(NBS)					
]				
		Co	nverting va	alues to a l	Near-Bank	Stress (NE	3S) rating		
Near-	Sank Str	ess (NBS)	(1)	(2)	(3)	ethod numb	oer (5)	(6)	(7)
	Verv L	ow	N/A	> 3.00	< 0.20	< 0.40	< 1.00	< 0.80	< 0.50
	Low		N / A	2.21 – 3.00	0.20 - 0.40	0.41 – 0.60) 1.00 - 1.50 0.80 - 1.05 0.50 - 1		
	Modera	ate	N / A	2.01 – 2.20	0.41 – 0.60	-0.60 0.61 - 0.80 1.51 - 1.80 1.06 - 1.14 1.01 - 1.64			
	High		See	1.81 – 2.00	0.61 – 0.80	0.81 – 1.00	1.81 – 2.50	1.15 – 1.19	1.61 – 2.00
	Very Hi	igh	(1)	1.50 – 1.80	0.81 – 1.00	1.01 – 1.20	2.51 – 3.00	1.20 – 1.60	2.01 – 2.40

Extren	ne	Above	< 1.50	> 1.00	> 1.20	> 3.00	> 1.60	> 2.40
				Overall N	ear-Bank S	Stress (NB	S) rating	Hi	gh

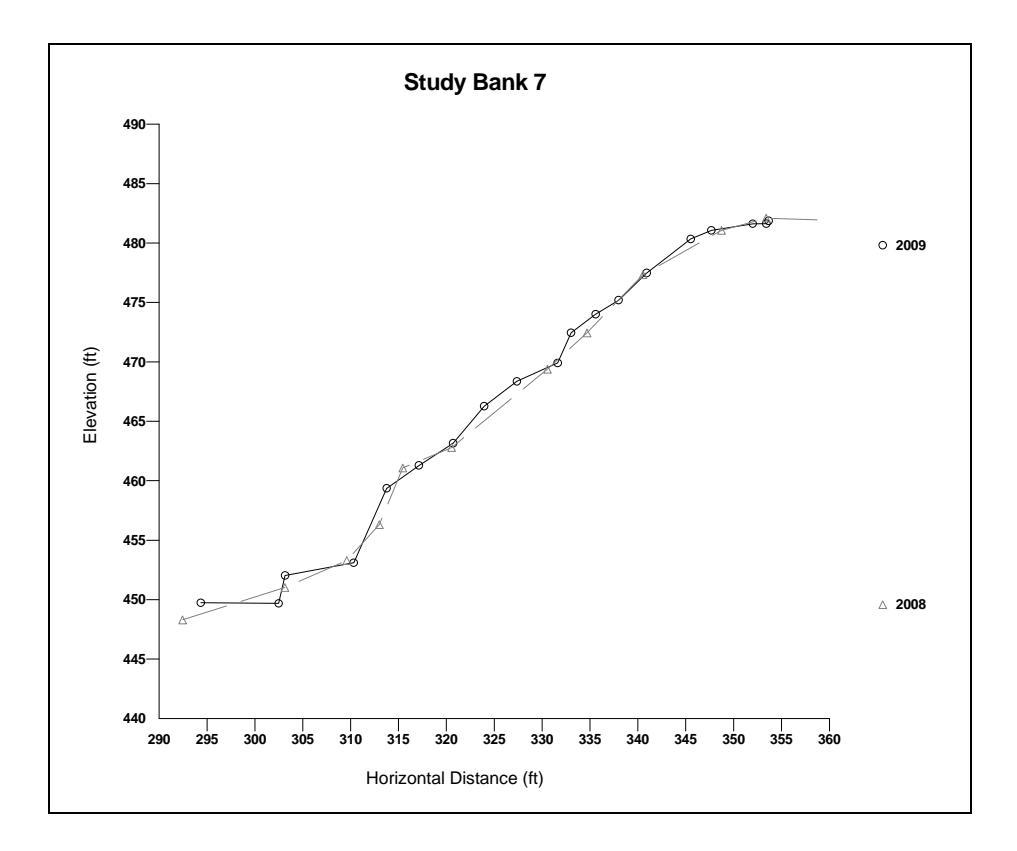
Stream:	Little Mia	imi River			Locati	ion: Rr	m 4.5 - 7.0		
Station:	Study Ba	ink 7			Observe	ers: SI	OP, TJT		
Date:	12/10/08	St	ream Type:	C 4c-	Valley Ty	/pe: VI	II

-			BEHI Score
				Study	/ Bank He	ight /	Bankfull He	eight(C)	(Fig. 5-19)
		Study	33.8	Bankfull	23.6		$(\mathbf{A})/(\mathbf{P})$	1.4322	5 46
		Bank Height (ff) =	(A)	Height (ft) =		(B)	$(\mathbf{A})/(\mathbf{D}) =$	(C)	5.40
		noight (it) =		R	oot Deptl	h / Stu	dy Bank H	eight (E)	
		Root	6	Study	33.8			0 17751	
		Depth		Bank	55.0		(D)/(A)=	0.17731 (E)	7.49
		(ft) =	(U)	Height (ft) =	W	(A) oighte	d Root De	(L) Asity (G)	
				Root		eigine			
				Density	20		$(\mathbf{F}) \times (\mathbf{E}) =$	3.5503	10
				as % =		(F)		(G)	
							Bank A	Angle (H)	
							Bank	29	2 30
						a	as Dearees =	(H)	2.39
						Su	Irface Prote	ection (I)	
							Surface	00	
							Protection	90 (1)	1.45
		Bank Matori	al Adjustmon	+-		, L	as % =	(1)	
	Bedrock (Overall Very Lov	v BEHI)	с. 			Ba	ank Material	
	Boulders	(Overall Low BE	HI)	2	>		<u>></u>	Adjustment	-10
	Cobble (St	ubtract 10 points	if uniform medi	um to large cobl	ole)		Ctratification /

(5)	d _{nb} (ft)	d _{bkf} (ft)	d _{bkf}	(NBS)					
		23.55	8.3	2.84	Very High					
eve		Neer Beek		Near-Bank Shear			Bankfull Shear			
	(6)	Max Depth	Near-Bank	Stress τ _{nb} (Mean Depth	Average	Stress τ_{bkf} (Ratio τ_{nb} /	Near-Bank Stress	
		d _{nb} (ft)	Slope S _{nb}	lb/ft ²)	d _{bkf} (ft)	Slope S	lb/ft ²)	τ_{bkf}	(NBS)	
2				Near-Bank						
/el	(7)	Velocity Grad	dient (ft/sec	Stress						
Le		/ 1	.)

-	J					
Neor	Donk Str		nverting va	alues to a l	Near-Bank	Stress (NE	BS) rating			
near-c	rating	ess (INDO) Is	(1)	(2)	(3)		ber (5)	(6)	(7)	
	Very Low N/A > 3.00 < 0.20				< 0.50					
	Low		N / A	2.21 – 3.00	0.20 - 0.40	0.41 – 0.60	30 1.00 - 1.50 0.80 - 1.05 0.50 - 1.			
	Modera	ate	N / A	2.01 – 2.20	0.41 – 0.60	0.61 – 0.80	1.51 – 1.80	1.06 – 1.14	1.01 – 1.60	
	High		See	1.81 – 2.00	0.61 – 0.80	0.81 – 1.00	1.81 – 2.50	1.15 – 1.19	1.61 – 2.00	
	Very Hi	gh	(1)	1.50 – 1.80	0.81 – 1.00	1.01 – 1.20	2.51 – 3.00	1.20 - 1.60	2.01 – 2.40	
	Extren	ne	Above	< 1.50	> 1.00	> 1.20	> 3.00	> 1.60	> 2.40	
			Overall Near-Bank Stress (NBS) rating Very High
