Stream Stability Analysis Report

Eastern Corridor Multi-modal Projects Segment II/III - Priority Part B Work Little Miami River Geomorphic Assessment

December 18, 2009

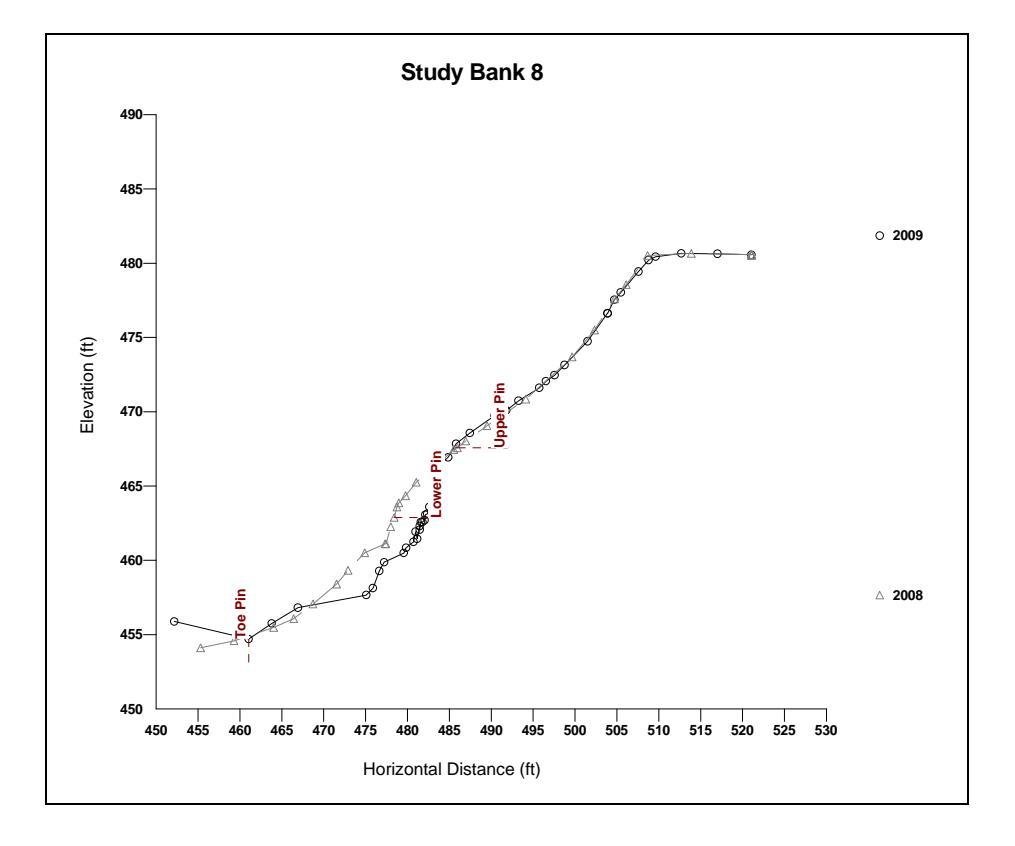
Reach 2 Erosion at SBs 11, 10, and 9 increased with proximity to Horseshoe Bend, ranging from 0.12 to 0.15 ft/yr, respectively. SB 8, which is on the outside bank of Horseshoe Bend, exhibited very high erosion potential according to the BEHI and NBS evaluations of Phase I. Data from Phase II shows that the lower portion of SB 8 experienced several feet of lateral erosion (See Figure 17), while the upper portion remained relatively unchanged. The average erosion rate for this bank was 1.34 feet. This erosion was observed frequently along the bank. As described in Section 3.2, the submerged logs extending from the bank were notably more exposed during Phase II data collection. Large bank slumps were also noted just downstream of SB 8, below the sewer outfall. This portion of bank is located in a small "pocket" on the outside of the bend, making it susceptible to eddy scour. It is also in the path of the modified flow line which comes across the inner portion of the bend, as illustrated in Figure 16a.

Stream:	Little Mia	mi River			Locatio	on: RM 4.5 - 7.0					
Station:	Study Ba	nk 8			Observe	rs: SDP, TJT					
Date:	12/10/08	Sti	eam Type:	C 4c-	Valley Typ	be: VIII					
				Study	/ Bank Heig	ght / Bankfull He	eight(C)	BEHI Score (Fig. 5-19)			
		Study Bank Height (ff) =	26.41 (A)	Bankfull Height (ft) =	19.06 ((A)/(B) =	1.38562 (C)	5.2			
		noight (it) =	,	R	loot Depth	/ Study Bank H	eight (E)				
		Root Depth (ft) =	1 (D)	Study Bank Height (ft) =	26.41	(D)/(A) =	0.03786 (E)	10			
					We	ighted Root De	nsity(G)				
				Root Density as % =	10	(F) × (E) =	0.37864 (G)	10			
						Bank A	Angle (H)				
						Bank Angle as Degrees =	30 (H)	2.44			
						Surface Prote	ection (I)				
						Surface Protection as % =	30 (1)	5.9			
	Bodrock ((Bank Materi	al Adjustmen	t:	l	B	nk Matorial				
	Boulders (Cobble (Su	Overall Low BE	HI) if uniform medi	um to large cobl	> ble)		Adjustment	0			
	Gravel or	Composite Ma	atrix (Add 5–10) points dependi	ng on	Stratification	Adjustment

Sand (Add Silt/Clay (r	oi parik material 10 points) no adjustment)	that is compose	eu or sand)		position of unstable relation to bankfull s	layers in stage	10			
Venili	1	Madarat	111-1-1-	Vendlad	Evelance and a	 A:	ive Deting	Von Liek			
very LOW	LOW	woderate	High	very High	⊨xtreme		and	very nigh			
5 – 9.5	10 – 19.5	20 – 29.5	30 – 39.5	40 – 45	46 – 50	To	tal Score	43.5			
	Estimating Near-Bank Stress (NBS)										
-------------------	-----------------------------------	----------------------	---	-------------------------------------	--------------------------------------	-------------	-----------------------	----------------------------	-------------------	--	--
Stream	Little N	liami Rive	r		Location:	RM 4.5 - 7	.0				
Station:	Study	Bank 8		S	tream Type:	C 4c-	١	/alley Type:	VIII		
Observ	ers:	SDP, TJT						Date:	12/10/08		
			Methods for	or estimati	ng Near-Ba	ank Stress	(NBS)

(6)	Max Depth	Near-Bank	Stress τ _{nb} (Mean Depth	Average	Stress τ_{bkf} (Ratio τ _{nb} /	Stress		
		d _{nb} (ft)	Slope S _{nb}	lb/ft*)	d _{bkf} (ft)	Slope S	lb/ft ²)	τ _{bkf}	(NBS)		
≥	()	Velocity Grad	dient (ft / sec	Near-Bank Stress							
eve	(7)	/ f	it)	(NBS)							
		Со	nvertina va	alues to a l	Near-Bank	Stress (NE	3S) rating				
Near-	Bank Str	ess (NBS)	Ŭ		M	ethod numb	per C				
	rating	S	(1)	(2)	(3)	(4)	(5)	(6)	(7)		
	Very Lo	ow	N/A	> 3.00	< 0.20	< 0.40	< 1.00	< 0.80	< 0.50		
	LOW	oto	N / A	2.21 - 3.00	0.20 - 0.40	0.41 - 0.60	1.00 - 1.50	0.80 - 1.05	0.50 - 1.00		
	High		See	2.01 - 2.20	0.41 - 0.00	0.81 - 1.00	1.81 - 2.50	1.00 - 1.14 1.15 - 1.10	1.01 - 1.00		
	Verv Hi	iqh	(1)	1.50 - 1.80	0.81 - 1.00	1.01 - 1.20	2.51 - 3.00	1.20 - 1.60	2.01 - 2.00		
	Extren	ne	Above	< 1.50	> 1.00	> 1.20	> 3.00	> 1.60	> 2.40

•				Overall N	ear-Bank S	Stress (NB	S) rating	Extr	eme		
				o torun h			e, i a ing		UNIT OF THE OTHER

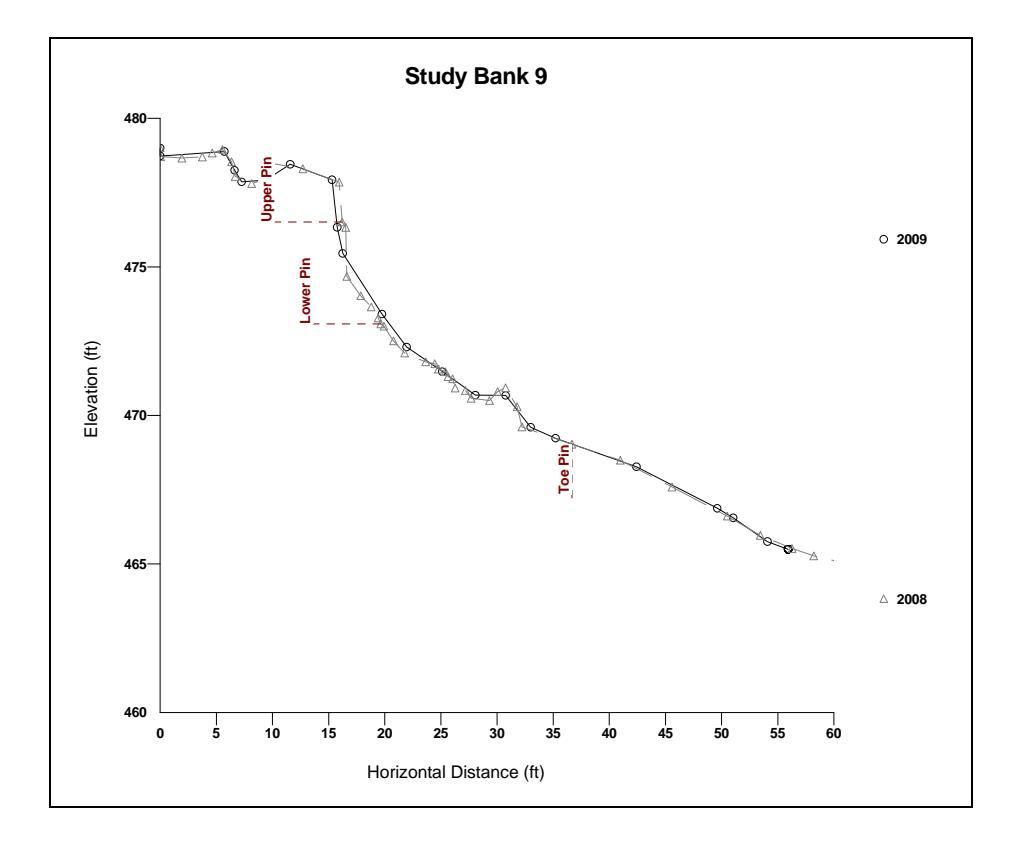
Stream:	Little Mia	ımi River			Locati	on: RM 4.5 - 7.0		
Station:	Study Ba	ınk 9			Observe	ers: SDP, TJT		
Date:	12/10/08	Sti	ream Type:	C 4c-	Valley Ty	rpe: VIII		
								BEHI Score
				Study	/ Bank He	ight / Bankfull H	eight (C)	(Fig. 5-19)
		Study Bank	8.55	Bankfull Height	4.64	(A)/(B) =	1.8427	7.14
		Height (ft) =	(A)	(ft) =		(B)	(C)	
				R	loot Depth	n / Study Bank H	eight (E)	
		Root	3	Study	8.55		0.3509	5.4
		Depth	(D)	Bank		(D)/(A)=	(E)	5.4

(11) =	(-)		W	eighted Root De	nsity (G)	
				Root	-			
				Density	1	(F)X(E) =	2.4561	10
				as % =		(F)	(G)	
						Bank	Angle (H)	
						Bank Angle	35	2.68
						as Degrees =	(H)	2100
						Surface Prot	ection (I)	
						Surface	25%	
						Protection		6.54
		Bank Materi	al Adiustmen	t:		as % =	(י)	
	Bedrock (Overall Very Lov	v BEHI)	_	l	B	ank Material	
	Boulders	(Overall Low BE	HI)	_			Adjustment	0
	Cobble (Si	ubtract 10 points	if uniform medi	um to large cobl	ole)	Stratification	Adjustmont	
	percentage	of bank material	that is compose	ed of sand)	ng on	Add 5–10 points, d	epending on	
	Sand (Add	10 points)		,		position of unstable	e layers in	5
	Silt/Clay (r	no adjustment)					siaye	
Very Low		Moderato	High	Vory High	Extreme		tive Rating	High
	LOW	wouerale	підп		LAUGING		and	<u>i iigii</u>
5 – 9.5	10 - 19.5	20 – 29.5	30 – 39.5	40 – 45	46 – 50	То	36.8

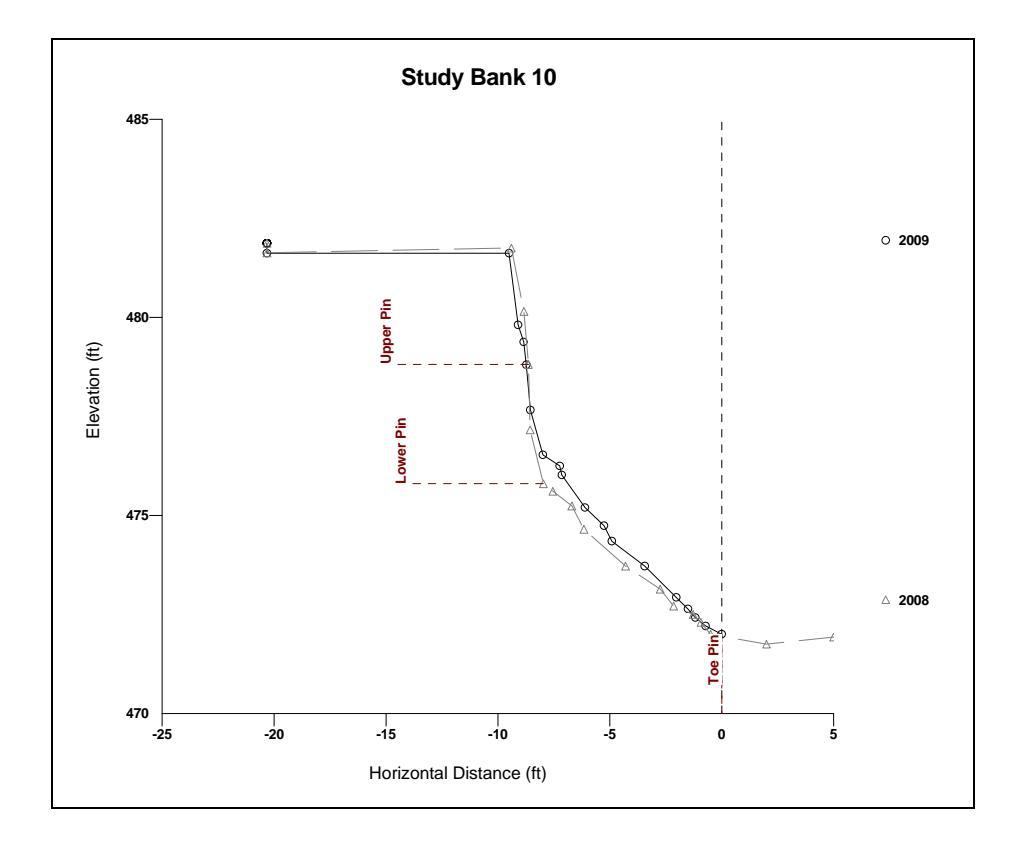
Stream:	Little Mia	mi River			Locatio	n: RM 4.5 - 7.0		
Station:	Study Ba	nk 10			Observer	s: SDP, TJT		
Date:	12/10/08	Str	eam Type:	C 4c-	Valley Typ	e: VIII		
				Cturch	Denk Hei		sight (C)	BEHI Score
		Otrata		Study	вапк неі	gnt / Bankfull He	eight (C)	(Fig. 5-19)
		Bank	9.75 (A)	Height	2	(A)/(B) =	4.875 (C)	10
		Height (ft) =	(A)	(π) = R	oot Depth	ے) / Study Bank H	eiaht (E)	
		Root	3	Study	9.75		0.3077	E Q
		Deptn (ft) =	(D)	Bank Height (ft) =	((D)/(A)=	(E)	J.O
					We	ighted Root Dei	nsity(G)	
				Root Density as % =	5 ((F) × (E) =	1.5385 (G)	10
			ļ		¥	Bank A	Angle (H)	
						Bank Angle	39 (H)	2.88
						Surface Prote	ection (I)	
						Surface Protection as % =	15 (I)	7.9
		Bank Materi	al Adjustmen	t:	L	~ •		
	Bedrock (Boulders (Overall Very Low	/ BEHI) HI)	\geq	> · · · · · · · · · · · · · · · · · · ·		Adjustment	0
	Cobble (Si	ubtract 10 points	t uniform medi	um to large cobl	ole)	Stratification	diustment

percentage	of bank material	that is compose	ed of sand)		Add 5–10 points, de	epending on	
	Sand (Add Silt/Clay (r	10 points) no adjustment)				position of unstable relation to bankfull s	layers in stage	0
					_			
Very Low	Low	Moderate	High	Very High	Extreme	Adject	ive Rating	High
	40 40 5	20 - 20 5	30 - 30 5	40 - 45	46 - 50	- 50 Total Score

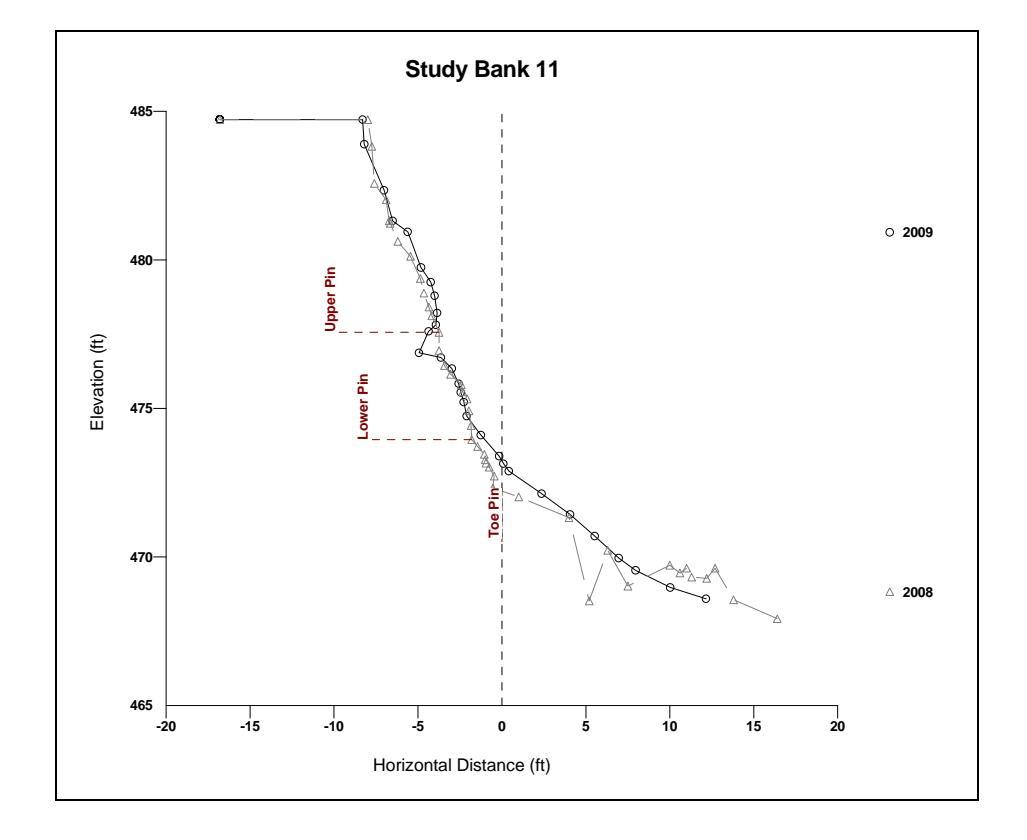
Stream:	Little Mia	mi River			Locatio	n: RM 4.5 - 7.0		
Station:	Study Ba	nk 11			Observer	s: SDP, TJT		
Date:	12/10/08	St	ream Type:	C 4c-	Valley Typ	e: VIII		
								BEHI Score
				Study	⁷ Bank Heig	ht / Bankfull H	eight(C)	(Fig. 5-19)
		Study Bank	12.4	Bankfull Height	2.08	(A)/(B)=	5.96154	10
		Height (ft) =	(A)	(ft) =	(I	B) / Official a Disarta th		
				R	oot Depth	/ Study Bank H	eight (E)	
		Root Depth	8	Study Bank	12.4	(D)/(A)=	0.64516	3.17
		(ft) =	(0)	Height (ft) =	We	aj Ale Root De	nsity (G)	
				Root				
				Density	5 ((F) X (E) =	3.2258 (G)	10
					N	Bank A	Angle (H)	
						Bank	58	
						Angle	ЭО (H)	3.8
						Surface Prote	ection (1)	
						Surface	20	
						Protection	30	5.9
		Bank Matori	al Adjustmon	4 -		as % =	(1)	
	Bedrock (C	Overall Very Lov	v BEHI)	с. 	L	Ba	ank Material	
	Boulders (Overall Low BE	HI)	2	> 		Adjustment	2
	Cobble (Su	ubtract 10 points	if uniform medi	um to large cobb	ole)

Gravel or	Composite Ma	atrix (Add 5–10) points dependir	ng on	Stratification	Adjustment	1
	Sand (Add	10 points)	that is compose	ed of sand)		position of unstable	layers in	5
	Silt/Clay (n	o adjustment)				relation to bankfull	stage	Ŭ
Vonulow		Modorato	High	Von Hich	Extrome	Adiaa	ivo Potina	High
very LOW	LOW	woderate	High	very nigh	Extreme	Adject	and	піуп
				/				-

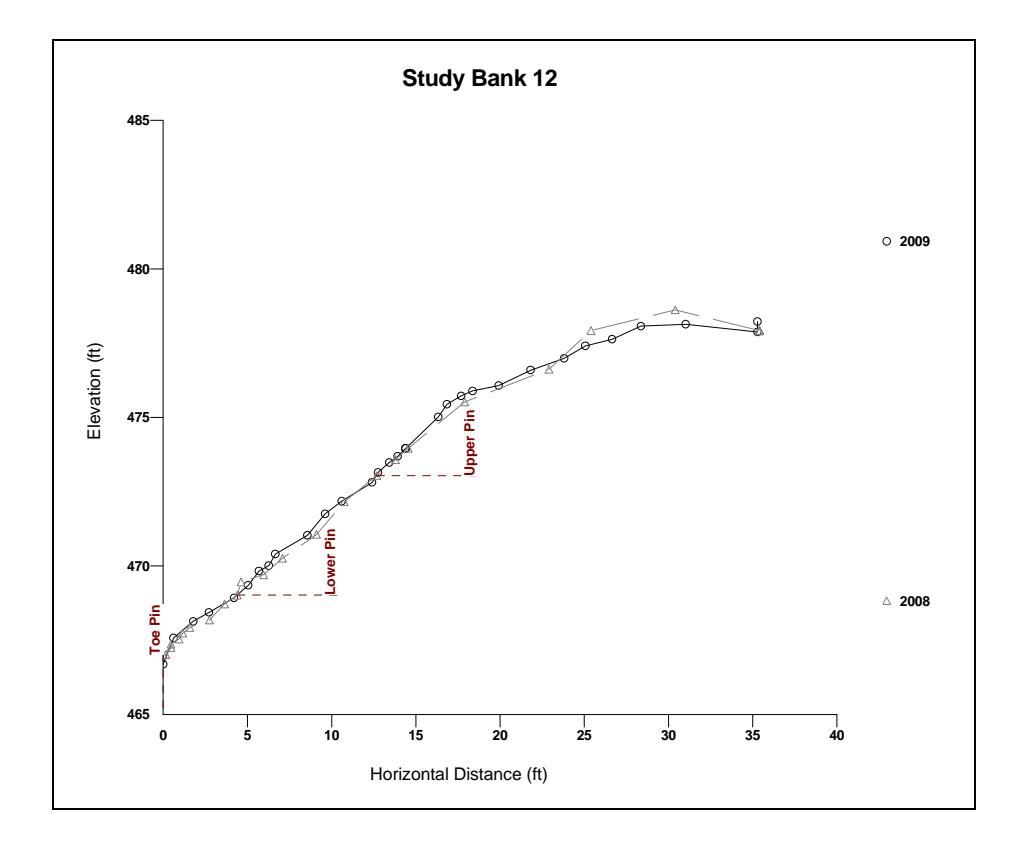
Stream:	Little Mia	mi River			Locatio	on: RM 4.5 - 7.0			
Station:	Study Ba	ink 12			Observe	ers: SDP, TJT			
Date:	12/10/08	Str	eam Type:	C 4c-	Valley Ty	pe: VIII			
								BEHI Score	
				Study	/ Bank Hei	ght / Bankfull H	eight(C)	(Fig. 5-19)	
		Study	8.23	Bankfull Hoight	8.08	$(\mathbf{A})/(\mathbf{B}) =$	1.0186	1 1 2	
		Height (ft) =	(A)	(ft) =		(B)	(C)	1.10	
				R	oot Depth	/ Study Bank H	eight (E)		
		Root	8	Study	8.23		0.9721	4.07	
		Depth	с (D)	Bank Height (#) -	0.20	(D)/(A)=	(E)	1.27

(11) =	(-)	neight (it) –	We	eighted Root De	nsity (G)		
				Root	20		20 162		
				Density	30	$(F) \times (E) =$	29.102	5.98	
				as % =		(F) Bank /			
						Bank			
						Angle	25.5	2.22	
						as Degrees =	(H)		
						Surface			
						Protection	45	4.71	
						as % =	(1)		
	Bedrock (Bank Materi	al Adjustmen	.t:			ank Material		
	Boulders	Overall Low BE	HI)	\geq	>		Adjustment	0	
	Cobble (Se	ubtract 10 points	if uniform medi	um to large cobl	ole)				
	Gravel or	Composite Ma of bank material	atrix (Add 5–10 that is compose) points dependii ed of sand)	ng on	Add 5–10 points, de	Adjustment	1	
	Sand (Add	d (Add 10 points)							
	Silt/Clay (r	no adjustment)				relation to bankfull	stage		
Verv Low	Low	Moderate	Hiah	Verv Hiah	Extreme		tive Rating	Low	
							and		
5 – 9.5	10 – 19.5	20 – 29.5	30 – 39.5	40 – 45	46 – 50	To	tal Score	15.4

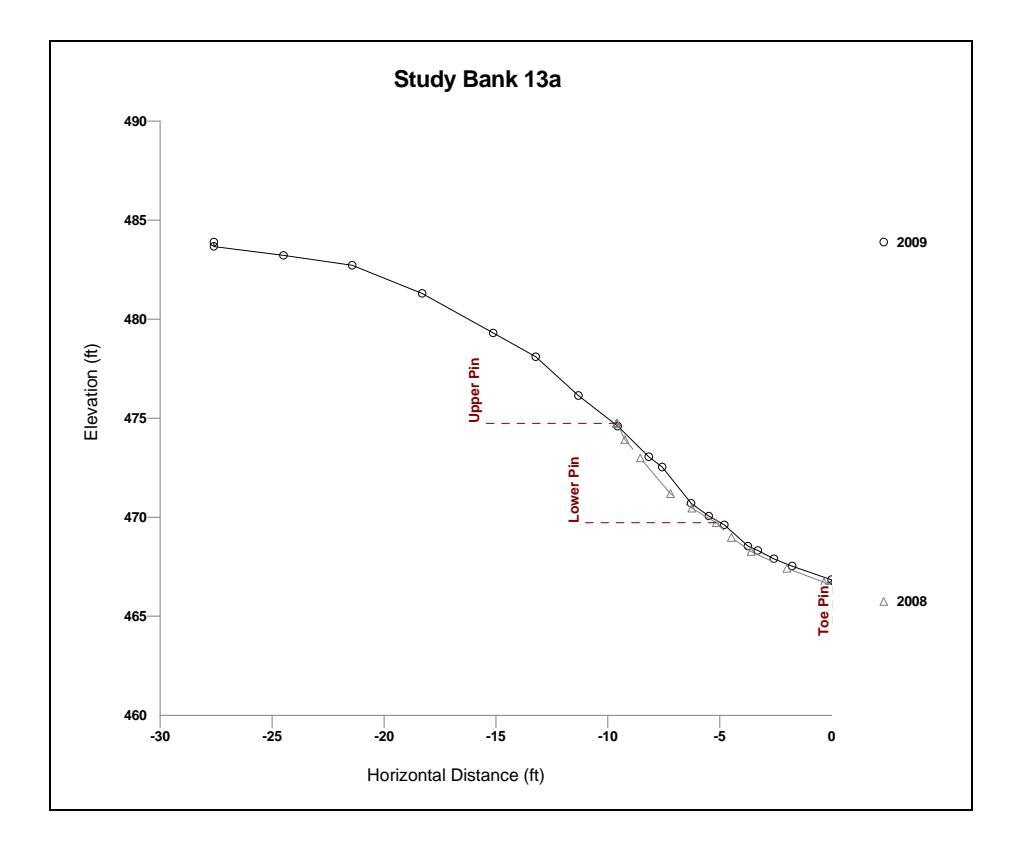
Study Bank 13a

Stream:	Little Mia	mi River			Location	n: RM 4.5 - 7.0		
Station:	Study Ba	ink 13a			Observers	s: SDP, TJT		
Date:	12/10/08	Str	eam Type:	C 4c-	Valley Type	e: VIII		
								BEHI Score
				Study	[,] Bank Heig	ht / Bankfull He	eight(C)	(Fig. 5-19)
		Study	17.1	Bankfull	8.56	$(\mathbf{A})/(\mathbf{B}) =$	1.9977	7 9
		Height (ft) =	(A)	(ft) =	(E	3) (A)/(B)=	(C)	1.5
				R	oot Depth /	Study Bank H	eight (E)	
		Root	17	Study	17.1		0.9942	4.00
		Depth (ft) =	(D)	Bank Height (ff) –	()	(D)/(A) =	(E)	1.09

(11) =	(-)		Wei	ghted Root Dei	nsity (G)	
				Root	25		2/ 85/	
				Density	25 //	$(F) \times (E) =$	24.004 (G)	6.56
				as 70 =	<u>r</u>	J Bank A	Angle (H)	
						Bank	24	
						Angle	34	2.63
						as Degrees =	ection (1)	
						Surface		
						Protection	25	6.54
		Bank Matori	al Adjustmon	4 -		as % =	(1)	
	Bedrock (Overall Very Low	/ BEHI)	с. 		Ba	ank Material	
	Boulders	(Overall Low BEI	HI)	2	· 		Adjustment	0
	Cobble (Si	ubtract 10 points	if uniform medi	um to large cob	ole)	Stratification	diuctmont	
	percentage	of bank material	that is compose	points dependir ed of sand)	ng on	Add 5–10 points, de	epending on	
	Sand (Add	(Add 10 points) position of unstable layers in relation to baptfull stare						
	Silt/Clay (r	no adjustment)					nay c	
Very Low	Low	Moderate	High	Very High	Extreme	Adject	ive Rating	Moderate
	1			$ \geq $			and	
5 – 9.5	10 – 19.5	20 – 29.5	30 – 39.5	40 – 45	46 – 50	Tot	tal Score	24.7

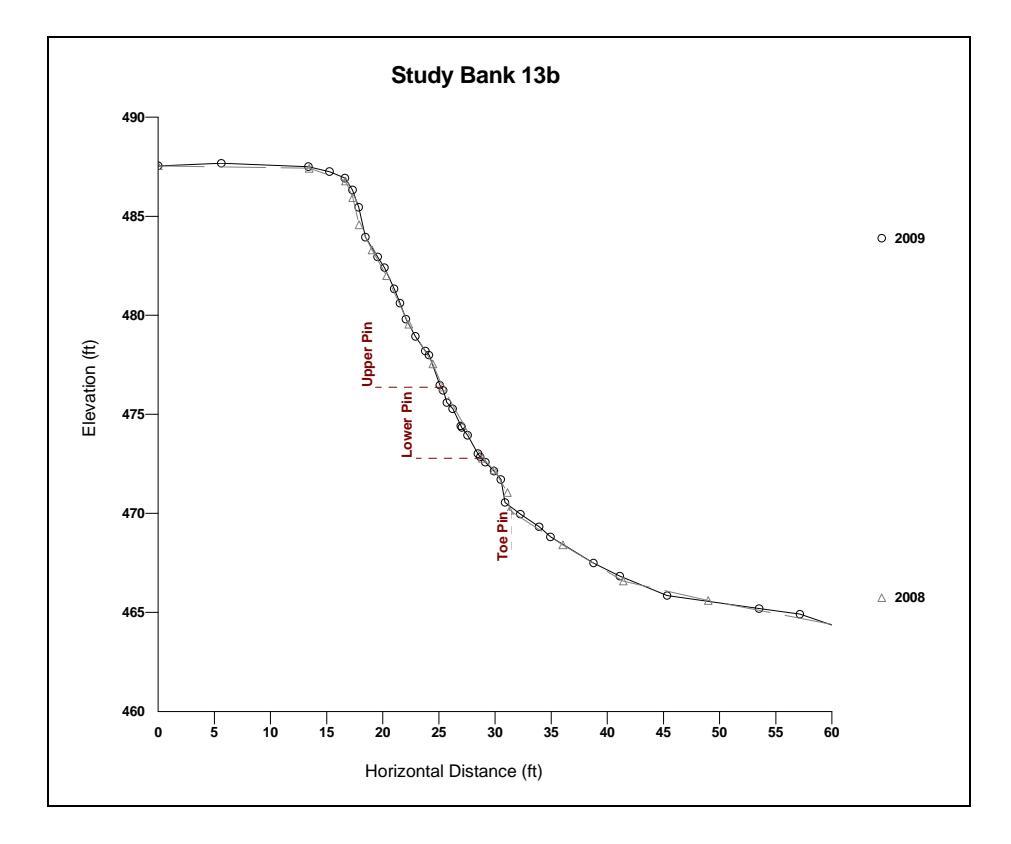
Study Bank 13b

Stream:	Little Mia	mi River			Locatio	on: RM 4.5 - 7.0		
Station:	Study Ba	nk 13b			Observe	rs: SDP, TJT		
Date:	12/10/08	Str	eam Type:	C 4c-	Valley Typ	be: VIII		
				Study	/ Bank Heig	ght / Bankfull H	eight(C)	BEHI Score (Fig. 5-19)
		Study Bank Height (ft) =	16.5 (A)	Bankfull Height (ft) =	5.5	(A)/(B)=	3 (C)	10
1				R	oot Depth	/ Study Bank H	eight (E)	
		Root Depth (ft) =	16 (D)	Study Bank Height (ft) =	16.5	(D)/(A) =	0.9697 (E)	1.27
					We	ighted Root De	nsity(G)	
				Root Density as % =	20	(F) × (E) =	19.394 (G)	7.3
				<u>.</u>		Bank /	Angle (H)	
						Bank Angle as Degrees =	48 (H)	3.32
						Surface Prote	ection (I)	
						Surface Protection as % =	25 (1)	6.54
	Dedreek "	Bank Materi	al Adjustmer	nt:			ank Motorial	
	Bearock (Boulders (Cobble (S)	Overall Very Low Overall Low BEI ubtract 10 points	/ BEHI) HI) ⊧if uniform med	ium to large cobl	> ple)		Adjustment	0
	Gravel or	Composite Ma	atrix (Add 5–10) points dependi	, ng on	Stratification /	Adjustment

percentage Sand (Add Silt/Clay (r	of bank material 10 points) no adjustment)	that is compos	ed of sand)		Add 5–10 points, de position of unstable relation to bankfull	epending on layers in stage	5
Very Low	Low	Moderate	High	Very High	Extreme	Adject	tive Rating	High
							and	
5 – 9.5	10 – 19.5	20 – 29.5	30 – 39.5	40 – 45	46 – 50	✓ To	tal Score	33.4

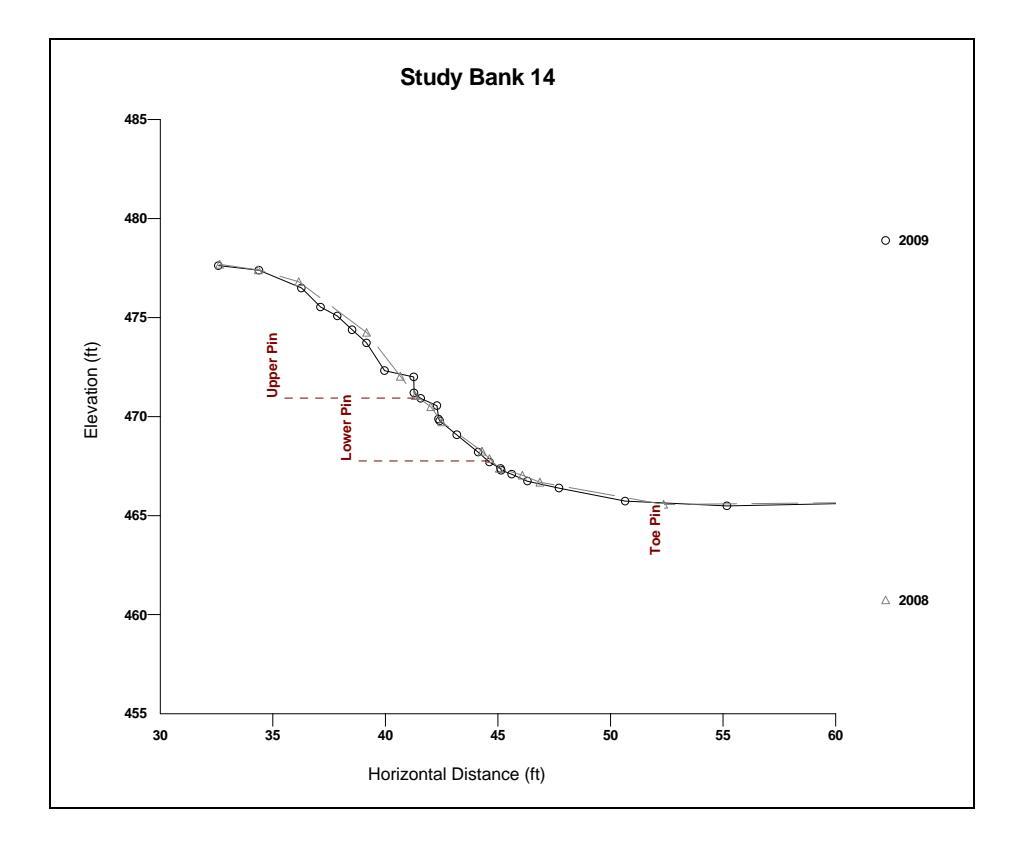
Stream:	Little Mia	mi River			Location	n: RM 4.5 - 7.0		
Station:	Study Ba	nk 14			Observers	s: SDP, TJT		
Date:	12/10/08	Sti	ream Type:	C 4c-	Valley Type	e: VIII		
								BEHI Score
				Study	Bank Heig	ht / Bankfull He	eight(C)	(Fig. 5-19)
		Study	11.7	Bankfull	10.26	$(\mathbf{A})/(\mathbf{B})$	1.1404	2 71
		Height (ft) =	(A)	(ft) =	(8	(A)/(B)=	(C)	2.71
				R	oot Depth /	Study Bank He	eight (E)	
		Root	10	Study	10.81		0.9402	4 5 4
		Depth (ft) -	(D)	Bank Height (#) -	(4	(D)/(A) =	(E)	1.54

(1) –			Weig	ghted Root Dei	nsity(G)	
				Root	30		28 205	
				Density		$(F) \times (E) =$	20.203 (G)	6.11
				as 7o =	U	Bank A	Angle (H)	
						Bank	40.5	
						Angle	40.5	2.95
						as Degrees =	(H)	
						Surface		
						Protection	20	7.22
		Bank Matari	al Adjuctmen	4.		as % =	(1)	
	Bedrock (Overall Very Low	v BEHI)	п. 		Ba	ank Material	
	Boulders	(Overall Low BE	HI)	2	•		Adjustment	0
	Cobble (Si	ubtract 10 points	if uniform medi	um to large cobb	ole)	Stratification	diuotmont	
	Gravel or percentage	of bank material	that is compose) points dependir ed of sand)	ng on	Add 5–10 points, de	epending on	l
	Sand (Add	10 points)		,		position of unstable	layers in	0
	Silt/Clay (r	no adjustment)					nay c	
Very Low	Low	Moderate	High	Very High	Extreme	Adject	ive Rating	Moderate

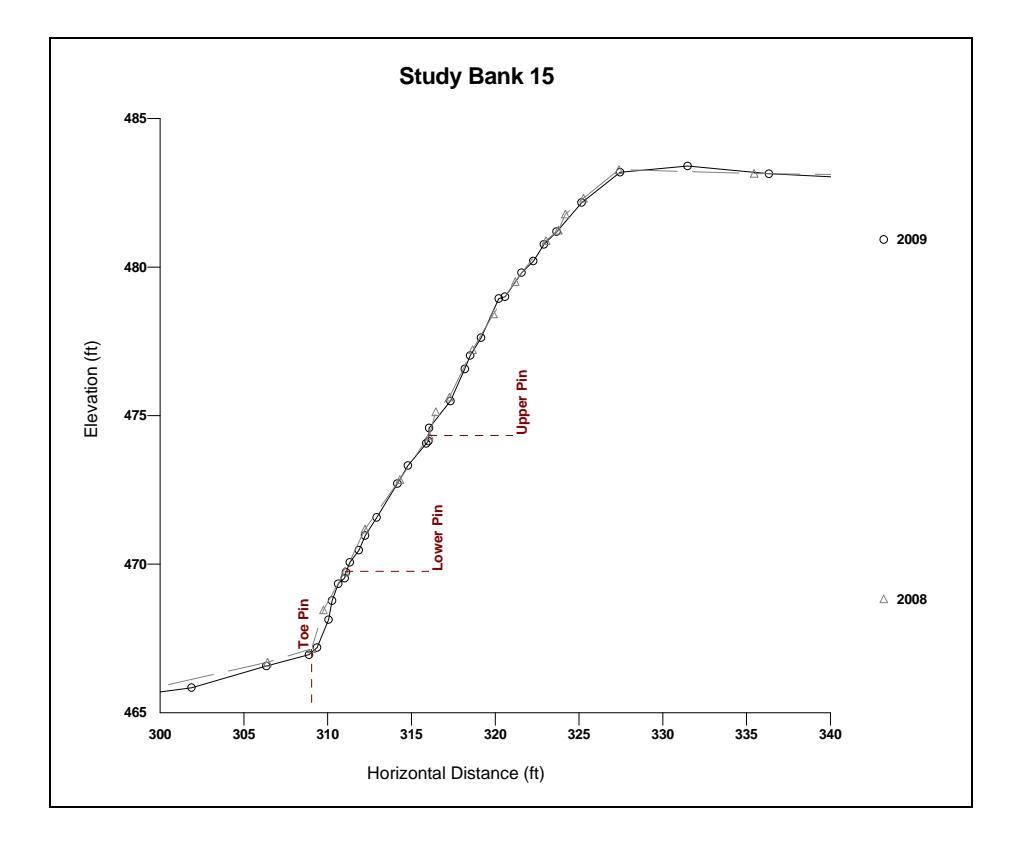
Station: Date:	Study Ba	nk 15									
Date:	12/10/08			Observers: SDP, TJT							
	12,10,00	Str	eam Type:	C 4c-	Valley Type	e: VIII					
								BEHI Score			
				Study	Bank Heig	ht / Bankfull He	eight(C)	(Fig. 5-19)			
		Study Bank	16.13	Bankfull Height	8.8	(A)/(B) =	1.833	7.09			
		Height (ft) =	(A)	(ft) =	(8	B)	(C)	1.00			
				R	oot Depth /	Study Bank He	eight (E)				
		Root	14	Study	16.13		0.8679	0.4			
		Depth	(D)	Bank Height (#) -	(4	(D)/(A) =	(E)	2.1

(11) =	(-)	neight (ii) =	Wei	ahted Root Dei	nsitv (G)				
				Root	25	Ĩ	24 600				
				Density	25	(F)X(E) =	21.099	6.99			
			-	as % =	(۲	-) Bank /					
						Bank Bank	(II)				
						Angle	42	3.02			
						as Degrees =	(H)				
						Surface Prote	ection(I)				
						Surface	30	59			
						as % =	(1)	0.0			
		Bank Materi	al Adjustmen	t:							
	Bedrock (C	Overall Very Low	/ BEHI)	>	>	Ba	ank Material	0			
	Cobble (Su	Overall Low BE	HI) if uniform medi	um to large cobb	ole)		Adjustment				
	Gravel or (Composite Ma	atrix (Add 5–10	points dependir	ng on	Stratification A	Adjustment				
	percentage of	e of bank material that is composed of sand) Add 5–10 points, depending on position of unstable layers in									
	Sand (Add Silt/Clav (n	10 points) lo adiustment)				relation to bankfull s	stage	5			
	, , , , , , , , , , , , , , , , , , ,	· · · · · · · · · · · · · · · · · · ·				L					
Very Low	Low	Moderate	High	Very High	Extreme	Adject	ive Rating	High

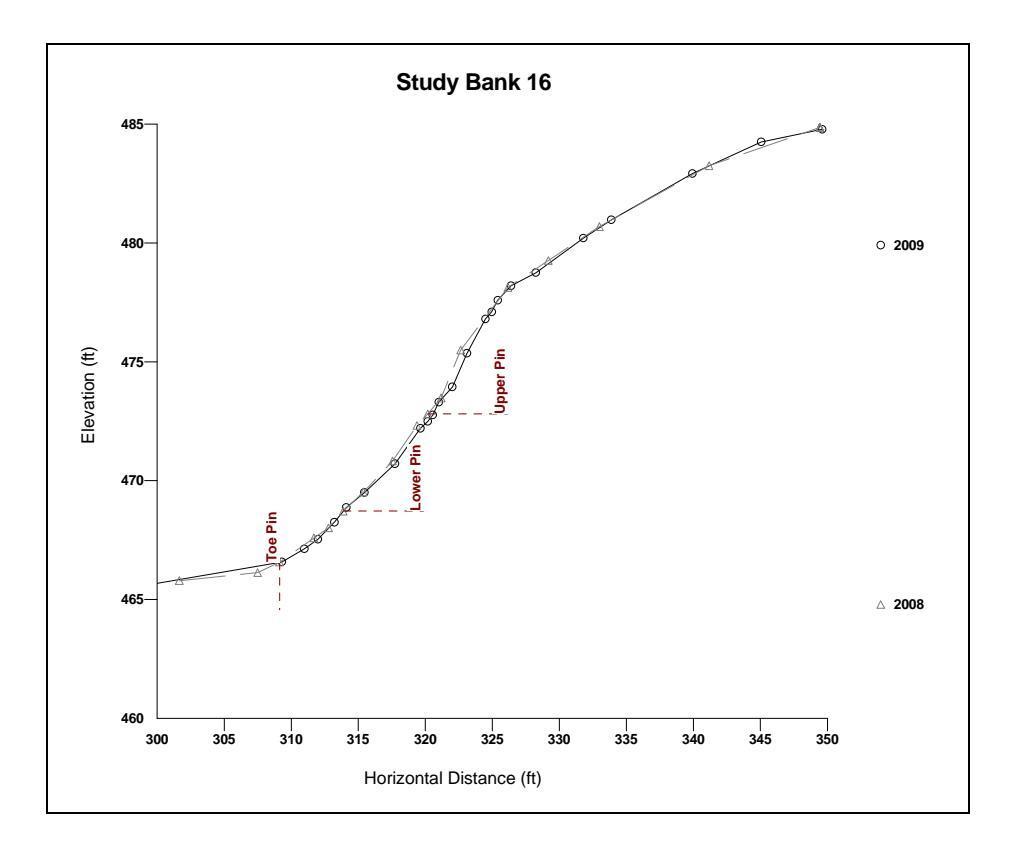
Stream:	Little Mia	mi River		Location: RM 4.5 - 7.0									
Station:	Study Ba	nk 16			Observers	s: SDP, TJT							
Date:	12/10/08	St	ream Type:	C 4c-	Valley Type	e: VIII							
				Study	Rook Hoig	ht / Bankfull U	aight (C)	BEHI Score					
		Study Bank Height (ft) =	18.73 (A)	Bankfull Height (ft) =	9.7	(A)/(B)=	1.9309 (C)	7.57					
				R	oot Depth /	Study Bank He	eight (E)						
		Root Depth (ft) =	13 (D)	Study Bank Height (ft) =	18.73 (/	(D)/(A)=	0.69407 (E)	2.97					
					Wei	ghted Root Dei	nsity(G)						
				Root Density as % =	5 (F	(F)×(E) =	3.47037 (G)	10					
						Bank A	Angle (H)						
						Bank Angle	32 (H)	2.54					
						Surface Prote	ection (I)						
						Surface Protection as % =	20 (1)	7.22					
		Bank Materi	al Adjustmen	it:	L	<u> </u>							
	Bedrock (Boulders (Cobble (S)	Overall Very Lov (Overall Low BE ubtract 10 points	v BEHI) HI) s if uniform medi	ium to large cob			Adjustment	0

Gravel or	Composite Ma	atrix (Add 5–10) points dependi	ng on	Stratification A	Adjustment						
	percentage	centage of bank material that is composed of sand) Add 5–10 points, depending											
	Sand (Add Silt/Clay (r	10 points) no adjustment)				relation to bankfull s	stage	0					
Very Low	Low	Moderate	High	Very High	Extreme	Adject	ive Rating	High

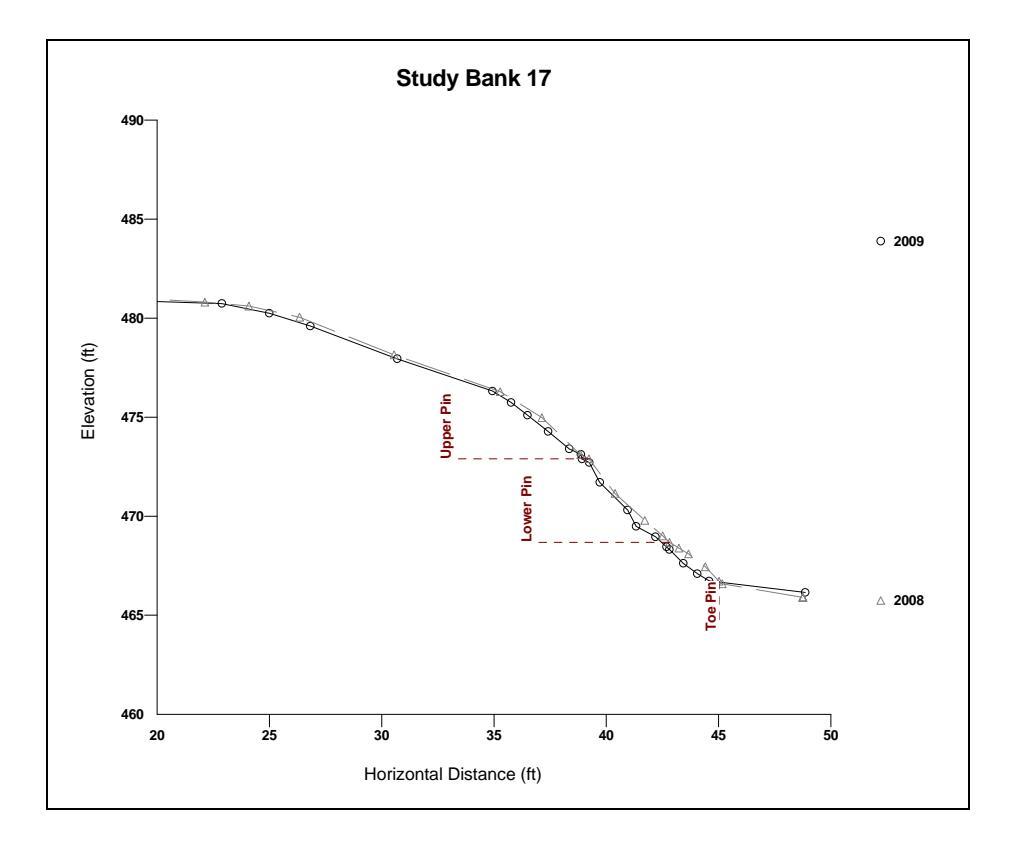
Stream:	Little Mia	mi River			Location	n: RM 4.0 - 7.0			
Station:	Study Ba	nk 17			Observers	: SDP, TJT			
Date:	12/10/08	Str	eam Type:	C 4c-	Valley Type	e: VIII			
				Study	[,] Bank Heig	ht / Bankfull H	eight(C)	BEHI Score (Fig. 5-19)	
		Study Bank Height (ft) -	14.02 (A)	Bankfull Height	9.71 (B	(A)/(B)=	1.44387 (C)	5.52	
		neight (it) =		R	eight (E)				
		Root Depth (ft) =	14 (D)	Study Bank Height (ft) =	14.02 (A	(D)/(A) =	0.99857 (E)	1	
					Wei	ghted Root De	nsity(G)		
				Root Density as % =	25 (F	(F)×(E) =	24.964 (G)	6.55	
						Bank A	Angle (H)		
						Bank Angle	45 (H)	3.17	
						Surface Prote	ection (I)		
						Surface Protection as % =	25 (1)	6.54	
		Bank Materi	al Adjustmen	t:					
	Bedrock (C Boulders (Cobble (S)	Overall Very Low Overall Low BE	/ BEHI) HI) . if uniform medi	um to large cob	>		Adjustment	0	
	Gravel or	Composite Ma	atrix (Add 5–10	points dependir	ng on	Stratification A	Adjustment

percentage Sand (Add Silt/Clay (r	of bank material 10 points) no adjustment)	iterial that is composed of sand) Add 5–10 points, depending on position of unstable layers in relation to bankfull stage						
Very Low	Low	Moderate	High	Very High	Extreme	Adject	ive Rating	Moderate	
E 0.5	10 10 5	20 - 20 5	20 - 20 5	40 - 45	46 - 50	To	and tal Score	22.8
