Eastern Corridor Segments II and III

Linwood/Eastern Interchange Focus Area

2.4 LINWOOD/EASTERN AVENUE INTERCHANGE FOCUS AREA

**EASTERN CORRIDOR SEGMENTS II AND III
(PID 86462)
TRANSPORTATION NEEDS ANALYSIS**

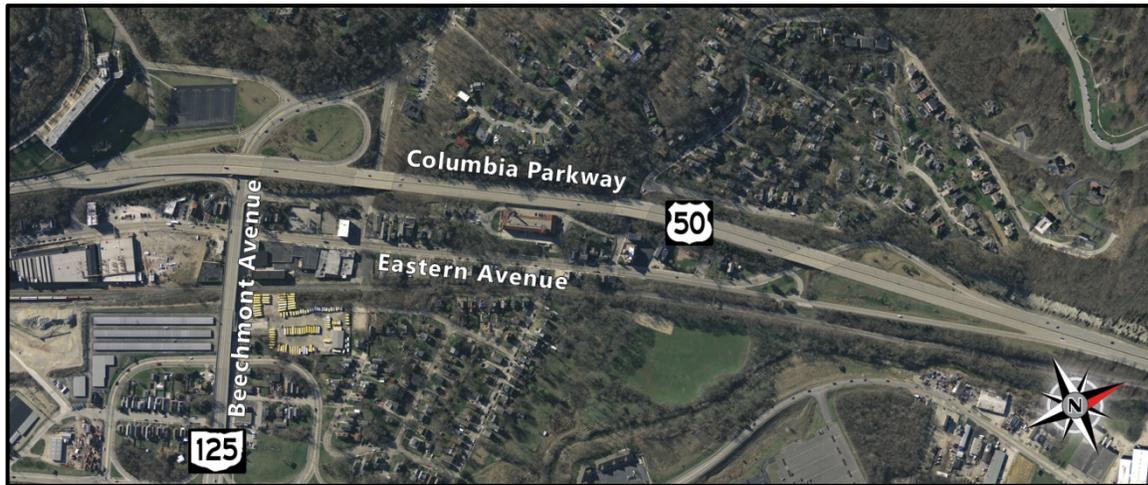
Figure 33: US 50/SR 125 Interchange

The SR 125/US 50 interchange is a trumpet interchange which features a loop ramp to serve traffic traveling from northbound SR 125 to westbound US 50. A slip ramp from southbound SR 125 provides access to eastbound US 50. Ramps also are provided from Eastern Avenue to southbound SR 125 and to westbound US 50.

Geometric Data: There are several geometric deficiencies within this interchange area. SR 125 has 3 deficient vertical curves west of US 50 and one deficient horizontal curve. The horizontal curve immediately west of US 50 has a degree of curvature of $14^{\circ}19'23''$ compared to the allowable $10^{\circ}45'$ for 40 mph. The superelevation through this curve is also not to current standards. The maximum superelevation through this curve is 0.06 ft/ft compared to the design standard of 0.04 ft/ft. Further compounding this issue is the corresponding vertical curve deficiency. The sag vertical curve has a k-value of 35 which is compared to the 64 allowable at 40 mph. There are two other deficient vertical curves west of this interchange. The next curve is a deficient crest curve; k-value of 40, allowable K-value is 44. The last curve is a deficient sag vertical curve with a k-value of 31 (64 is the minimum allowable). US 50 also has a deficient vertical curve just south of SR 125. The sag vertical curve has a k-value of 45 compared to the allowable k-value of 96 for a design speed of 50 mph.

The remainder of the deficiencies are for the ramps. The ramp from Eastern Avenue to SR 125 has a deficient horizontal curve with a degree of curvature of $76^{\circ}0'$. The loop ramp from SR 125 to US 50 has a deficient horizontal curve with a degree of curvature of $44^{\circ}0'$. Neither of these curves meets the minimum degree of curvature for 25 mph, which is the minimum acceptable design speed on ramps. These curves also have maximum superelevations which exceed current standards. The length of the merging taper on the ramp from Eastern Ave to SR 125 is deficient. The actual length of the merge taper is 115' and the required taper length is 420 feet using *L&D, Vol. 1, Figure 503-4*. The total length of the exit ramp from US 50 to SR 125 does not meet the minimum 800 foot deceleration length required for high speed exit ramps. The intersection sight distance, as well as the degree of curvature of the slip lane at the end of the exit ramp, are also

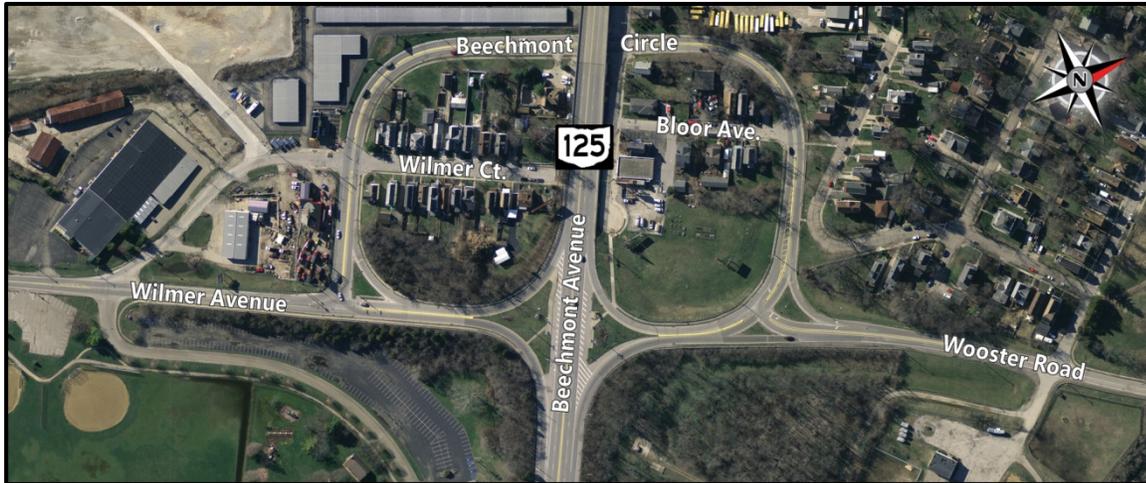
Figure 34: Beechmont Circle Interchange

The Beechmont Circle is a diamond interchange with eastbound and westbound slip ramps to and from SR 125.

Geometric Data: There are several geometric deficiencies throughout the Beechmont Circle interchange. Three intersections have deficient intersection sight distance. Using a 30 mph design speed for the circle, the corresponding minimum intersection sight distances are 335 feet left and 290 feet right. Wilmer Court has an intersection sight distance of 220 feet looking left and 150 feet looking right. Beechmont Court has an intersection sight distance of 460 feet looking left and 180 feet looking right. Bloor Ave has an intersection sight distance of 100 feet looking left and 300 feet looking right.

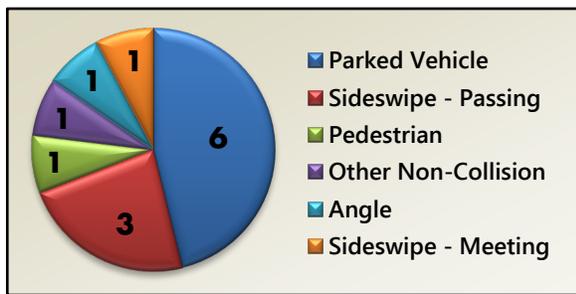
Figure 35: Frequency of Crashes by Crash Type Eastern Avenue: SR 125 to US 50

As illustrated in **Figure 35**, there were 13 total crashes in this roadway section during the three-year period between 2013 and 2015. Parked vehicles and sideswipe crashes represent 75% of the total crashes. Although parked vehicle crashes are the most prevalent crashes, they do

not occur at the same location. There is no correlation between the crash data and a specific contributing cause for the crashes. A plot of all 13 crashes is provided in **Attachment A-2**.

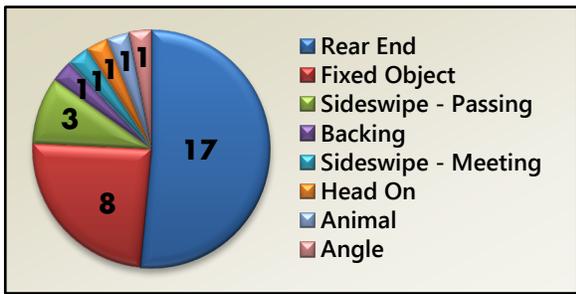
**Figure 36: Frequency of Crashes by Crash Type
Wooster Road: Beechmont Circle to Red Bank**

As illustrated in **Figure 36**, there were 33 total crashes in this roadway section during the three-year period between 2013 and 2015. Rear-end and fixed object crashes represent 75% of the total crashes. Of the 33 total crashes on the segment, 25 (75%) occurred in the high hazard section. Within the high hazard segment, 12 of the 25 crashes were rear-end crashes and eight of the 25 were fixed object crashes. There was not a clustering of crashes at a particular location. Half of the rear end crashes occurred between 3:00 PM and 5:00 PM with the majority of crashes occurring during the day in clear conditions. Thirty-three percent (33%) of the rear-end crashes occurred in wet conditions. Other than the observations described above, there was no correlation between the crash data and a specific contributing cause for rear-end crashes.
