The Eastern Corridor
Figure ES-6

Eastern Corridor Segments II and III US 50 Corridor Focus Area

**EASTERN CORRIDOR SEGMENTS II AND III
(PID 86462)
TRANSPORTATION NEEDS ANALYSIS**

2.6 US 50 CORRIDOR FOCUS AREA

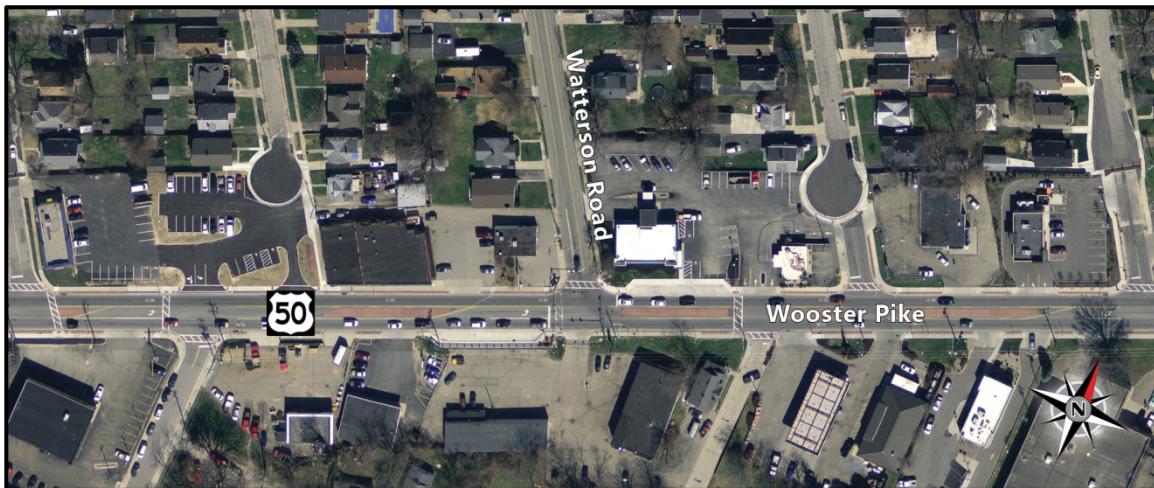
Figure 45. US 50/Watterson Road Intersection

The US 50/Watterson Road intersection is a signalized four-leg intersection.

LOS Analysis: The HCS analysis indicates that the southbound left turn movement 95th percentile queue length exceeds the storage length during the AM and PM peak hours. This occurs for the existing, the No Build opening year (2022), and No Build design year (2042) conditions. The LOS and v/c ratios are acceptable. By the design year, the westbound through movement is failing with a v/c ratio of 1.0 in the AM peak-hour. It is anticipated that operational or minor intersection improvements are required for the existing, No Build opening year and No Build design year conditions.

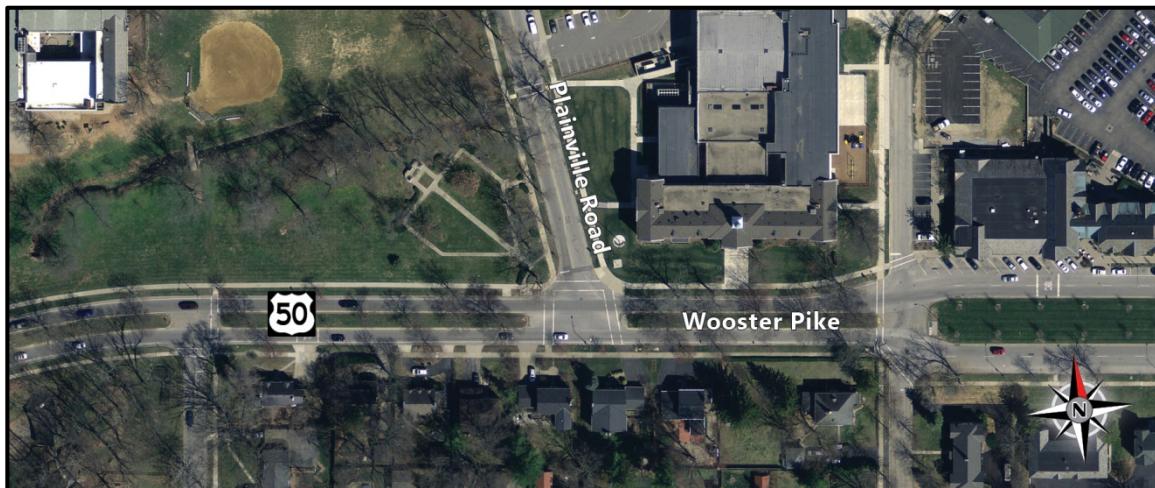
Figure 46: US 50/Plainville Road Intersection

The US 50/Plainville Road intersection is an unsignalized three-leg intersection in which Plainville Road is under stop control.

LOS Analysis: The HCS analysis indicates that traffic on Plainville Road waiting to enter US 50 is LOS F during both the AM and PM peak hour for the existing, No Build opening year (2022), and No Build design year (2042) conditions. During the PM peak-hour, the southbound approach has a v/c ratio of 1.50 for the existing conditions and is expected to increase to 2.51 by the design year. It is anticipated that major capacity improvements are required for the existing, No Build opening year, and No Build design year conditions.

Geometric Data: The intersection sight distance on Plainville Road and the stopping sight distance on Wooster Pike are both deficient. Vehicles turning right from Plainville Road to eastbound Wooster Pike have an intersection sight distance of 100 feet (the required intersection sight distance is 445 feet). Vehicles traveling east on Wooster Pike have a stopping sight distance of 200 feet (required stopping sight distance is 305 feet). Landscaping at the corner of the intersection is primary sight-distance obstruction.

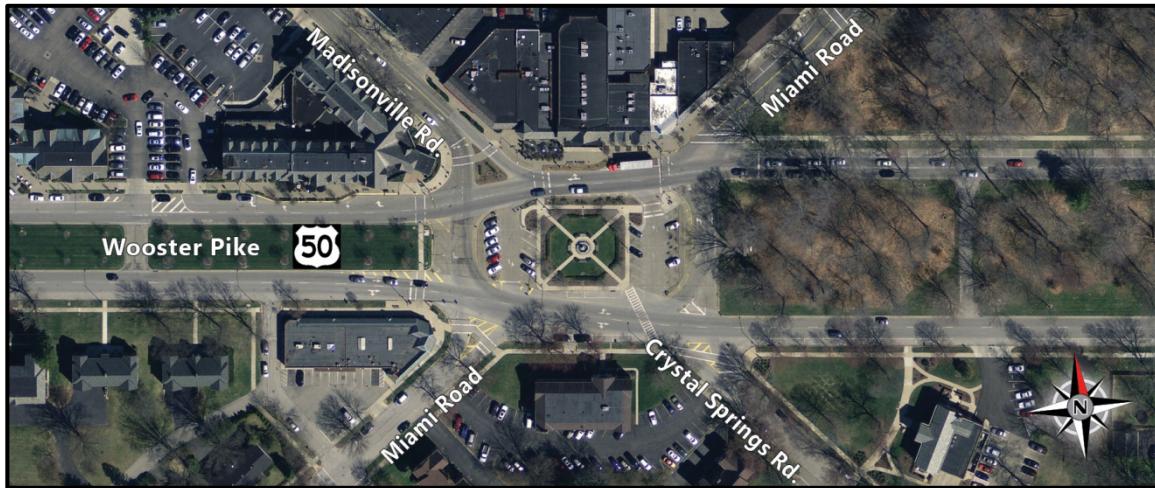
Figure 47: Mariemont Square Intersections

The Mariemont Square consists of four closely spaced intersections. Three of the four intersections are signalized. The US 50/Crystal Springs Road intersection is unsignalized. Through the Mariemont Square, US 50 acts as a one-way pair.

Geometric Data: Intersection sight distance is limited on several approaches to Mariemont Square, due primarily to building obstruction. The intersection of Wooster Pike/Crystal Springs Road has deficient intersection sight distance; vehicles on northbound Crystal Springs Road have a limited sight distance to vehicles traveling eastbound on Wooster Pike due parallel parked cars. The intersection sight distance is 120 feet and the required sight distance is 335 feet. The remainder of the intersections are either signalized or have adequate sight distances.

Pedestrian Data: A significant number of pedestrians were observed in the square. There were 298 pedestrians observed at the US 50/Miami Road intersection (NE corner), 510 pedestrians observed at the US 50/Madisonville Road intersection (NW corner), 110 pedestrians observed at the US 50/Miami Road intersection (SW corner), and 67 pedestrians observed at the US 50/Crystal Springs Road intersection (SE corner) during a 24-hour period recorded on December 1, 2015.

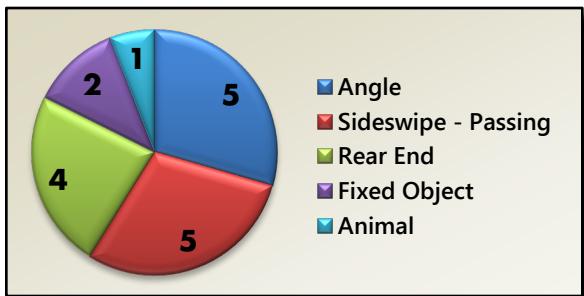
Figure 48: Frequency of Crashes by Crash Type

Crash Data: The western part of the Mariemont Square intersection was identified as a high hazard location through ODOT's crash screening of the Segments II and III roadway network. Considering the complexity of the entire square, all four intersections were evaluated. As illustrated in **Figure 48**,

Mariemont Square Intersections

The sideswipe passing crashes in the square appear to be, in part, due to driver confusion with the complicated nature of the four closely spaced intersections and parking around the square. At the US 50/Madisonville Road intersection, where the highest number of crashes occurred, all of them occurred in the daylight, 90% occurred in dry conditions, and 60% occurred between the hours of noon to 3:00 PM. For a plot of all 17 crashes, please refer to [Attachment A-2](#).

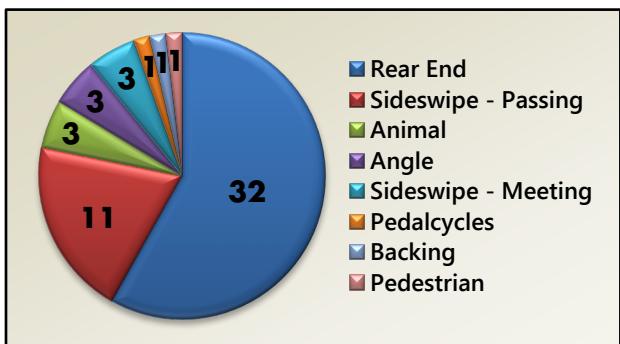
**Figure 49: Frequency of Crashes by Crash Type
Mariemont Square to Walton Creek Road**

Crash Data: An ODOT crash screening identified the approximate 0.15 stretch of US 50 at the Mariemont Promenade shopping center as a high-hazard area. Therefore, a detailed crash analysis of the entire segment from the Mariemont Square to Walton Creek Road was completed.

As illustrated in [Figure 49](#), there were 55 total crashes on this segment during a three-year period (2013-2015). Rear-end crashes represent almost 60% of the total crashes. Of the 55 total crashes on the segment, 15 (30%) occurred in the high-hazard segment. All but one crash on this high-hazard segment was a rear-end crash. See [Attachment A-2](#) for a plot of all 55 crashes.

Rear-end crashes were the most prevalent type of crash. Of the 32 rear-end crashes along the entire segment from the Mariemont Square to Walton Creek Road, 24 occurred during daylight hours, 20 occurred in the westbound direction, 10 occurred in wet conditions, and two resulted in injury.

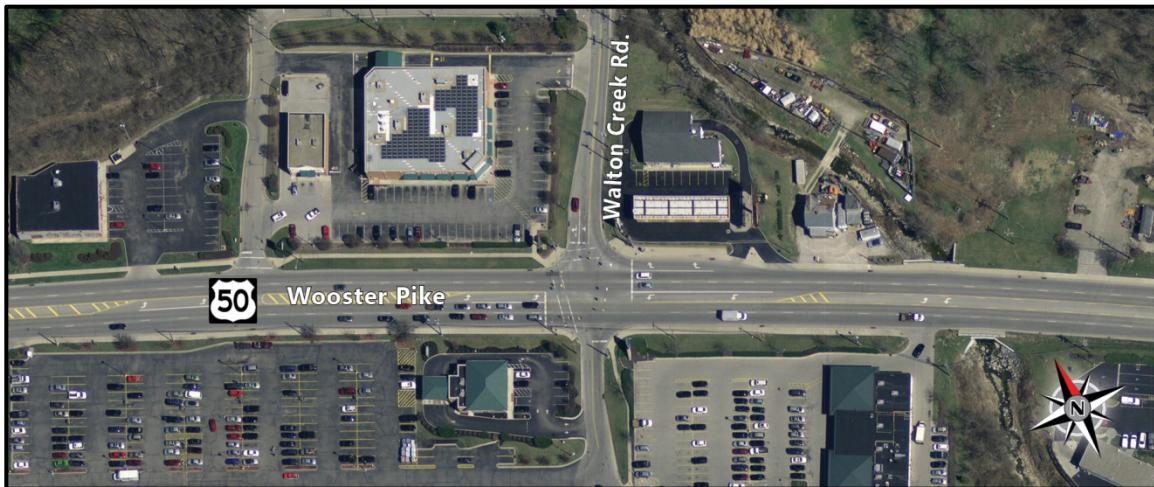
Figure 50: US 50/Walton Creek Road Intersection

The US 50/Walton Creek Road intersection is a signalized four-leg intersection.

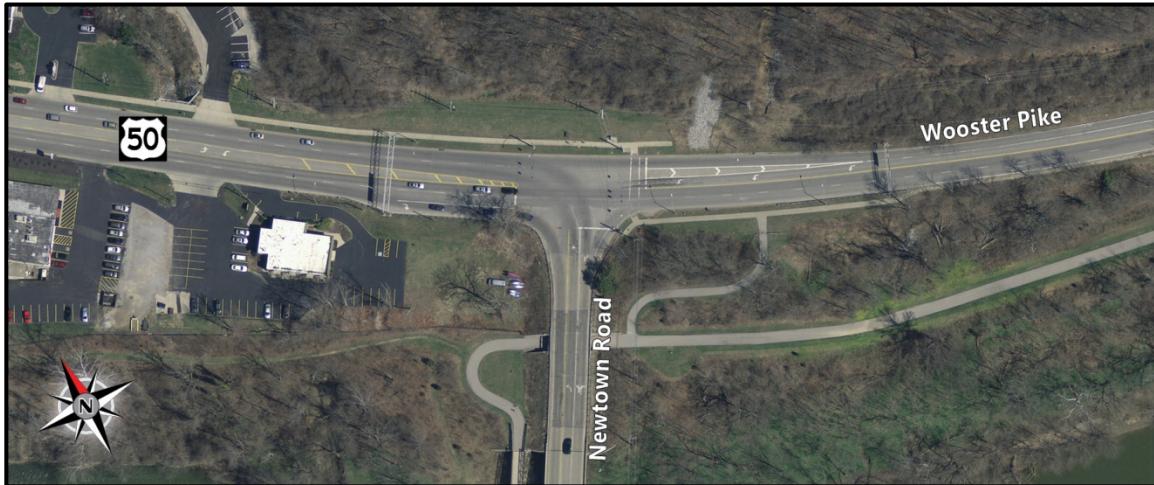
Figure 51: US 50/Newtown Road Intersection

The US 50/Newtown Road intersection is a signalized three-leg intersection.

LOS Analysis: The HCS analysis indicates that during the AM peak-hour the overall intersection is failing for the existing conditions. The two movements contributing to the overall intersection failure is the failing northbound left turn movement with a v/c ratio of 1.25 and the failing westbound left turn movement with a v/c ratio of 1.02. These failures are only exacerbated in the No Build opening year (2022) and No Build design year (2042) conditions. It is anticipated that major capacity improvements are required for the existing, No Build opening year and No Build design year conditions.

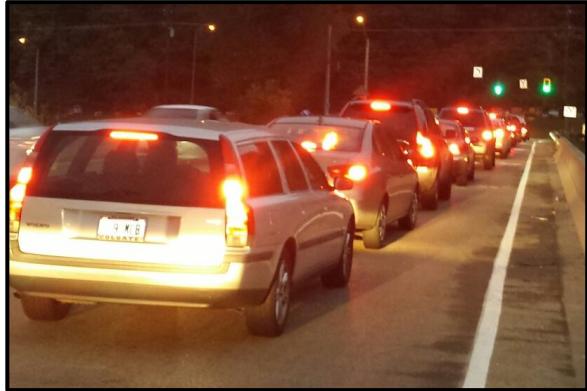
Northbound Newtown Road at US 50 (AM Peak)

ended. The number of cars was translated to a length by assuming a queue length of 25 feet per vehicle. During the AM peak period the maximum northbound queue extended 625 feet. During the PM peak period the maximum northbound queue extended 350 feet and the maximum westbound queue extended 225 feet. The recorded queues during the AM peak period are shown in [Figure 52](#) and the recorded queues during the PM peak period are shown in [Figure 53](#) and [Figure 54](#).
