# Eastern Corridor Segments II and III Village of Newtown Focus Area

### 2.2 VILLAGE OF NEWTOWN FOCUS AREA

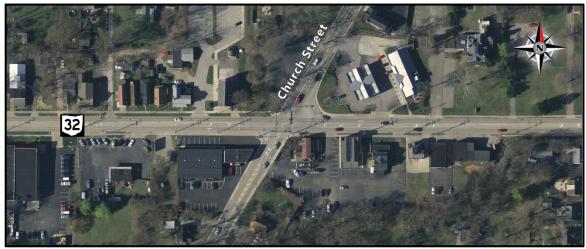
Figure 13. SR 32/Church Street Intersection

The SR 32/Church Street intersection represents the center of the Newtown business district, and is a four-leg, signalized intersection. Crosswalks connect the sidewalks on each corner of this intersection, which represents the center of Newtown's business district.

<u>Geometric Data</u>: The intersection sight distance is very poor due to obstruction by buildings on two corners of the intersection. Because this intersection is fully-controlled by a traffic signal, proper intersection sight distance is not required per *L&D Vol. 1.*; however, intersection sight distances for vehicles on SR 32 making right turns are 80 feet for eastbound traffic and 90 feet for westbound traffic. Both sight distances are less than the required 335 feet, and inhibit the ability for vehicles to execute right-turns during red signal phases.

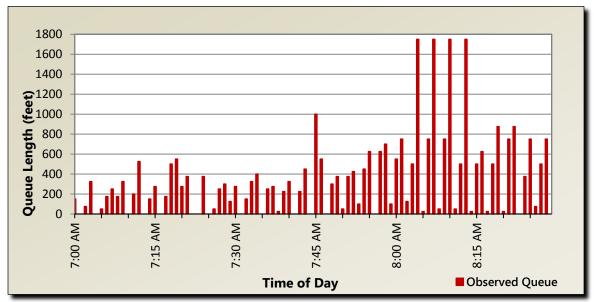
Figure 14. Westbound SR 32 AM Peak Period Queues at Church Street

To supplement the HCS analysis a queue study was conducted for the westbound and northbound approaches during the AM peak period and the eastbound, northbound, and southbound approaches during the PM peak period. The number of cars in the queue was recorded at the end of green for 15 minutes prior to the peak hour to 15 minutes after the peak-hour ended. The number of cars was translated to a length by assuming a queue length of 25 feet per vehicle. During the AM peak period the maximum westbound queue extended 1,750 feet back past the Round Bottom Road intersection and the maximum northbound queue extended 1,250 feet. During the PM peak period the maximum eastbound queue extended almost a half mile (2,400 feet) past the Newtown Corporate limits, the maximum northbound queue extended 1,100 feet, and the maximum southbound queue extended 1,200 feet. The recorded queues during the AM peak period are shown in Figures 14 and 15 and the recorded queues during the PM peak period are shown in Figures 16, 17, and 18.

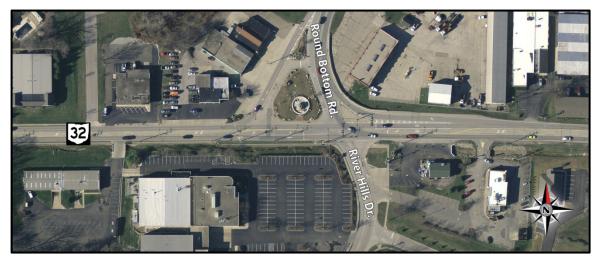
Figure 19. SR 32/Round Bottom Road/River Hills Drive Intersection

The SR 32/Round Bottom Road/River Hills Drive intersection is a five-leg, signalized intersection:

Geometric Data: As seen in Figure 19 (above), vehicles turning right onto SR 32 from Round Bottom Road are removed from the rest of the intersection. This right turn is stop-sign controlled, whereas all other intersection approaches are traffic signal-controlled. This right-turning movement has deficient intersection sight distance. The intersection sight distance for this movement is 290 feet looking left and the required sight distance is 335 feet. Although adequate intersection sight distance is not required at signalized intersections, the left intersection sight distance on River Hills Diver, the right intersection sight distance on Round Bottom Road, and the eastbound SR 32 stopping sight distance are all less than the 335-foot design standard for 30 mph design speed.

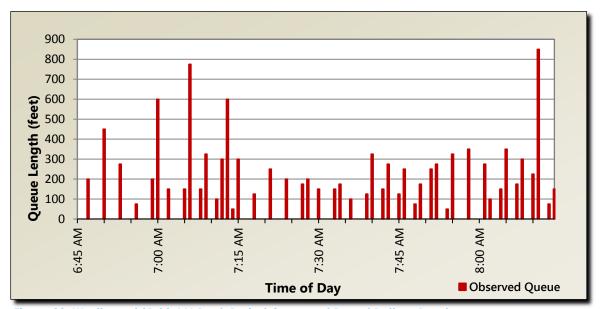
Figure 20. Westbound SR 32 AM Peak Period Queues at Round Bottom Road

To supplement the HCS analysis a queue study was conducted for the westbound approach during the AM peak period and the eastbound and southbound approaches during the PM peak period. The number of cars in the queue was recorded at the end of green for 15 minutes prior to the peak hour to 15 minutes after the peak-hour ended. The number of cars was translated to a length by assuming a queue length of 25 feet per vehicle. During the AM peak period the maximum westbound queue extended 850 feet. During the PM peak period the maximum eastbound queue extended 1,250 feet and the maximum southbound queue extended 1,050 feet. The recorded queues during the AM peak period are shown in Figures 20 and the recorded queues during the PM peak period are shown in Figures 21 and 22:

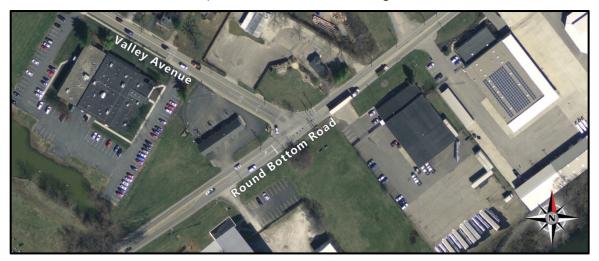
Figure 23. Round Bottom Road/Valley Avenue Intersection

The Round Bottom Road/Valley Avenue intersection is a signalized T-intersection:

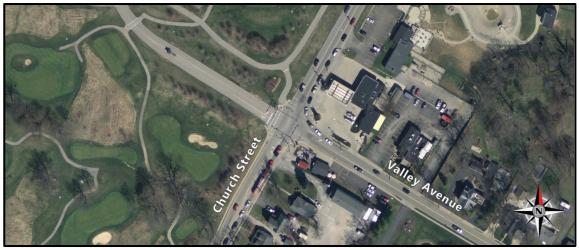
Figure 24. Church Street/Valley Avenue Intersection

The Church Street/Valley Avenue intersection is a signalized four-leg intersection. The northwest leg of this intersection serves as the entrance road to the Little Miami Golf Center:
